Little Beaver Creek Stream and Wetland Restoration Site

2008 Annual Monitoring Report- (Year 2)

Wake County
EEP Project No. 221
Design Firm: Earth Tech

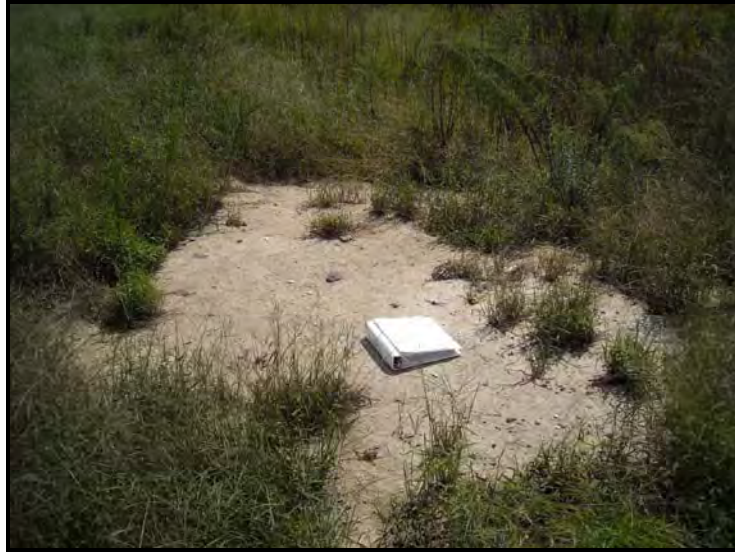
VPA 6. Bare area within the buffer with no vegetation.

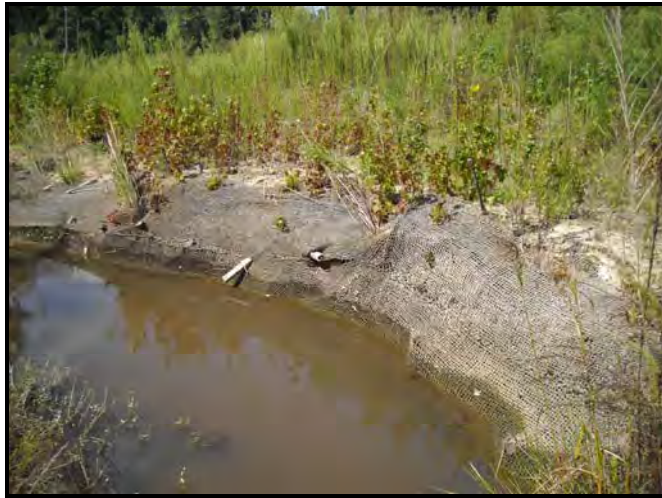
VPA 13. Bare coir matting.

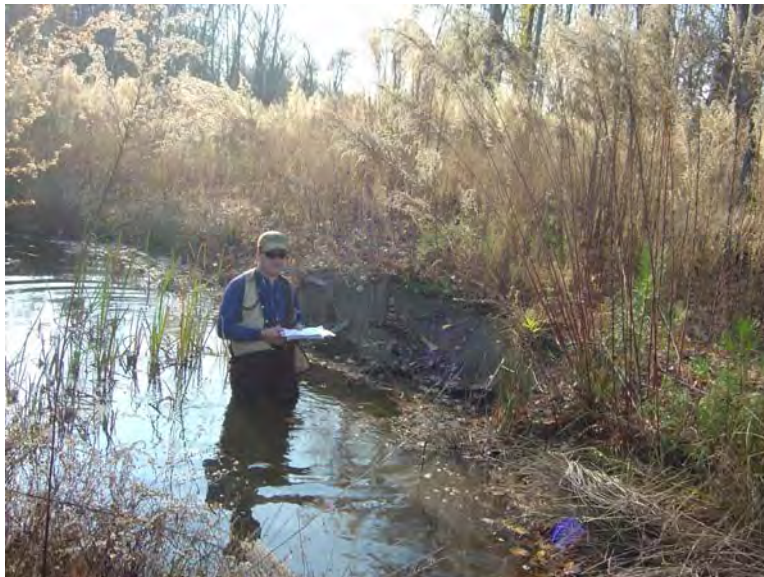
Photo 17: PA_17

Bank Erosion	25+00	Erosion on right bank due to scour hole formation.	PA_17
	25+08		
Over-widening	25+50	Over-widening as a result of depositional aggradation.	PA_18
	25+90		
Over-widening	26+25	Over-widening as a result of depositional aggradation and unstable banks.	PA_19
	26+75		
Bank Failure and Widening	27+00	Unstable bank erosion and channel widening.	PA_20
	27+50		
Structure Failure	27+00	Piping of structure, flow bypassing on right bank.	PA_21
	27+00		
Structure Failure	27+30	Structure has gaps and piping due to improper construction erosion due to bypassing on right bank, no root wads at this location.	PA_22
	27+50		
Degrading Riffle	28+00	Riffle is degrading, no root wads before or after riffle as indicated.	PA_23
	28+00		
Unstable Bank	28+00	No root wads at this location, vertical unstable banks, scouring due to no bank protection or stabilization.	PA_24
	28+25		
Degradation	28+25	Firm structure, scour hole formation causing riffle to degrade degrading riffle material has migrated to banks, structure beginning to pipe.	PA_25

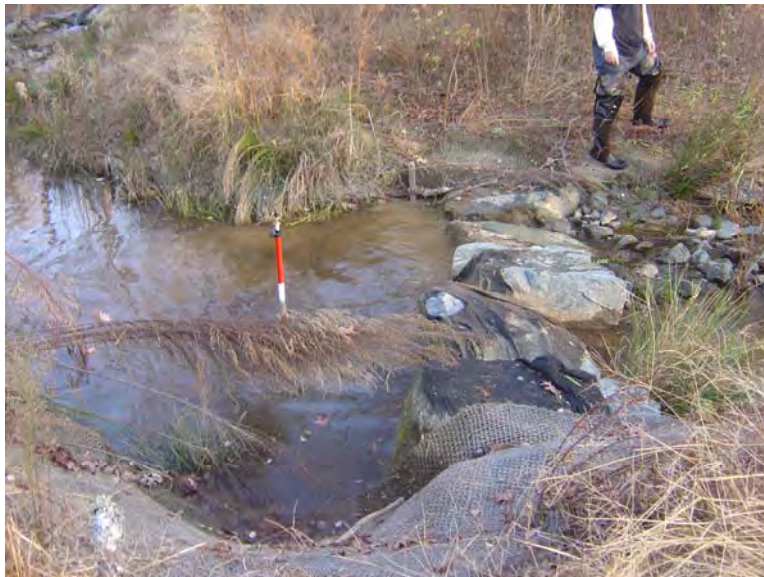
Photo 5: PA_26

28+45		
Structure Failure	28+50	Rootwad placement too high, no footer present piping resulting, erosion is resulting as well.	PA_26
	28+50		
Bank Erosion	28+95	No root wads or structure at this location, channel is widening with vertical eroding bank walls.	PA_27
	29+10		
Structure Failure	29+25	Structure is piping due to boulder gapping and no chinking.	PA_28
	29+25		
Bank Erosion	29+30	Banks are beginning to erode at toe.	PA_29
	29+50		
Bank Erosion	29+75	Right bank is eroding, no root wads at this location.	PA_30
	29+80		
Bank Erosion	30+50	Steep banks in tight meander, no point bar formation.	PA_31
	30+70		
Structure Failure	30+60	Structure is piping due to boulder gapping and no chinking.	PA_32
	30+60		
Structure Erosion	31+10	Structure causing backwater, scour at upstream bank against structure no sill visible.	PA_33
	31+20		
Structure and Bank Failure	31+50	Boulders too large, chinking failed because of joint gapping no root wads present at location, piping, scour on left and right banks.	PA_34

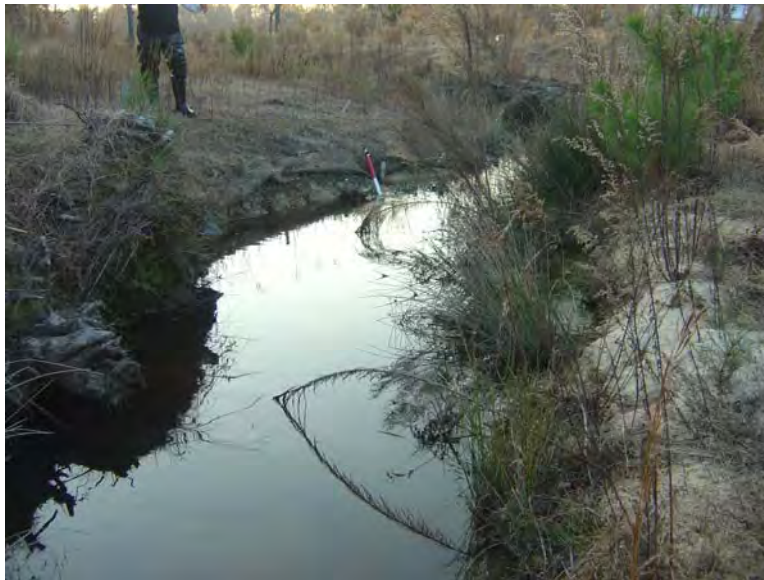
Photo 2: PA_35

Channel Widening	35+25	Erosion on right and left banks, root wads beginning to scour upstream.	PA_35
	36+10		
Degradation, Erosion, Structure Failure	36+10	Erosion and degradation resulting because of structure failure due to piping.	PA_36
	36+10	Possible loss of riffle.	
Bank Erosion & Scour	36+70	Erosion and scour possibly resulting from backwater due to structure.	PA_37
	36+75		
Scour Hole	36+75	Scour resulting from upstream degradation and channel widening possible loss of upstream structure could result in the future.	PA_38
	37+00		
Aggradation	38+00	Aggradation in pool.	PA_39
	38+15		
Bank Erosion	10+60	Bank erosion left and right banks possibly due to steep upstream riffle transition to pool and ending into bench.	TPA_1
	10+80		
Bank Erosion	11+40	Bank eroding on left bank at bench, channel is beginning to straighten due to upstream riffle.	TPA_2
	11+60		
Bank Erosion	11+70	Channel widening in bend erosion and bank failures resulting	TPA_3

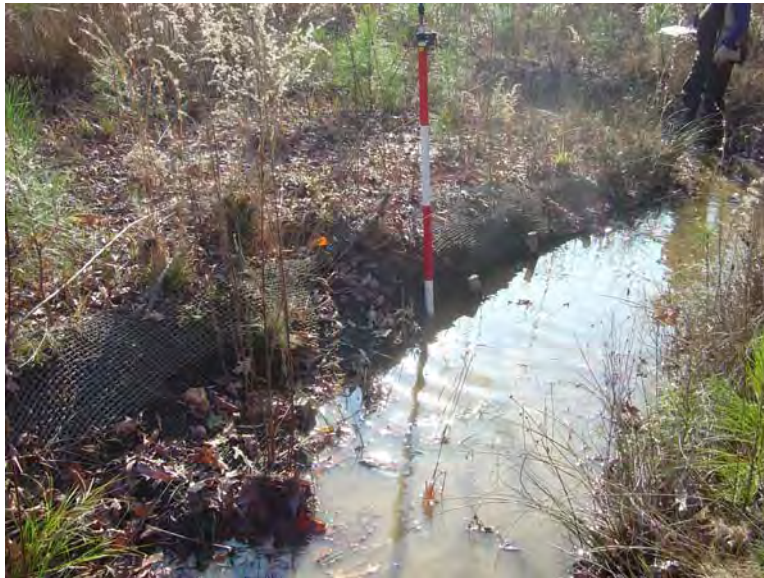
Photo 10: TPA_4

11+95		
Bank Erosion	12+50	Bank erosion	TPA_4
	12+25		
Easment Violation	12+75	Vehicular/ATV crossing of stream, rutting resulting causing stream bank destabilization and disruption of the channel.	TPA_5
	13+00

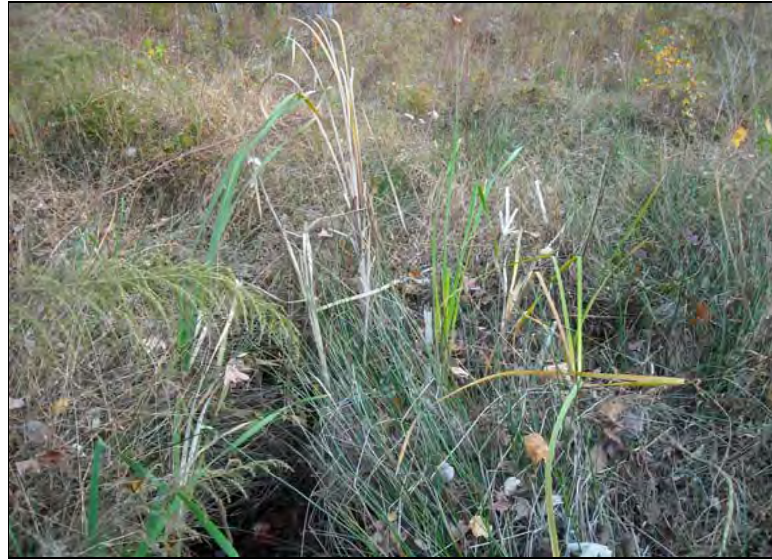
Photo of XS-3, Sta 21+16 looking in the downstream direction

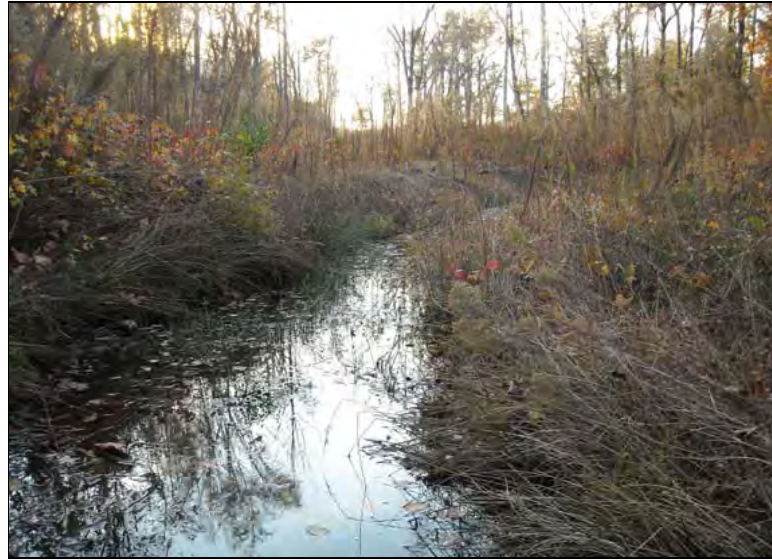
Photo of XS-4, Sta 25+40 looking in the downstream direction

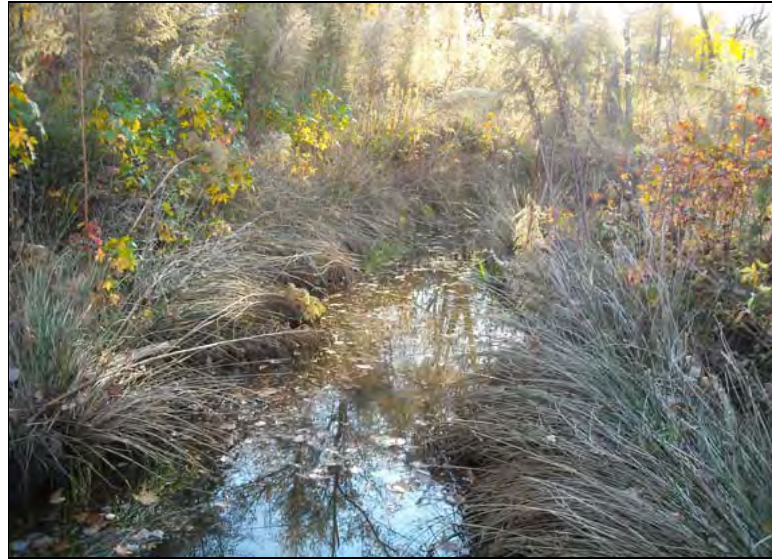
Photo of XS-5, Sta 29+86 looking in the downstream direction

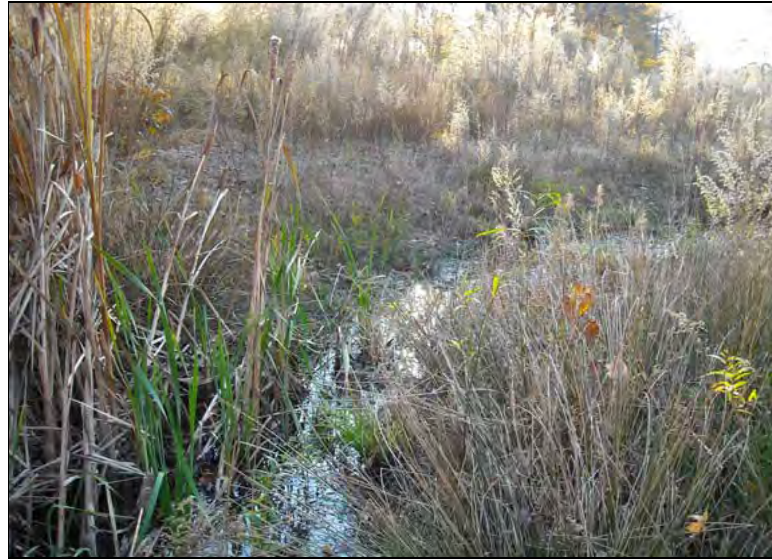
Photo of XS-6, Sta 33+28 looking in the downstream direction

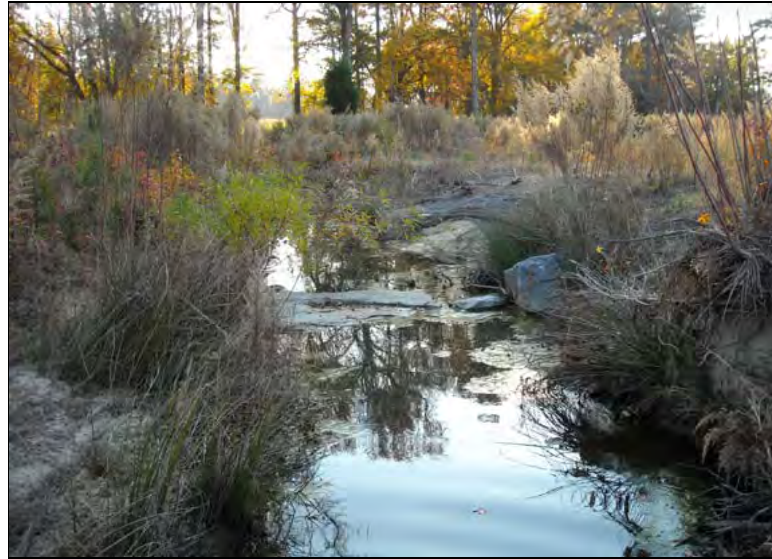
Photo of XS-7, Sta 36+03 looking in the downstream direction

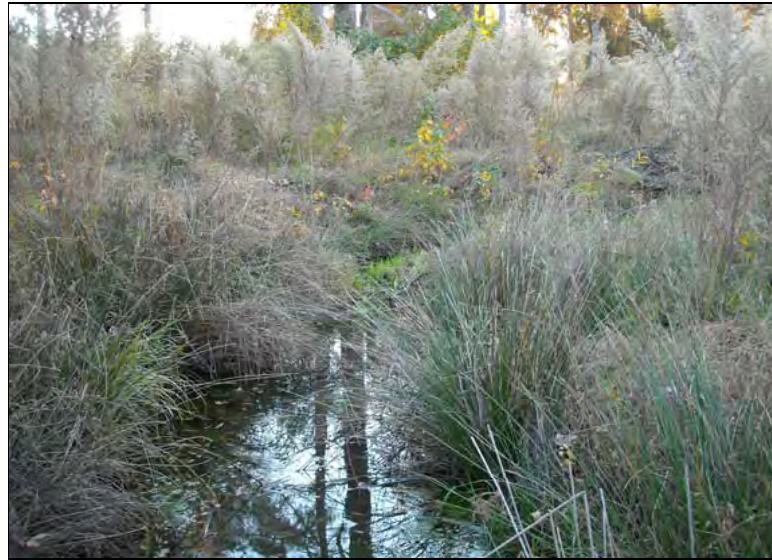
Photo of XS-8, Sta 38+95 looking in the downstream direction

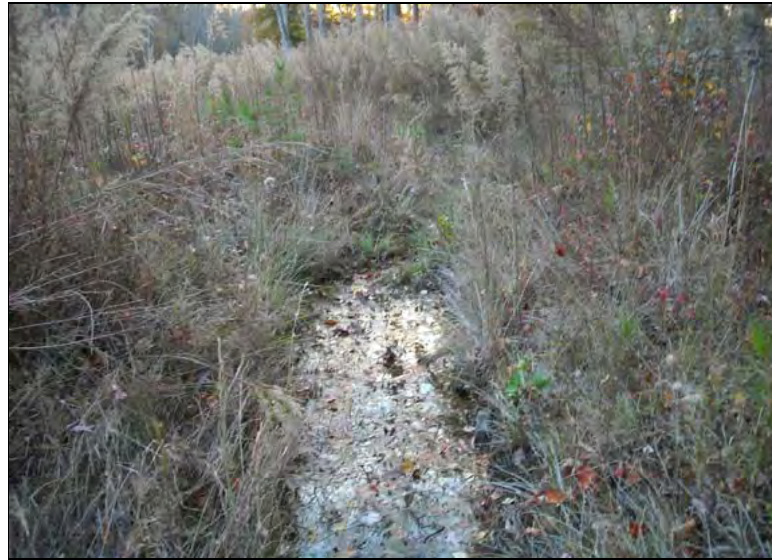
Photo of XS-T1, Sta 11+63 looking in the downstream direction

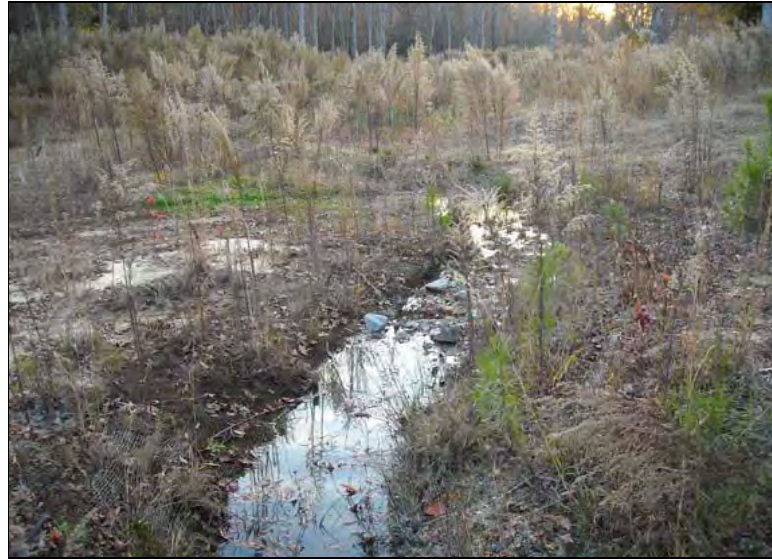
Photo of XS-T2, Sta 12+89 looking in the downstream direction
