**Monitoring Report
Year 1
FINAL
Little Buffalo Creek Stream Mitigation Project**

NCDENR-DMS Project Number: 94147

Data collection: September 2015

Submitted: March 2016

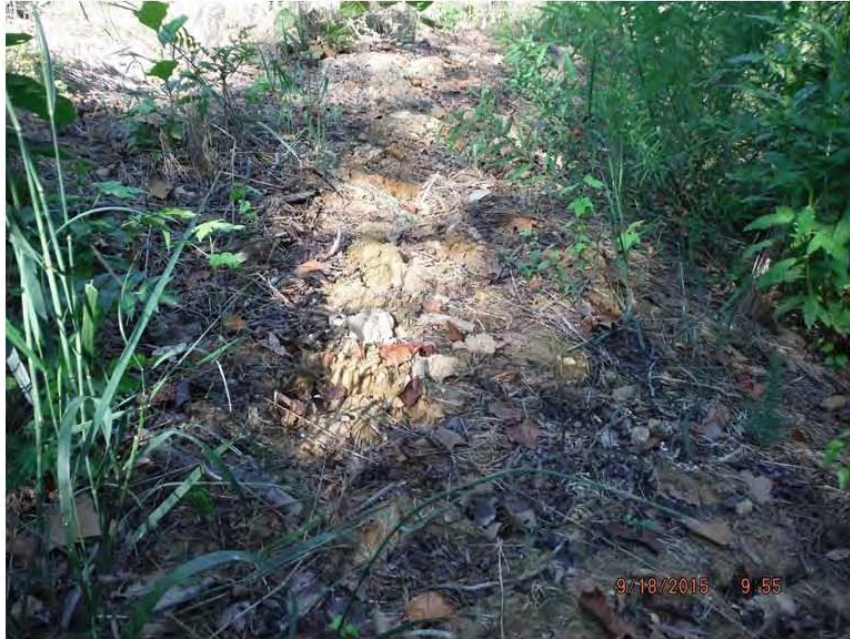
Reach 3 – UT4 - Cow prints in E1 area

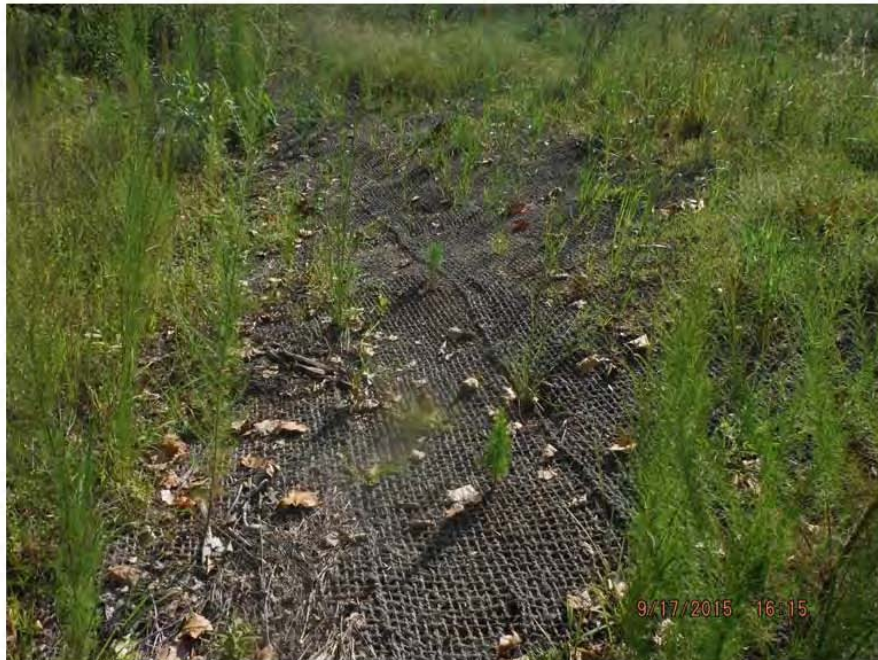
Reach 4 – MS-3P – Low vegetation cover

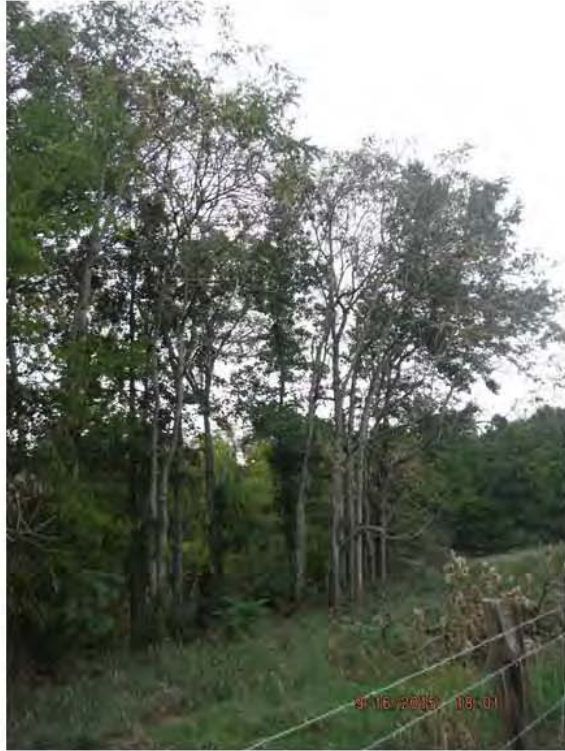
Reach 6 - Tree of Heaven at UT7

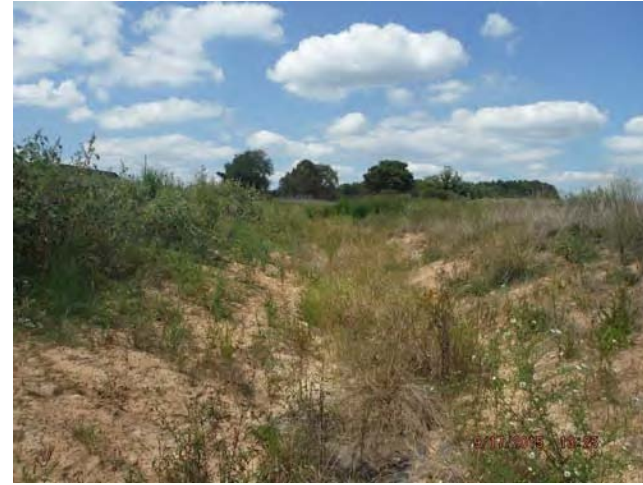
Station and description 1534.98 UT3-1P Looking Upstream

- 1) Bankfull Elevation held as MY0 Baseline Elevation
MY-1 Bankfull elevation has significantly changed and is 639.22

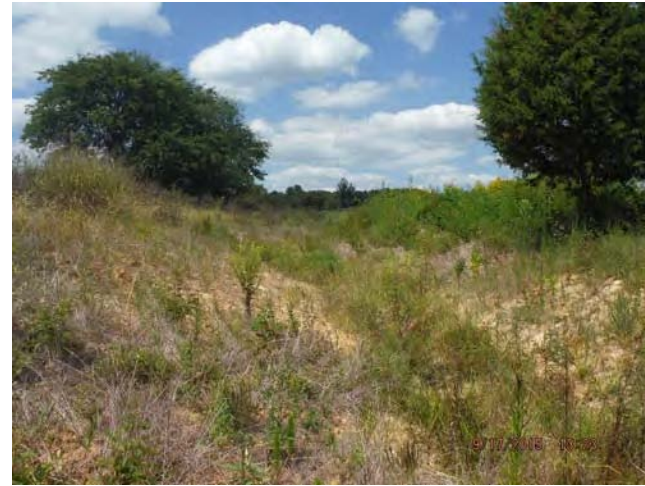
Station and description 1802.03 UT3-2R Looking Upstream

- 1) Bankfull Elevation held as MY0 Baseline Elevation
- MY-1 Bankfull elevation has significantly changed and is 633.69
