**Monitoring Report  
Year 3  
FINAL  
Little Buffalo Creek Stream Mitigation Project**

*NCDEQ-DMS Project Number: 94147  
Contract Number: 2029  
USACE Permit Action ID: 2014-00386  
DWR Permit: 14-0129  
Cabarrus County*

**Data collection: September/November 2017  
Draft Submitted: December 2017  
Final Submitted: February 2018**

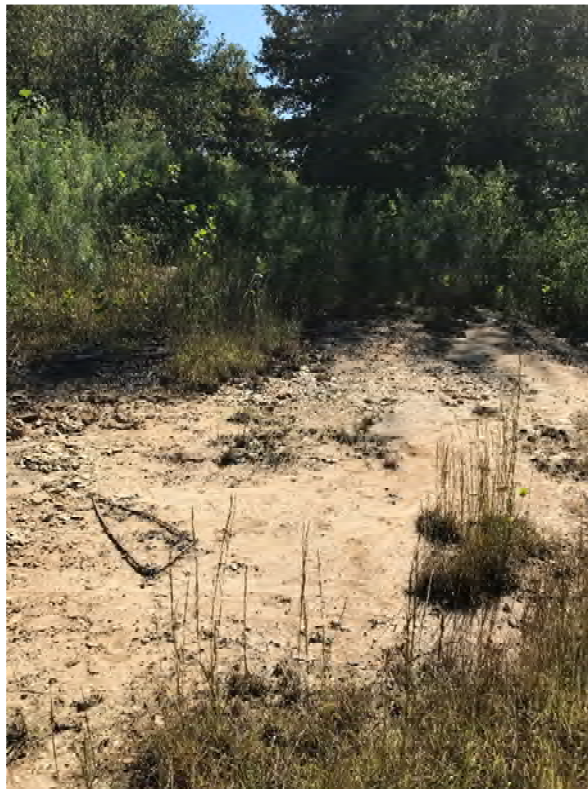
Bare spot in floodplain in reach 1

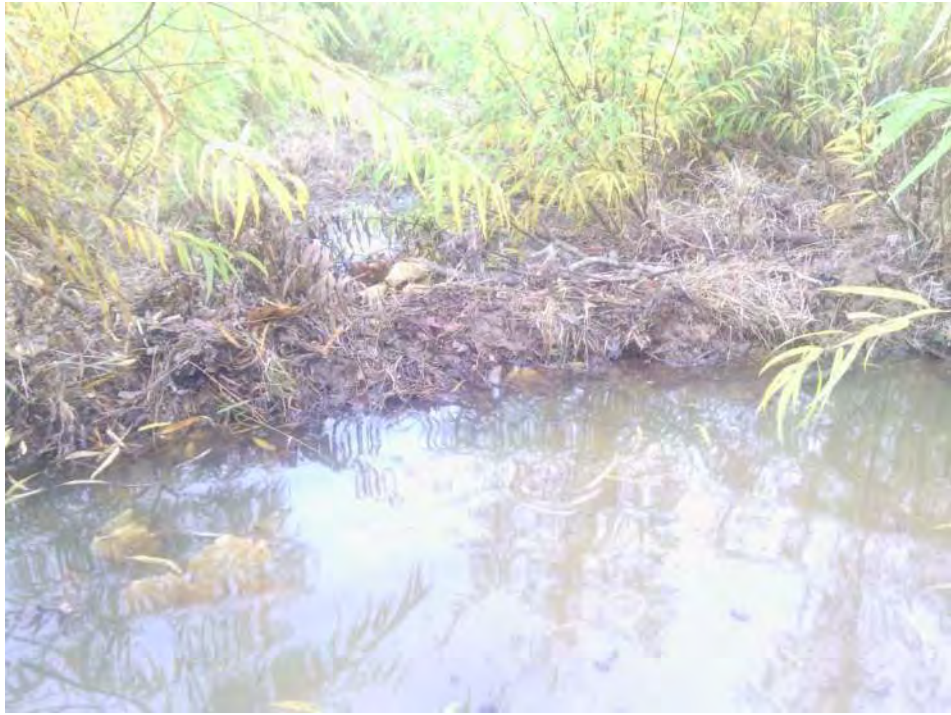
Beaver dam in restoration area of reach 1

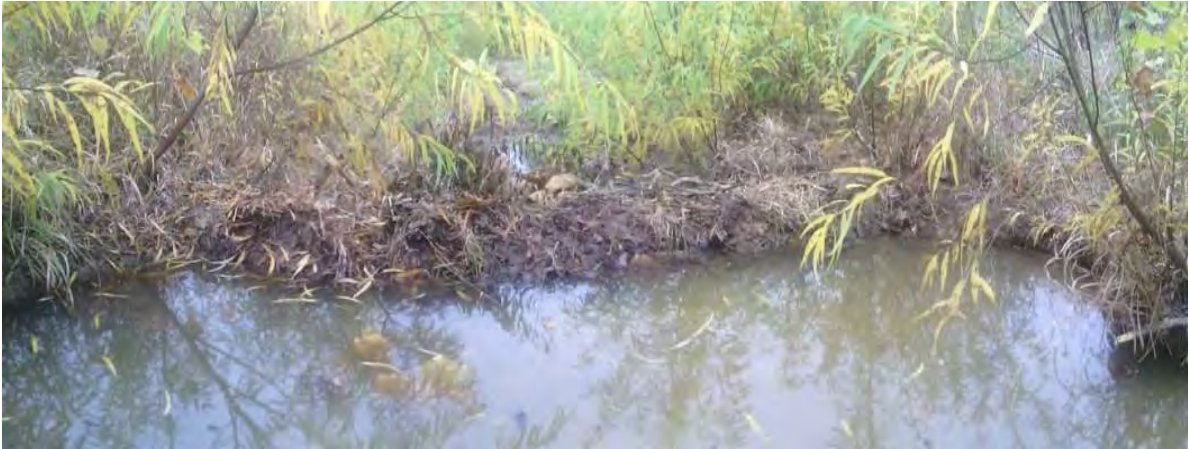
Panoramic view of beaver dam in restoration area of reach 1

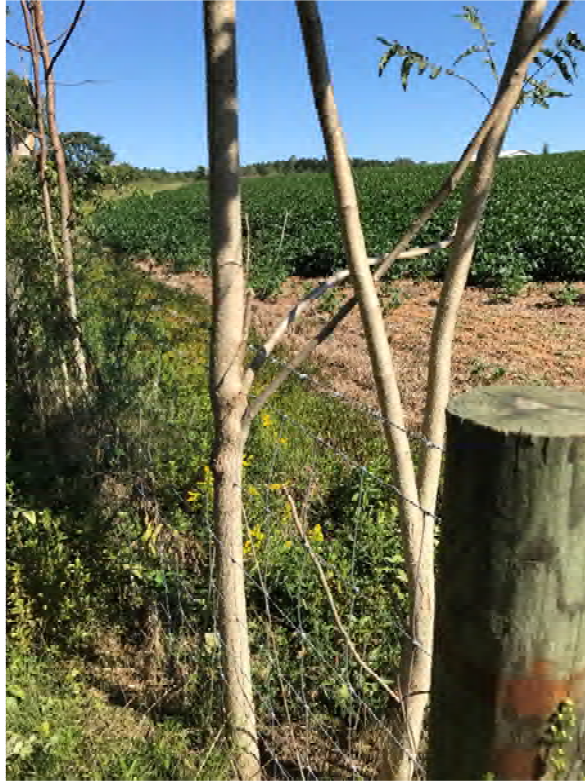
Tree of heaven in upper portions of UT2

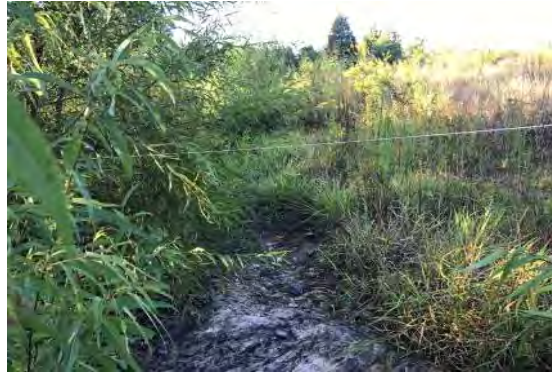
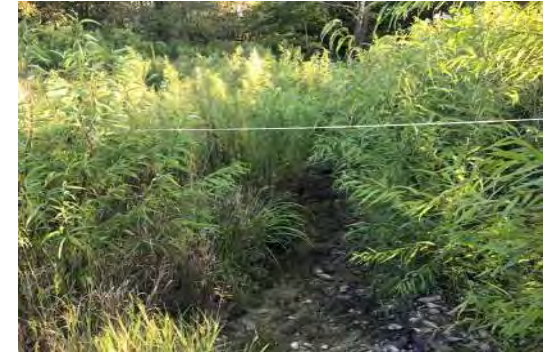
Station and description 24+91.17 MS-1R Looking Upstream

Note: Beaver Dam located upstream of MS-1R in MY3 survey - no flowing water for cross section

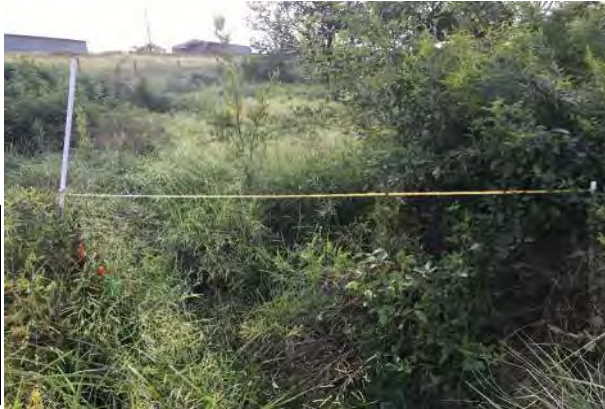
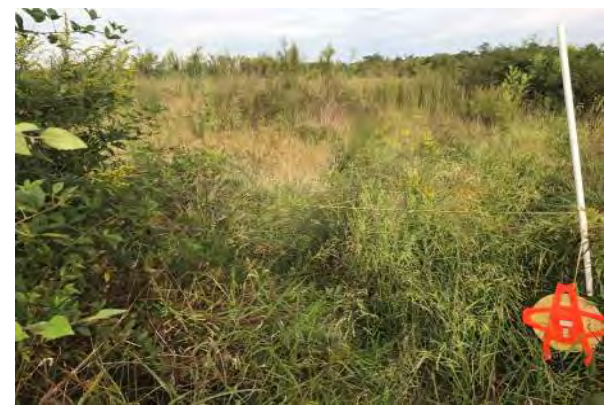
Station and description 1166.28 UT3-1R Looking Upstream

Note: No visual water surface during MY 3 survey

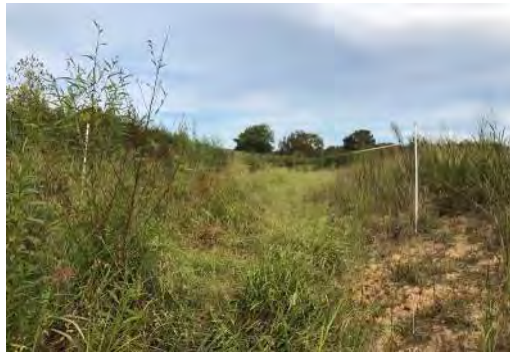
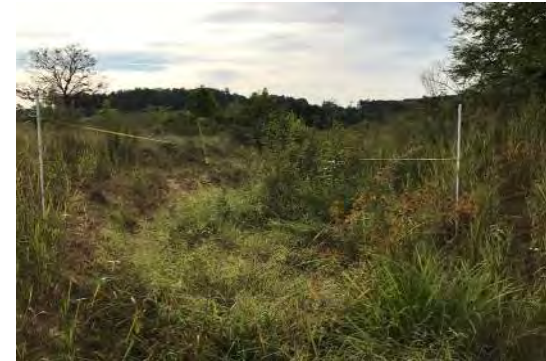
Station and description 1534.98 UT3-1P Looking Upstream

Note: No visual water surface during MY 3 survey

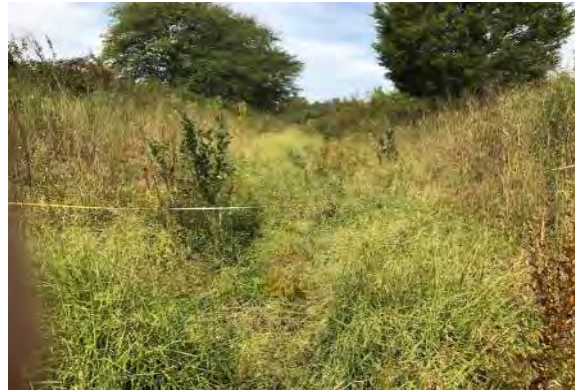
Station and description 1802.03 UT3-2R Looking Upstream

Note: No visual water surface during MY 3 survey

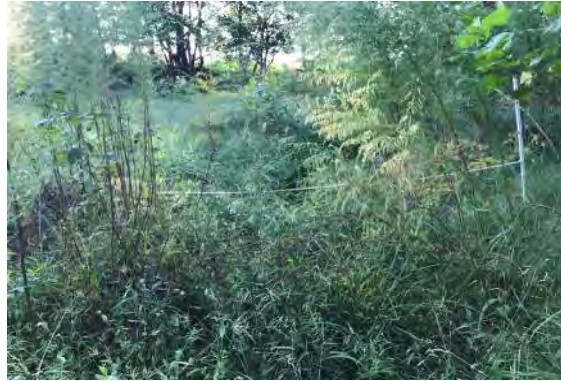
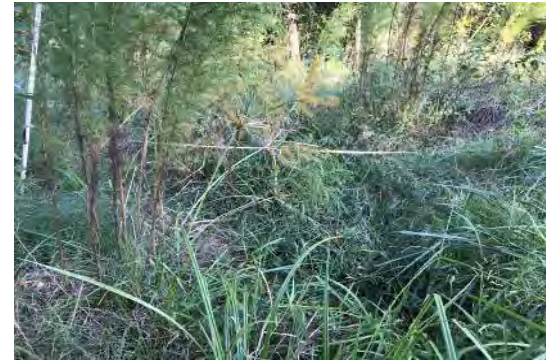
Station and description 2426.03 UT3-3R Looking Upstream

Note: No visual water surface during MY 3 survey

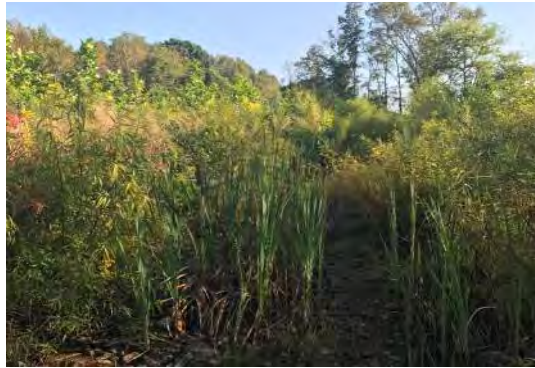
Station and description 1345.64 UT7-1R Looking Upstream

Note: UT 7 was dry during MY 3 survey

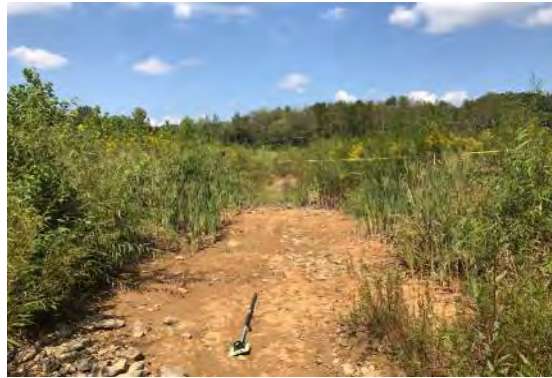
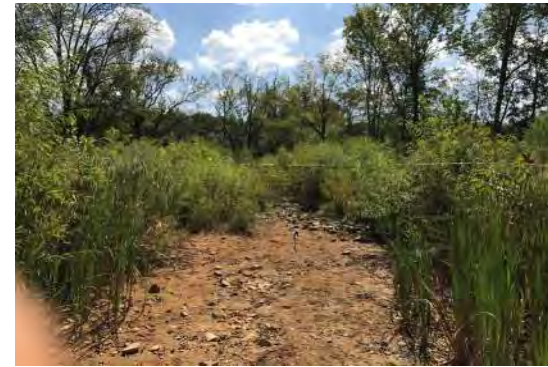
Station and description 1592.61 UT7-1P Looking Upstream

Note: UT 7 was dry during MY 3 survey
