**Monitoring Report
Year 4
FINAL**

Little Buffalo Creek Stream Mitigation Project

*NCDEQ-DMS Project Number: 94147
Contract Number: 2029
USACE Permit Action ID: 2014-00386
DWR Permit: 14-0129
Cabarrus County*

**Data collection: September/October/November 2018
Draft Submitted: January 2019
Final Submitted: March 2019**

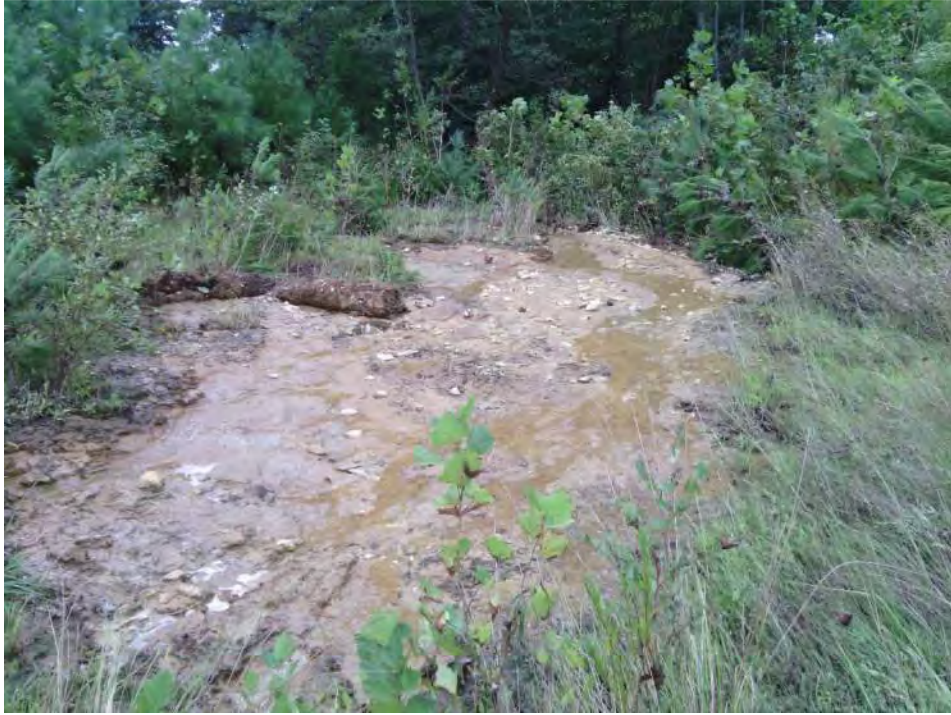
Bare spot (Copper Toxicity) in floodplain in Reach 1

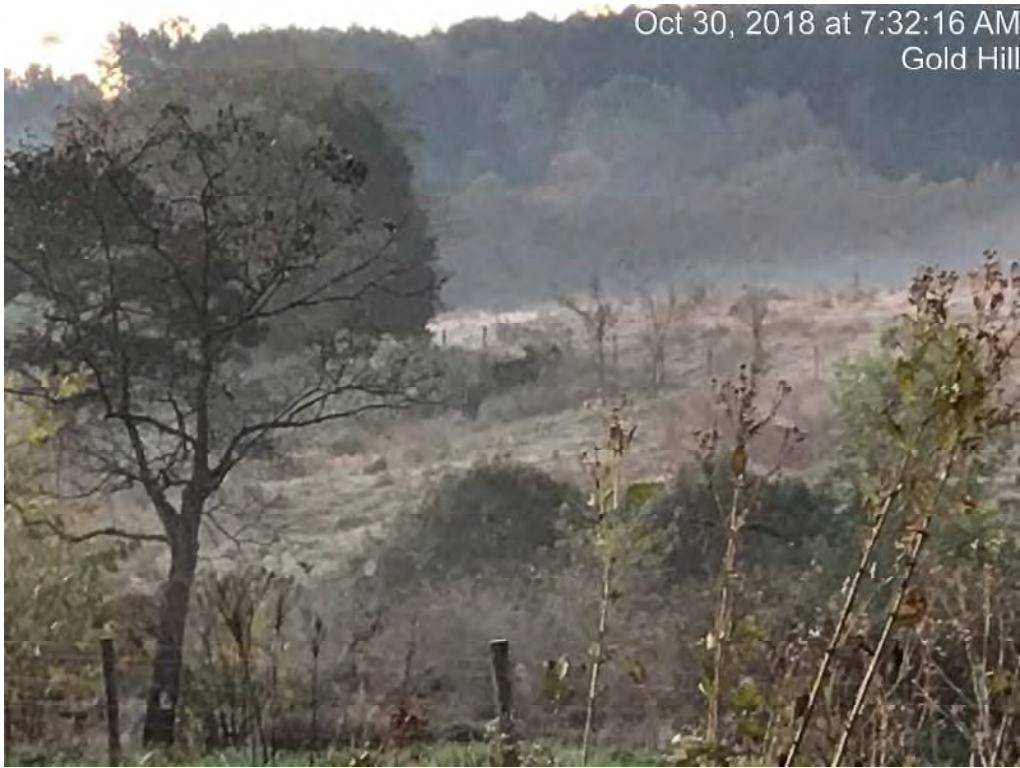
Cows in UT3

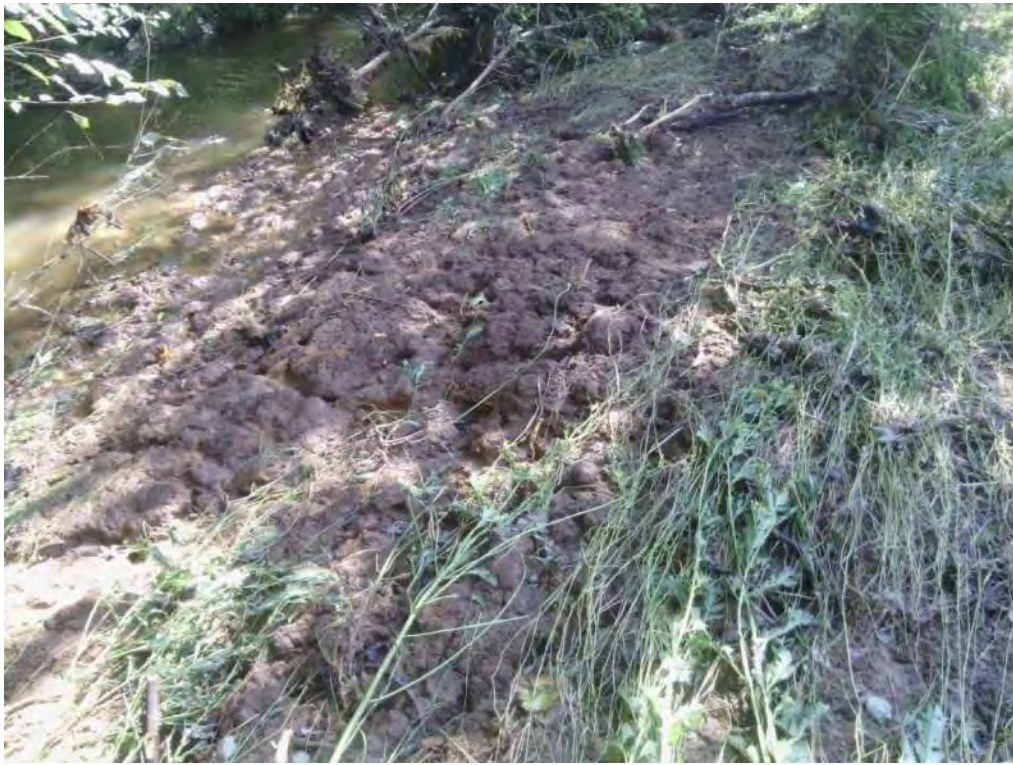
Cow Trampling in Reach 2

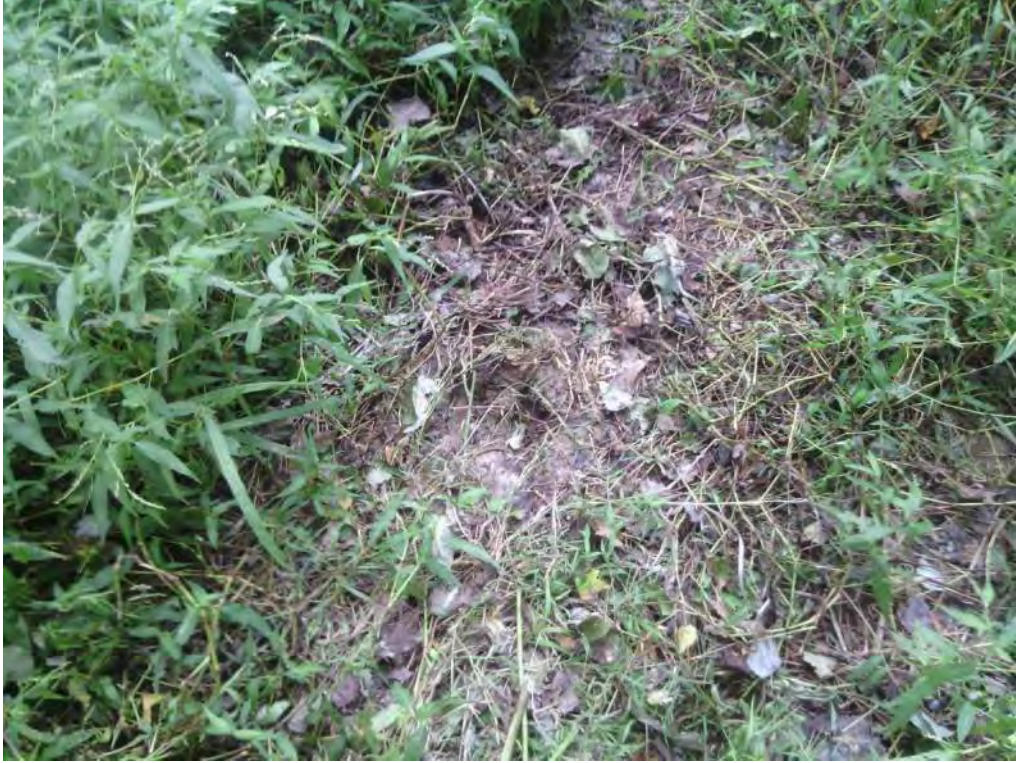
Cow tracks in Reach 3

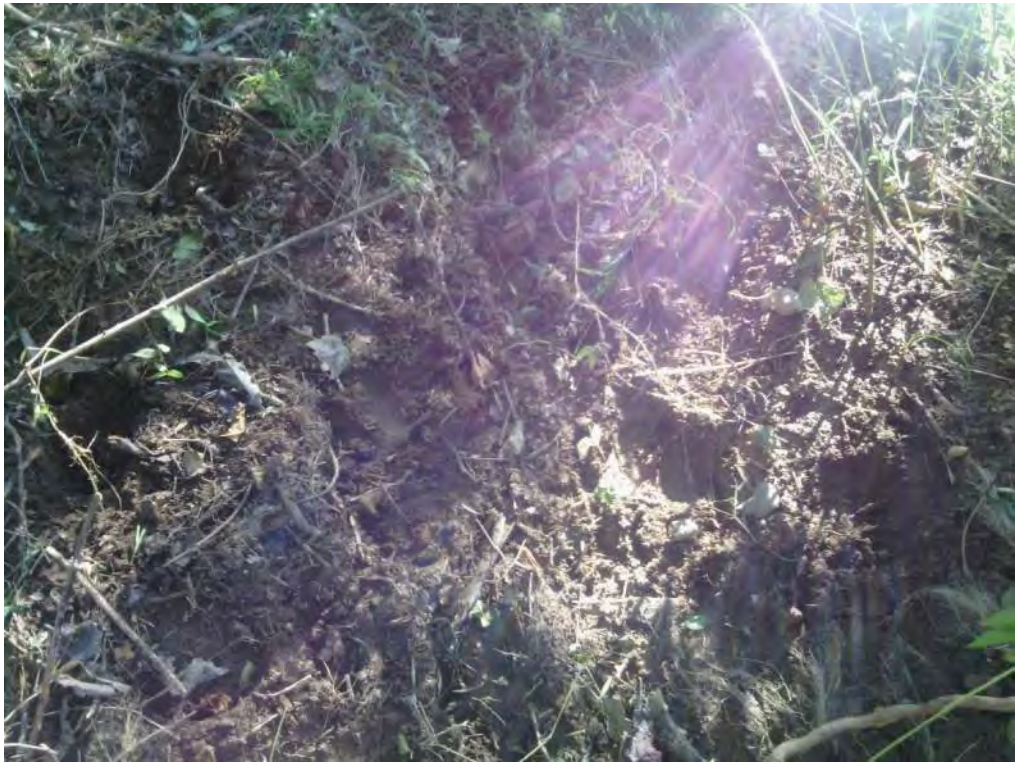
Cow tracks in Reach 5

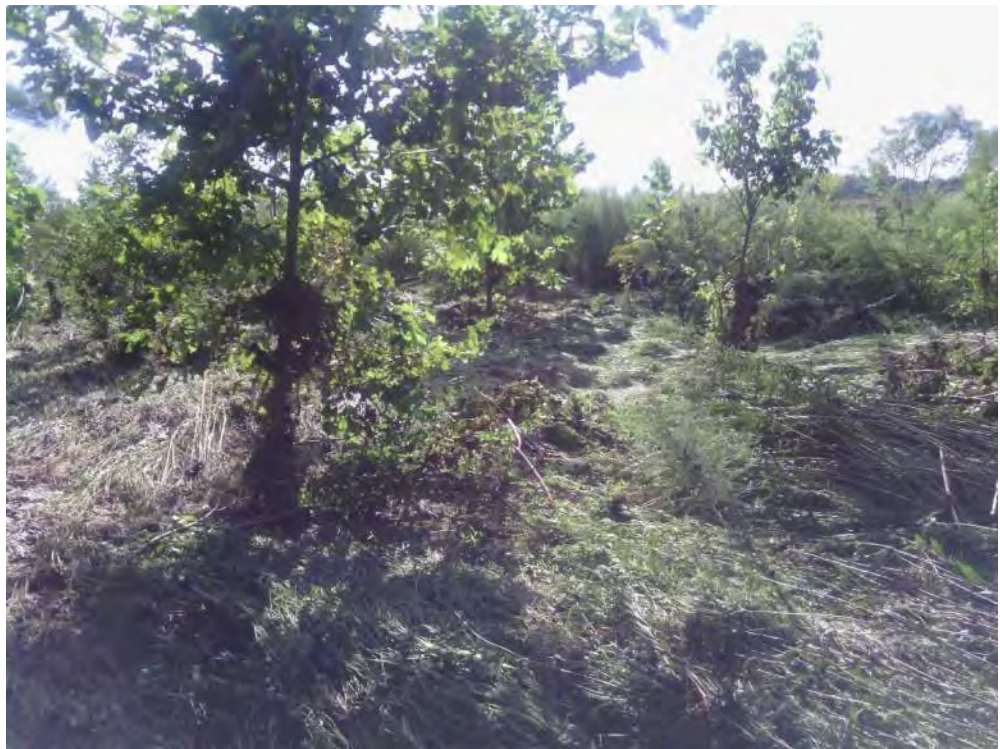
Flattened vegetation from hurricane flow event (Reach 2)

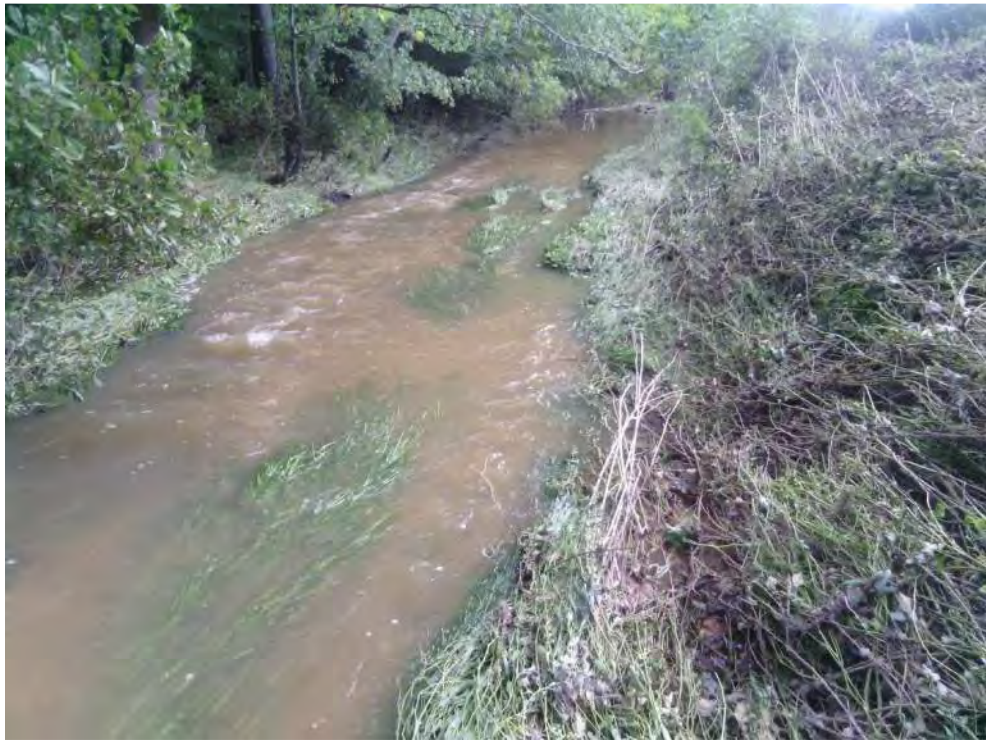
Over flowing in Reach 3

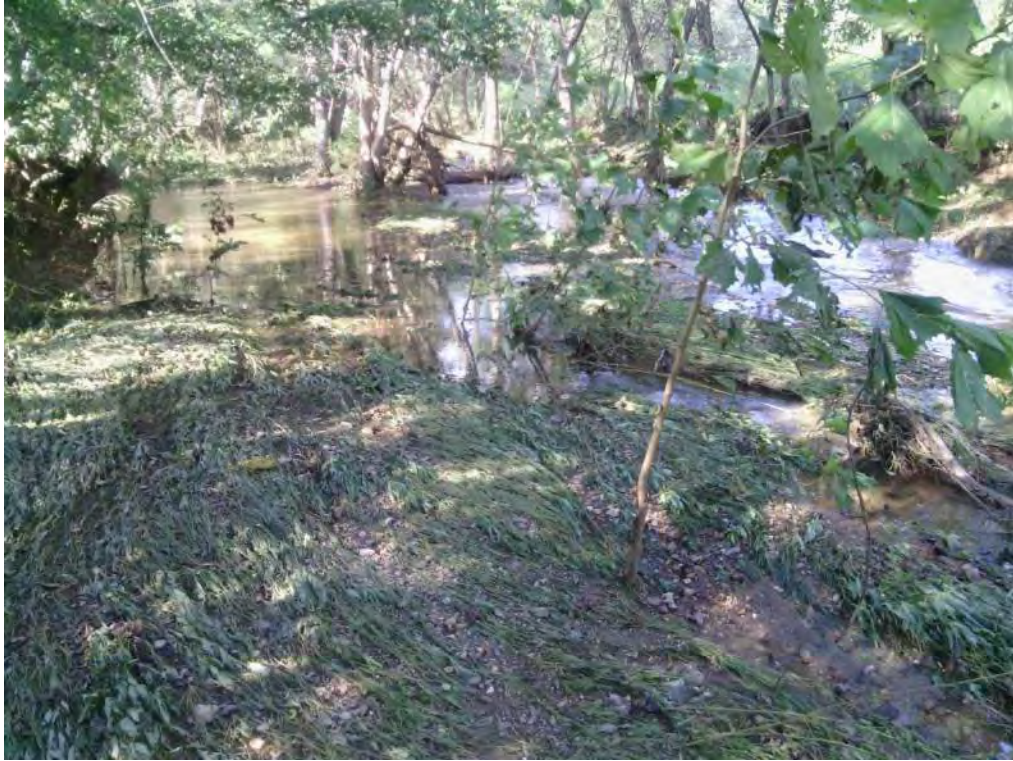
Significant flow evidence in Reach 4

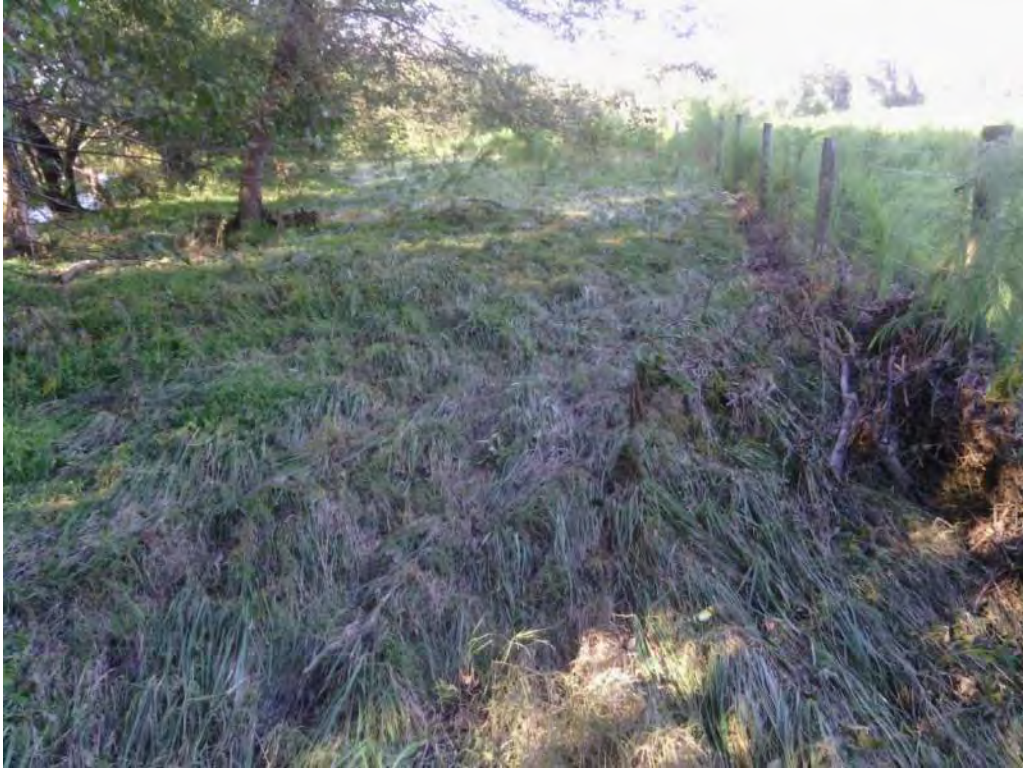
Significant flow evidence in Reach 5

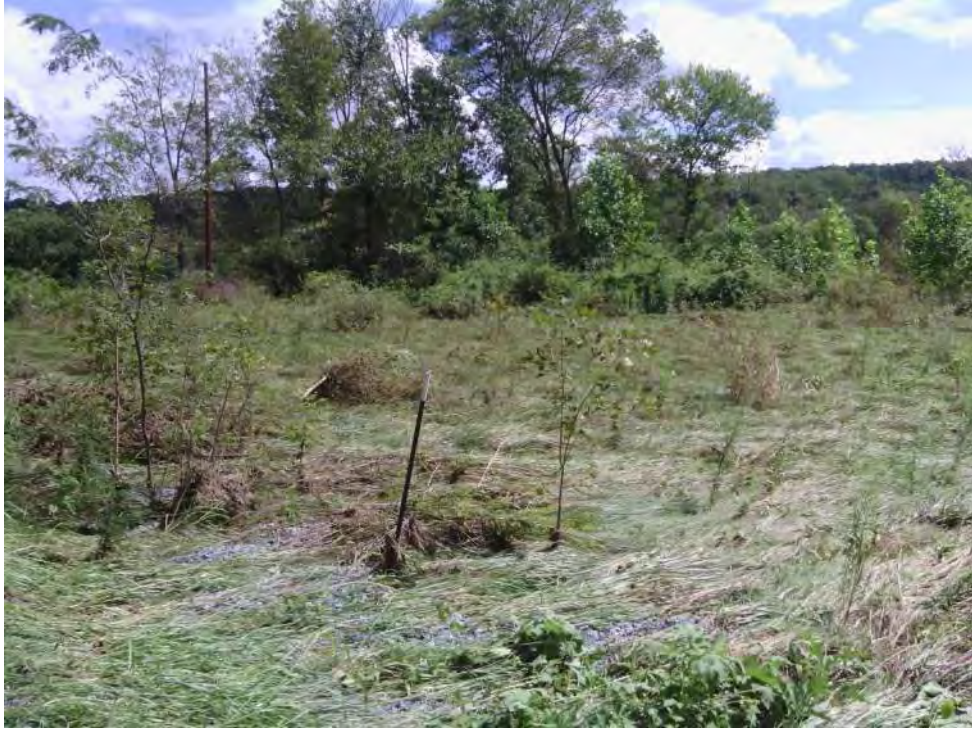
Bent vegetation in floodplain of UT7

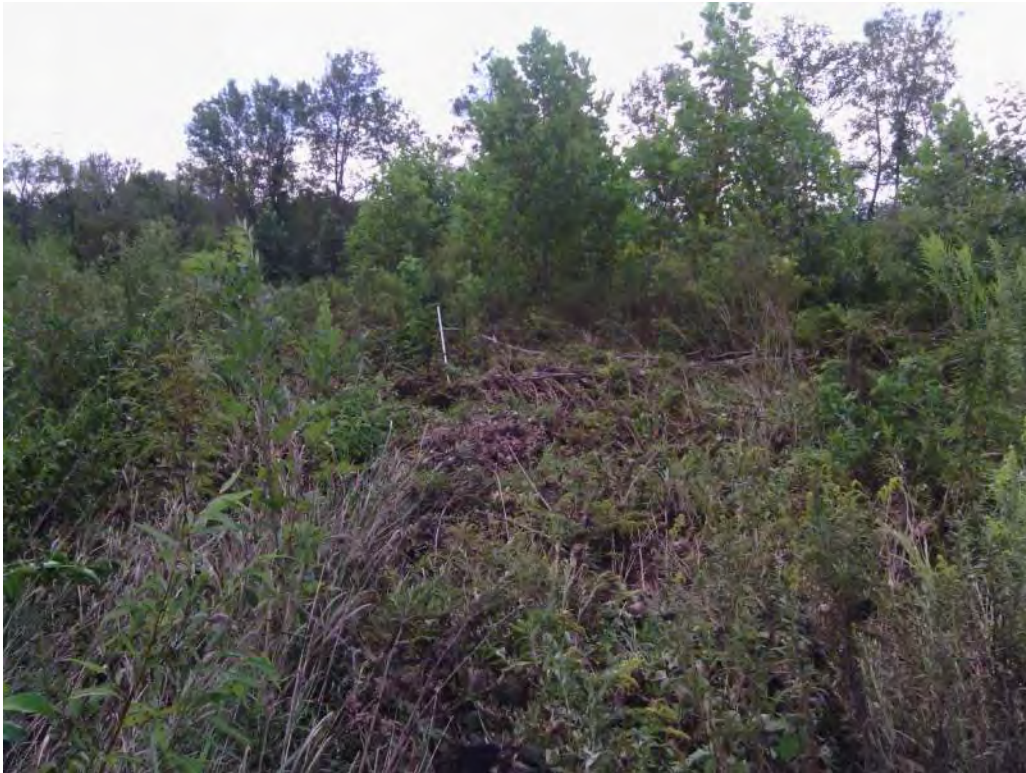
Bent vegetation in floodplain of UT7

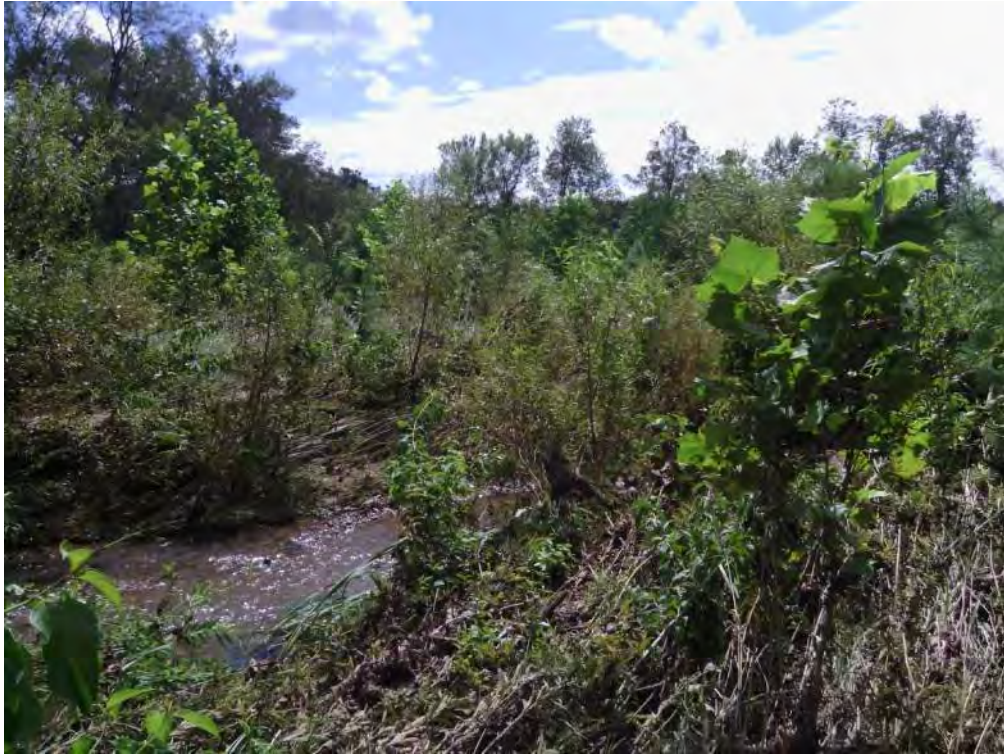
Bent vegetation in floodplain of UT7

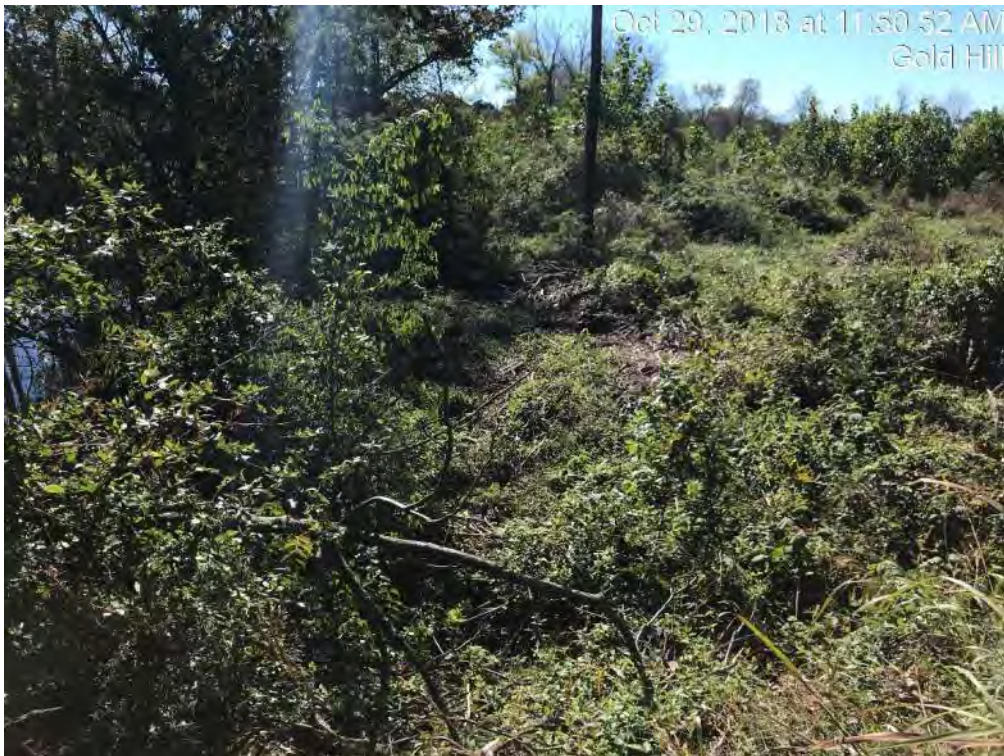
Bent vegetation in floodplain of UT7

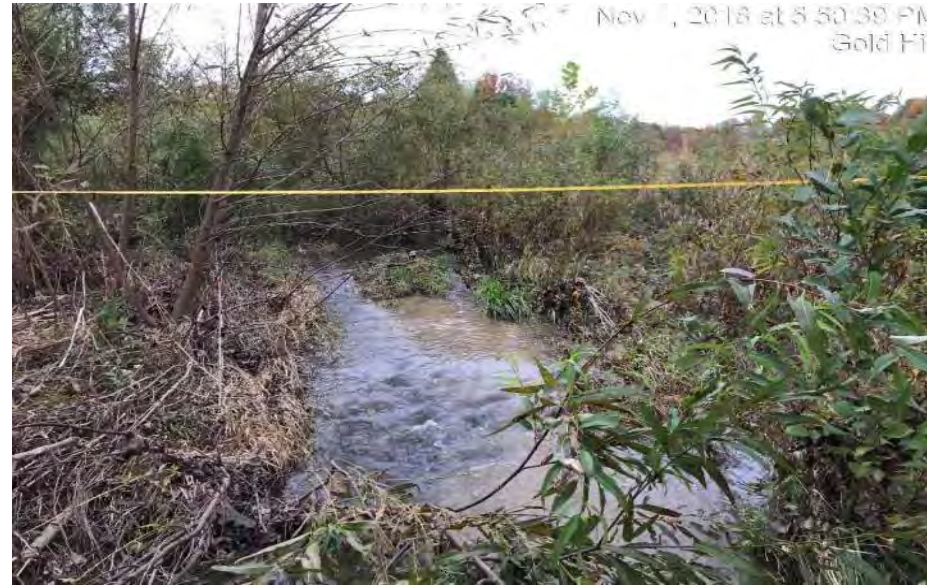
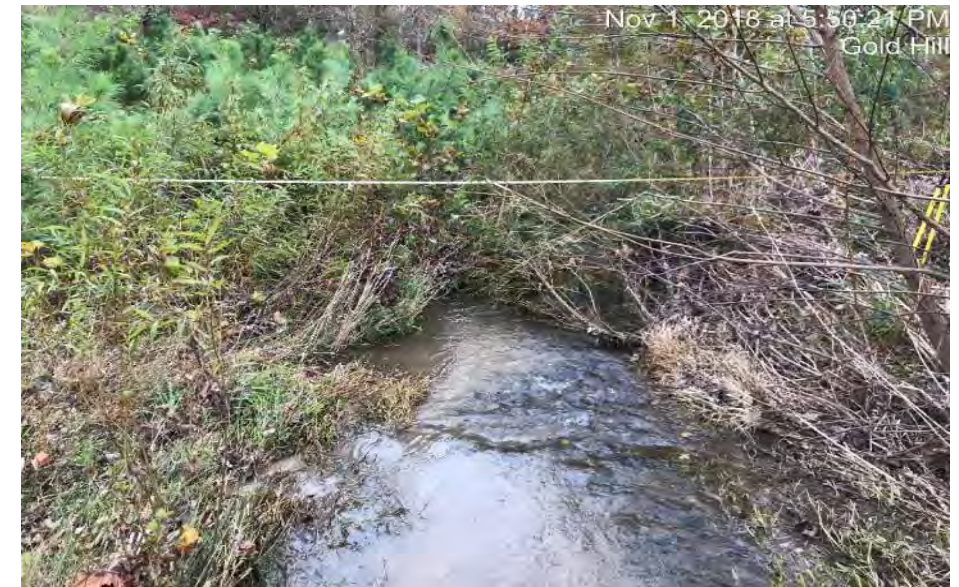
Little Buffalo Creek Mainstem
X-Section 2, Riffle, Station 24+91.17

Station and description 24+91.17 MS-1R Looking Upstream

24+91.17 MS-1R Looking Downstream

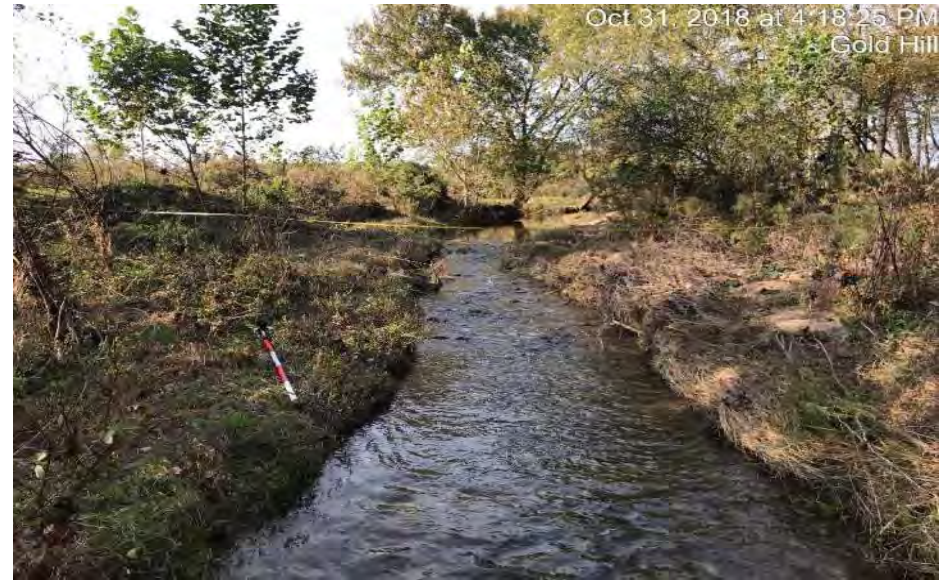
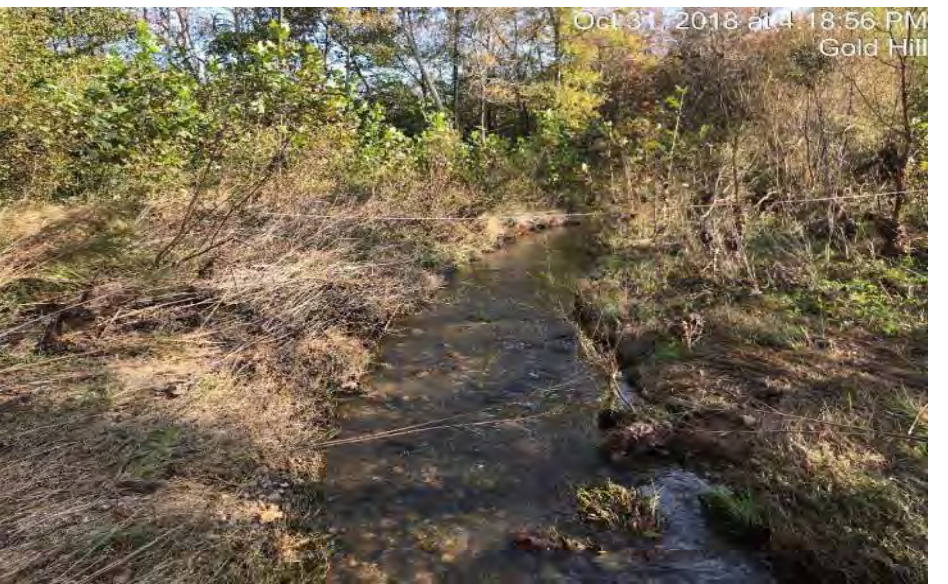
River Basin:	Yadkin-Pee Dee River
Watershed:	Little Buffalo Creek
XS ID:	MS-2R
Drainage Area (sq mi):	2.82
Date:	10/31/2018
Field Crew:	Matthew Holthaus, Alston Willard, Louis Berger

NOTE: XS 2R and 2P reshaped as part of MY2 to remove backwater and overflow conditions upstream.

As observed in the method of determining bank height ratio, modifications to the channel in year 2 at XS 2R has created high bank height ratios. This is not a valid characterization of stability at this section with holding by holding the as-built baseline bankfull elevation in determining cross-section characterizations. The channel in this section of restoration is a tiered system and is providing proper floodplain connection to allow waters out of the channel. The work was performed due to backwater conditions caused by this riffle, which was a greater sign of instability.

Station and description 4908.73 MS-2R Looking Upstream

4908.73 MS-2R Looking Downstream

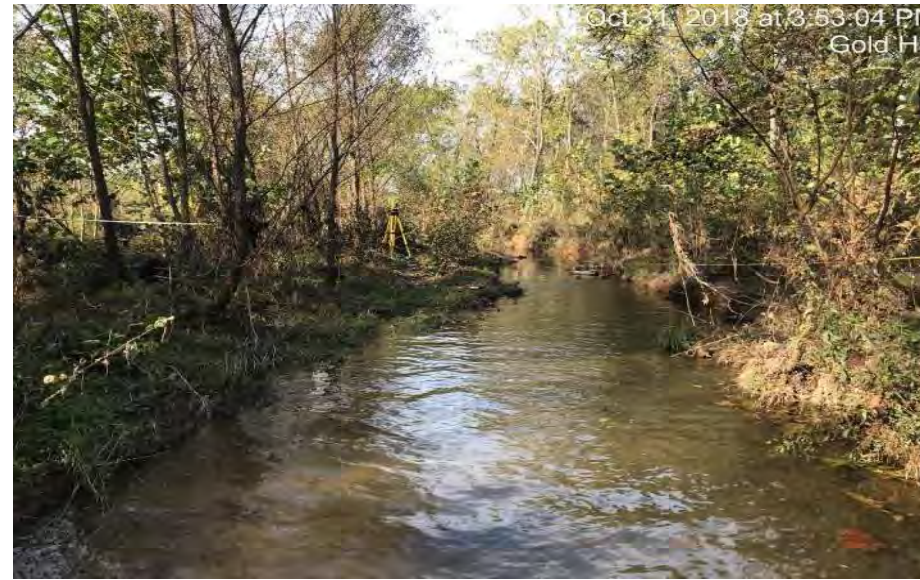
River Basin:	Yadkin-Pee Dee River
Watershed:	Little Buffalo Creek
XS ID:	MS-2P
Drainage Area (sq mi):	2.82
Date:	10/31/2018
Field Crew:	Matthew Holthaus, Alston Willard, Louis Berger

Station and description 5008.51 MS-2P Looking Upstream

5008.51 MS-2P Looking Downstream

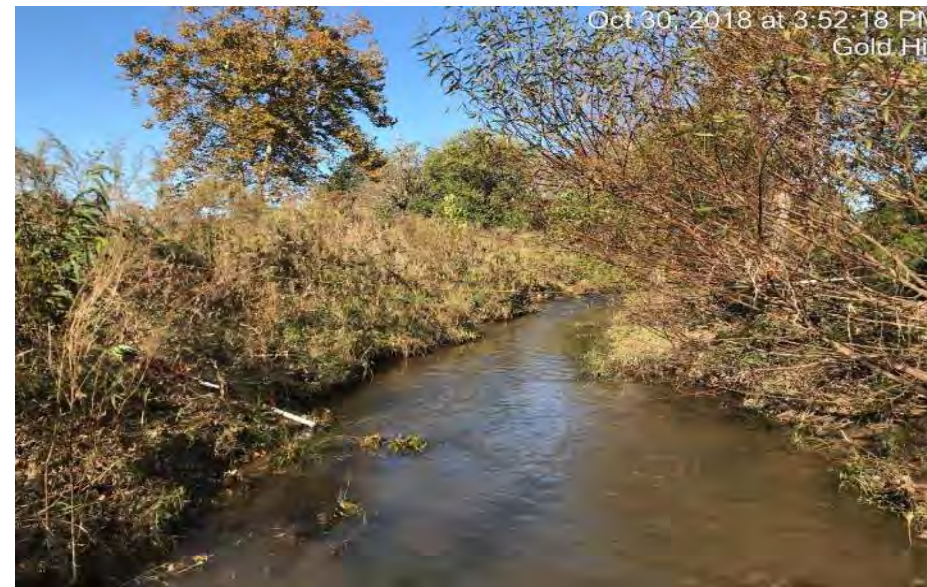
River Basin:	Yadkin-Pee Dee River
Watershed:	Little Buffalo Creek
XS ID:	MS-3P
Drainage Area (sq mi):	4.01
Date:	10/30/2018
Field Crew:	Matthew Holthaus, Alston Willard, Louis Berger

Station and description 6433.12 MS-3P Looking Upstream

6433.12 MS-3P Looking Downstream

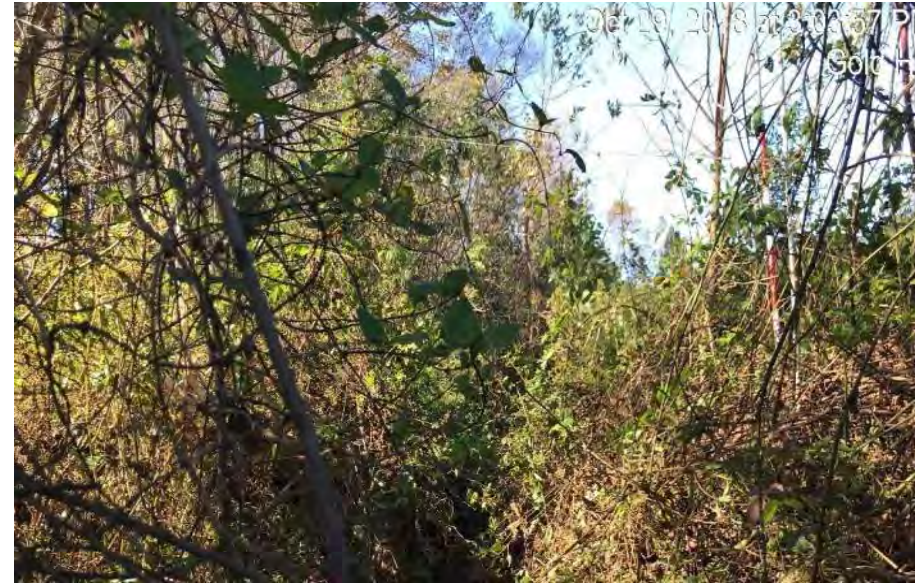
River Basin:	Yadkin-Pee Dee River
Watershed:	Little Buffalo Creek
XS ID:	UT2-1R
Drainage Area (sq mi):	0.3
Date:	10/29/2018
Field Crew:	Matthew Holthaus, Alston Willard, Louis Berger

Station and description 1391.34 UT2-1R Looking Upstream

1391.34 UT2-1R Looking Downstream

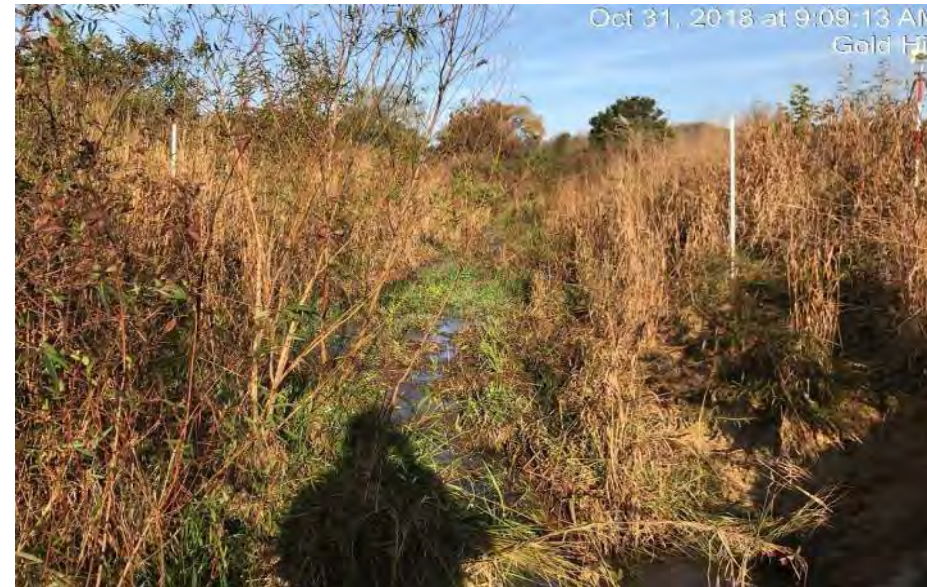
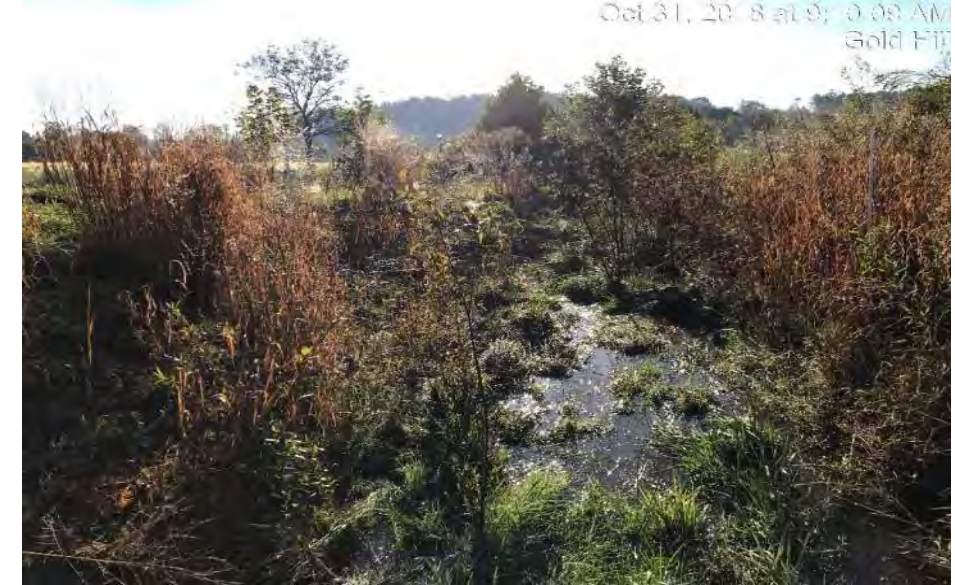
River Basin:	Yadkin-Pee Dee River
Watershed:	Little Buffalo Creek
XS ID:	UT3-1P
Drainage Area (sq mi):	0.097
Date:	10/30/2018
Field Crew:	Matthew Holthaus, Alston Willard, Louis Berger

Station and description 1534.98 UT3-1P Looking Upstream

1534.98 UT3-1P Looking Downstream

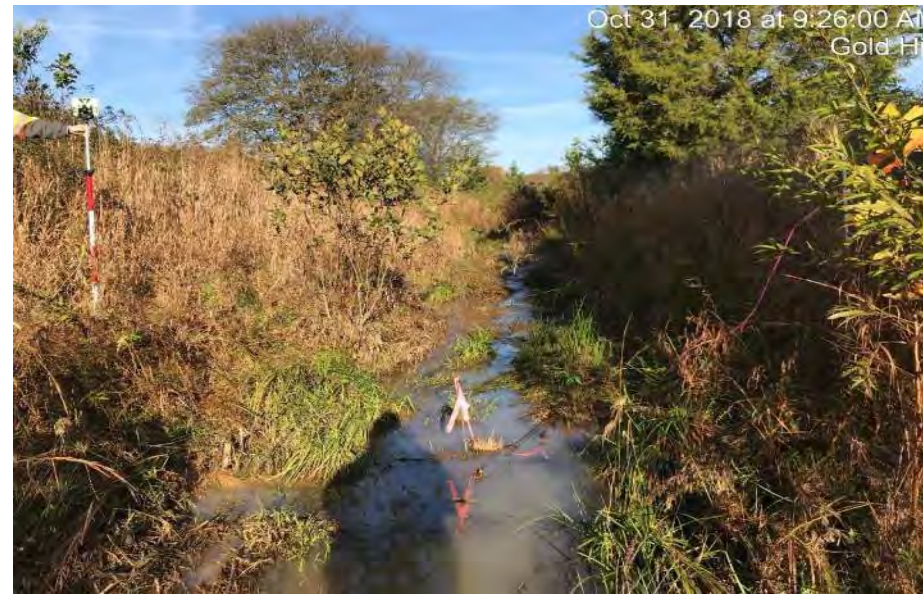
River Basin:	Yadkin-Pee Dee River
Watershed:	Little Buffalo Creek
XS ID:	UT3-2R
Drainage Area (sq mi):	0.097
Date:	10/31/2018
Field Crew:	Matthew Holthaus, Alston Willard, Louis Berger

Station and description 1802.03 UT3-2R Looking Upstream

1802.03 UT3-2R Looking Downstream

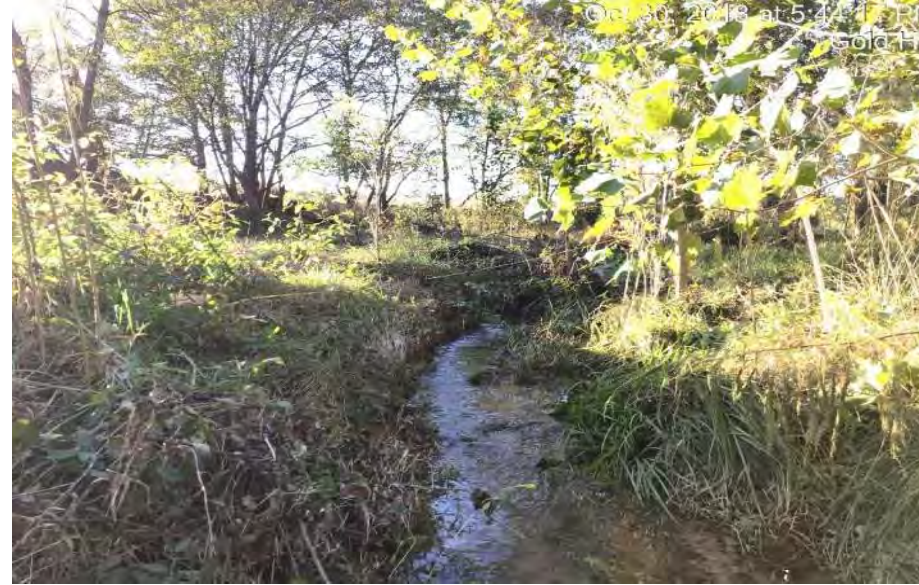
River Basin:	Yadkin-Pee Dee River
Watershed:	Little Buffalo Creek
XS ID:	UT3-3R
Drainage Area (sq mi):	0.097
Date:	10/30/2018
Field Crew:	Matthew Holthaus, Alston Willard, Louis Berger

Station and description 2426.03 UT3-3R Looking Upstream

2426.03 UT3-3R Looking Downstream

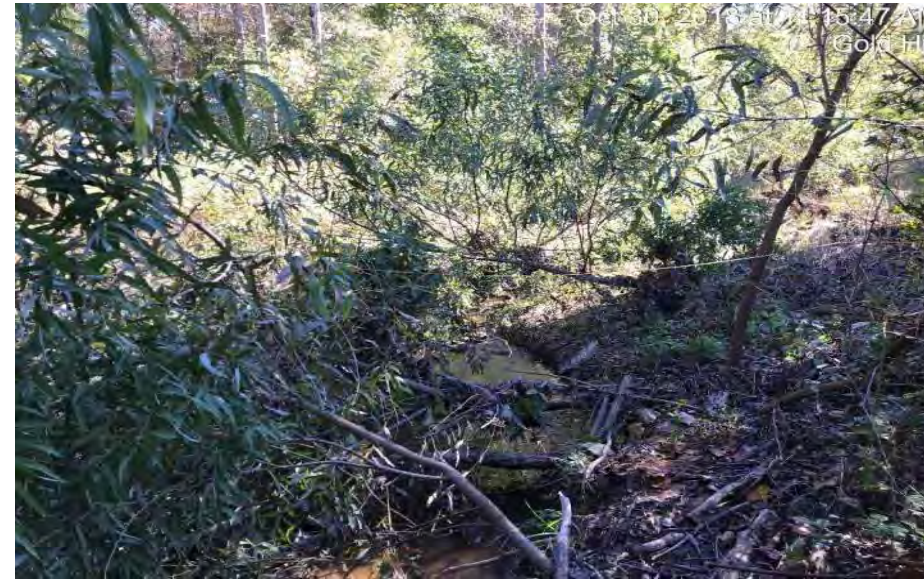
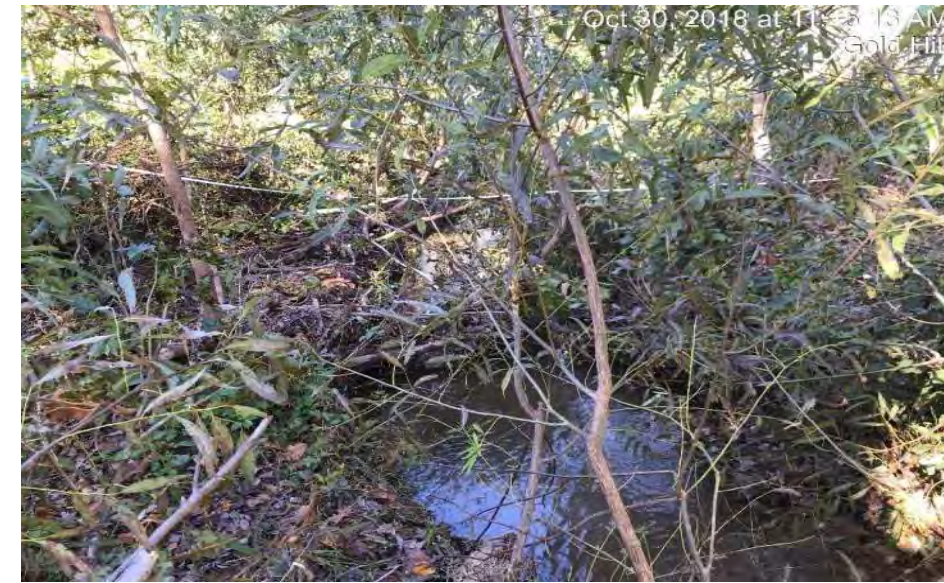
River Basin:	Yadkin-Pee Dee River
Watershed:	Little Buffalo Creek
XS ID:	UT4-1P
Drainage Area (sq mi):	0.4
Date:	10/30/2018
Field Crew:	Matthew Holthaus, Alston Willard, Louis Berger

Station and description 1559.37 UT4-1P Looking Upstream

1559.37 UT4-1P Looking Downstream

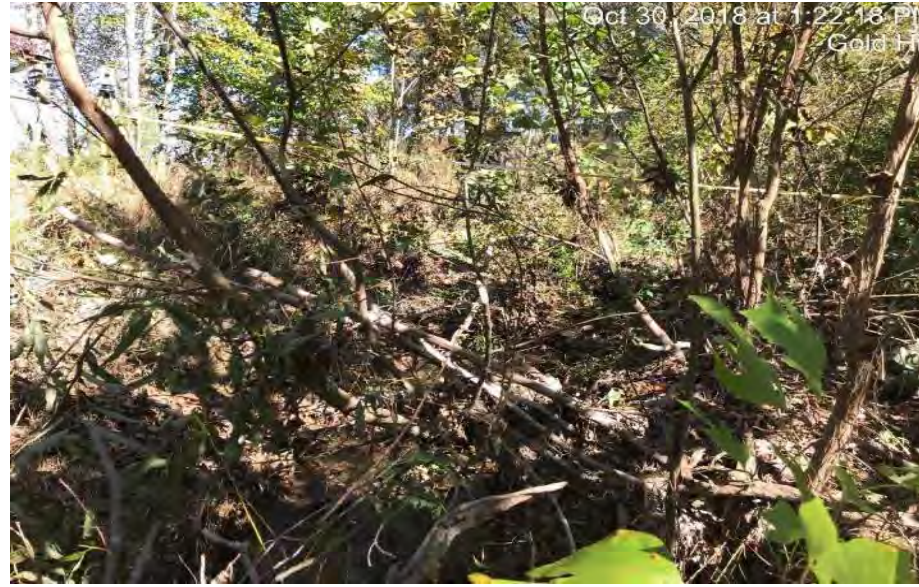
River Basin:	Yadkin-Pee Dee River
Watershed:	Little Buffalo Creek
XS ID:	UT4-1R
Drainage Area (sq mi):	0.4
Date:	10/30/2018
Field Crew:	Matthew Holthaus, Alston Willard, Louis Berger

Station and description 1727.36 UT4-1R Looking Upstream

1727.36 UT4-1R Looking Downstream
