**Monitoring Report
Year 5
FINAL**

Little Buffalo Creek Stream Mitigation Project

*NCDEQ-DMS Project Number: 94147
Contract Number: 2029
USACE Permit Action ID: 2014-00386
DWR Permit: 14-0129
Cabarrus County*

**Data collection: October 2019-January 2020
Draft Submitted: February 2020
Final Submitted: March 2020**

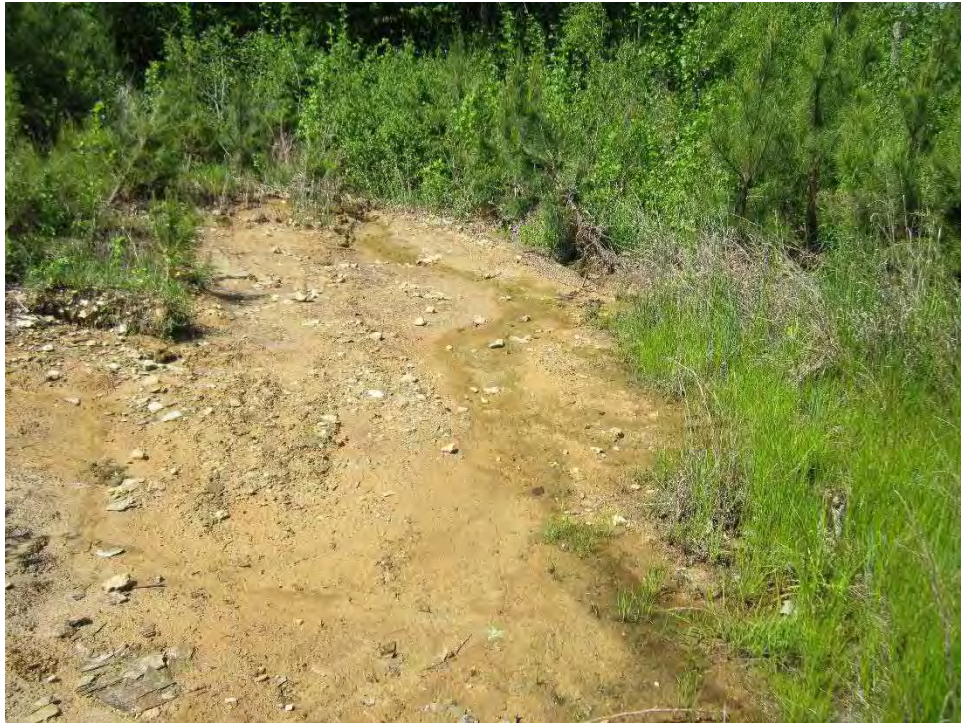
Bare spot (Copper Toxicity) in floodplain in Reach 1

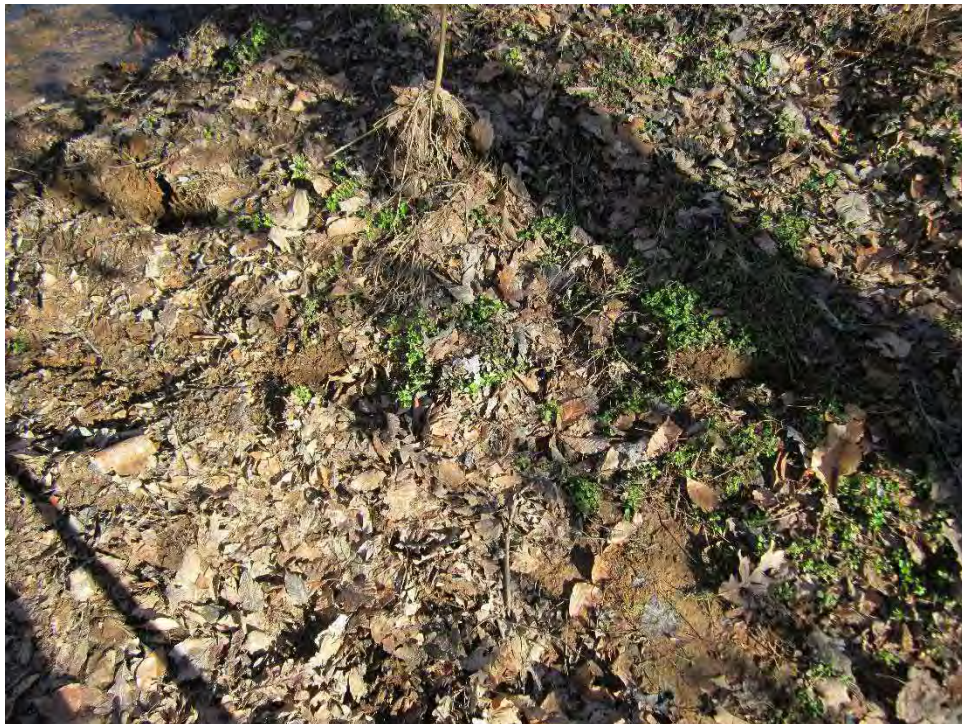
Cow tracks crossing UT4 in January 2020

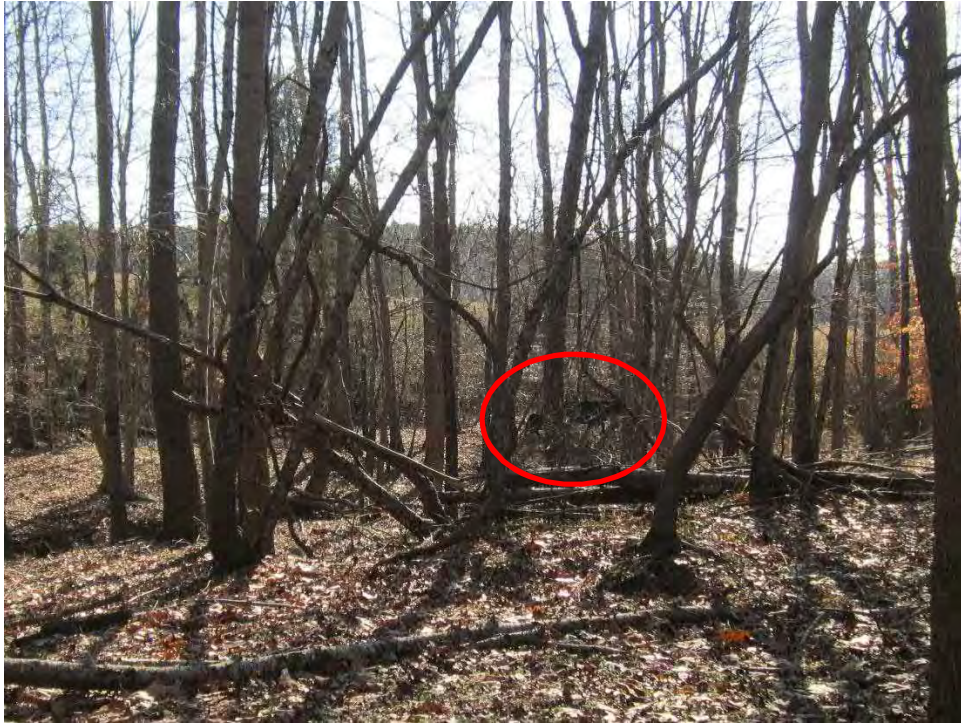
Cow and calf spotted in conservation easement along UT4 in January 2020

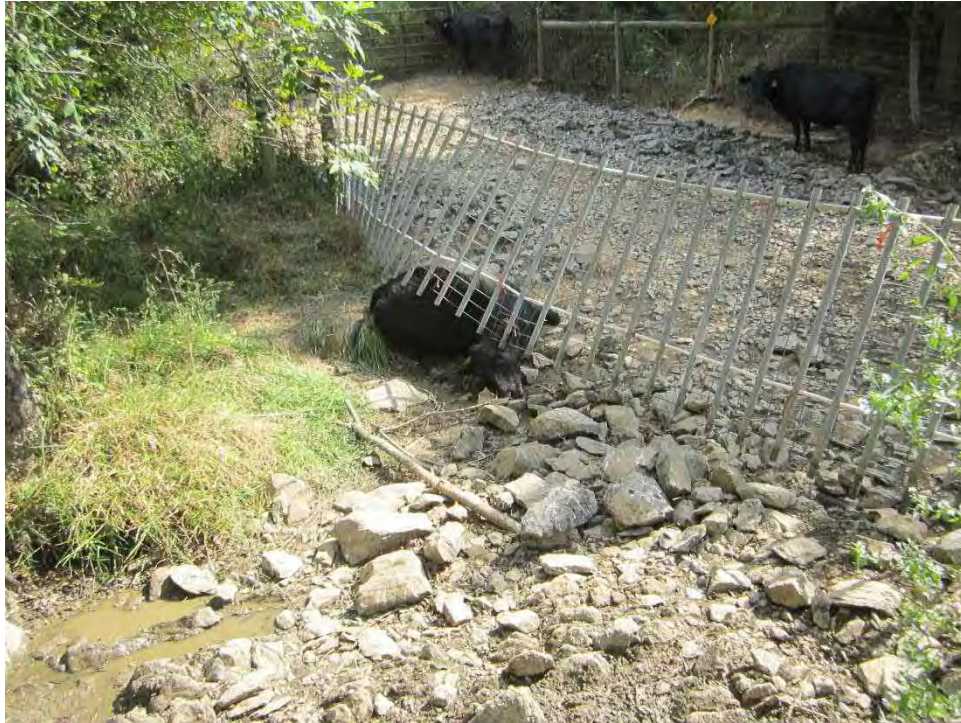
Dead cow under cattle crossing (Reach 5) in October 2019

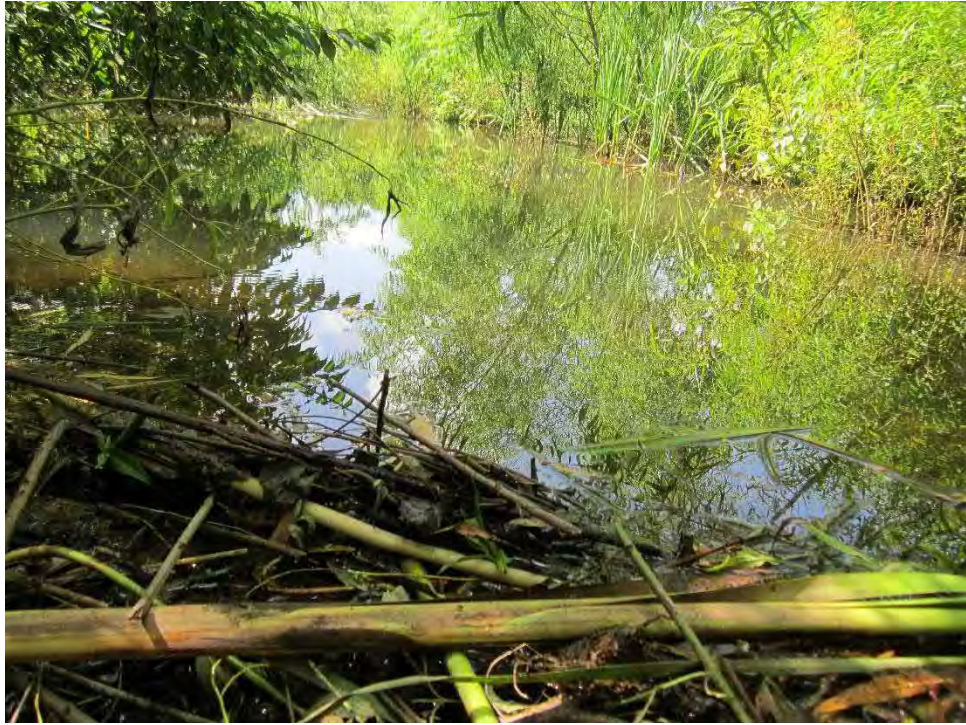
Beaver dam at UT7

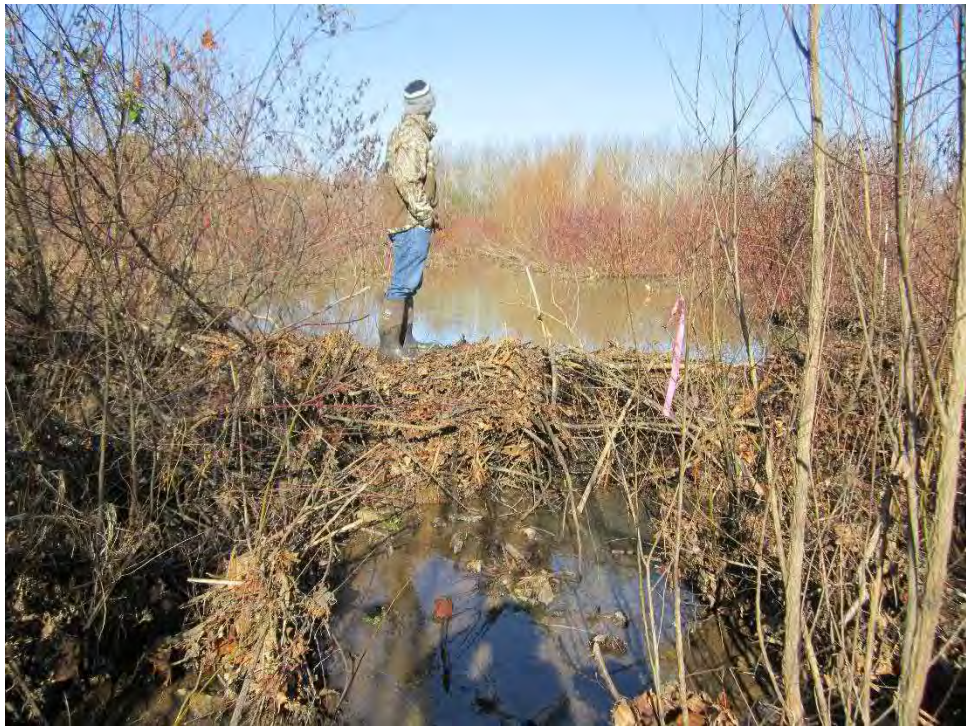
Beaver dam at UT7 in December 2019

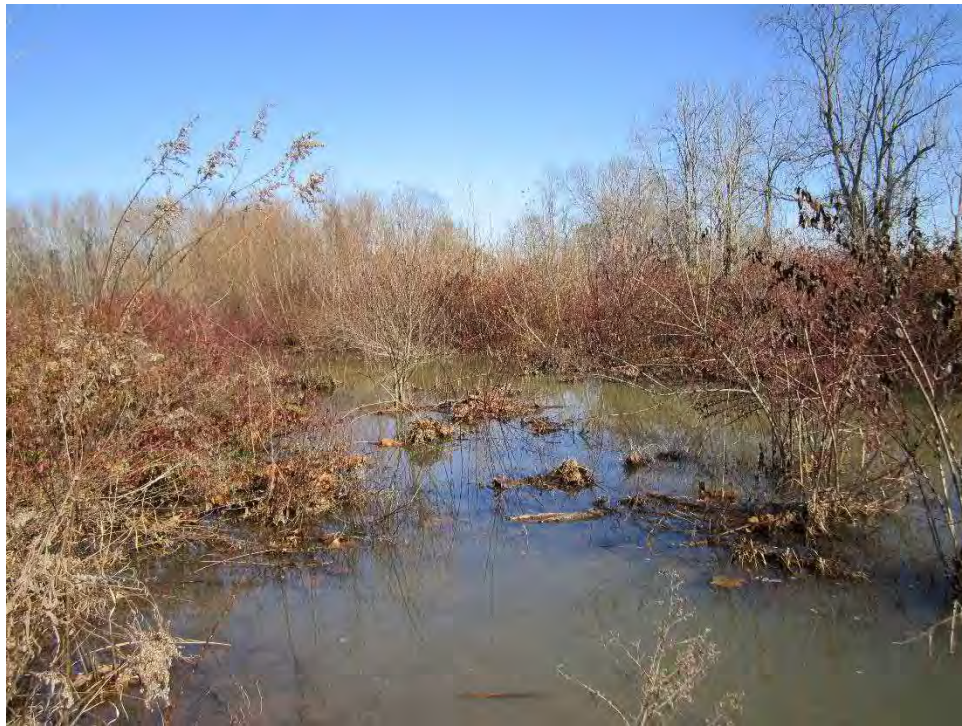
Beaver dam at UT7 in December 2019

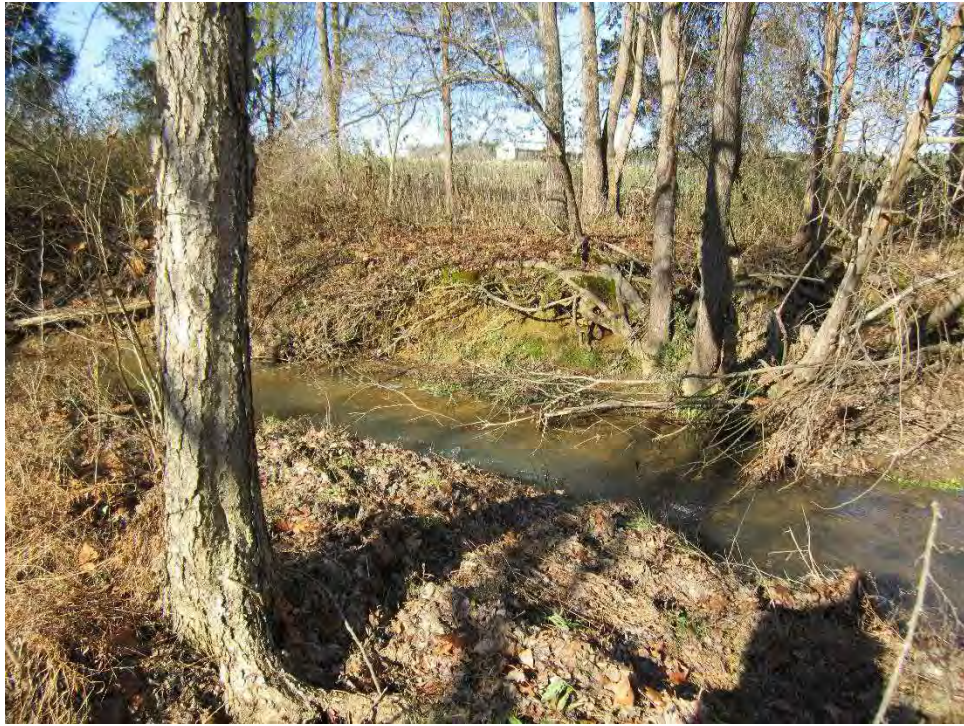
Flattened vegetation in floodplain of Reach 1

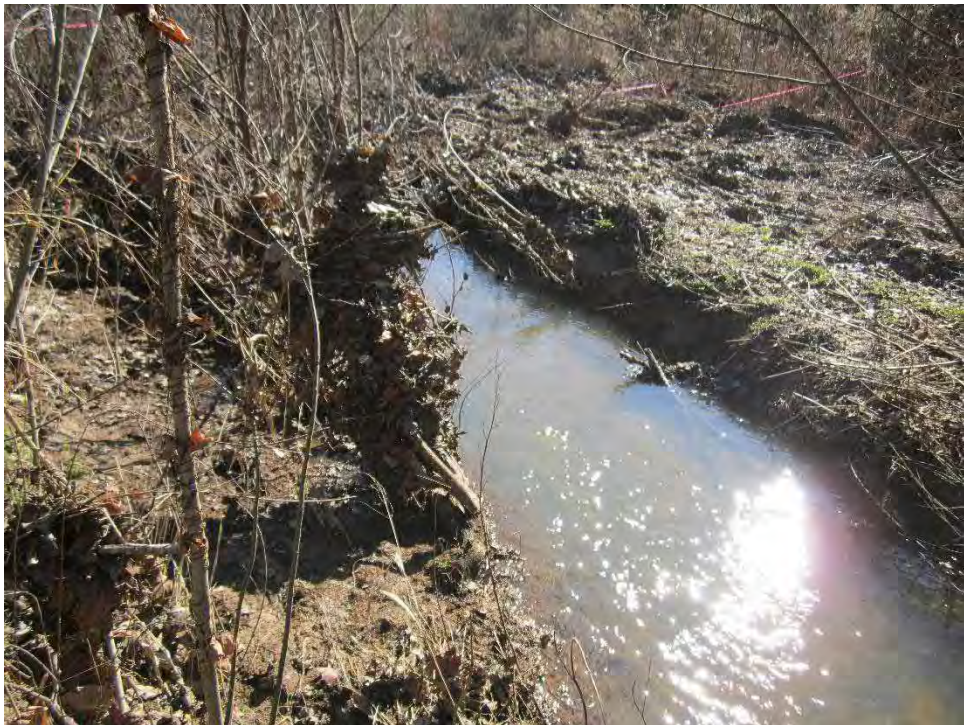
High drift lines in Reach 1 near MS-1P

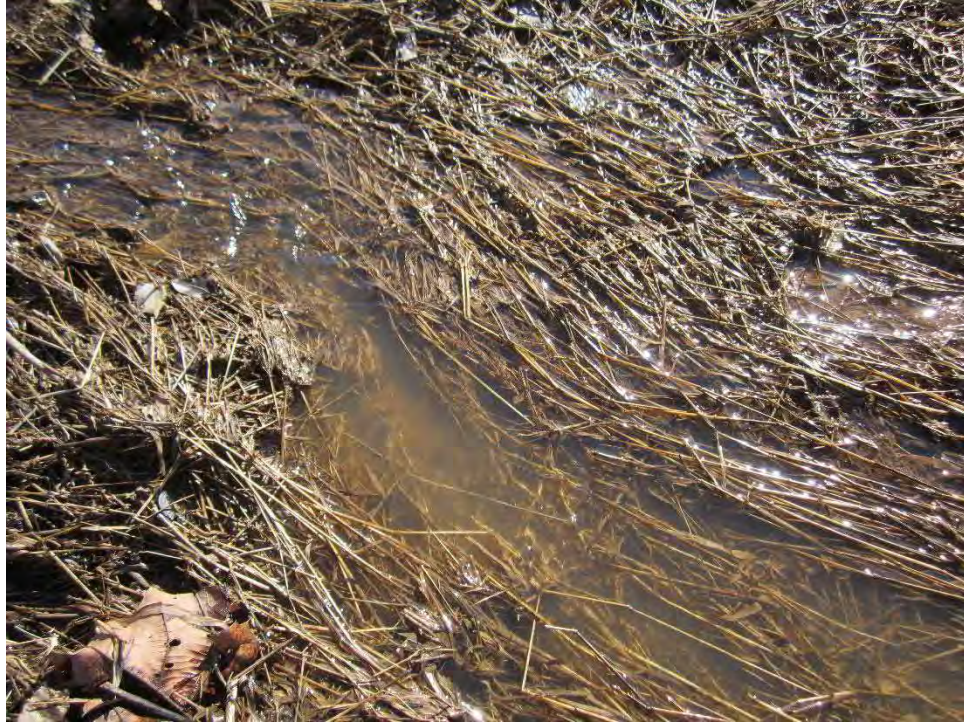
Flow path through vegetation in UT3 near Station 12+00 in January 2020

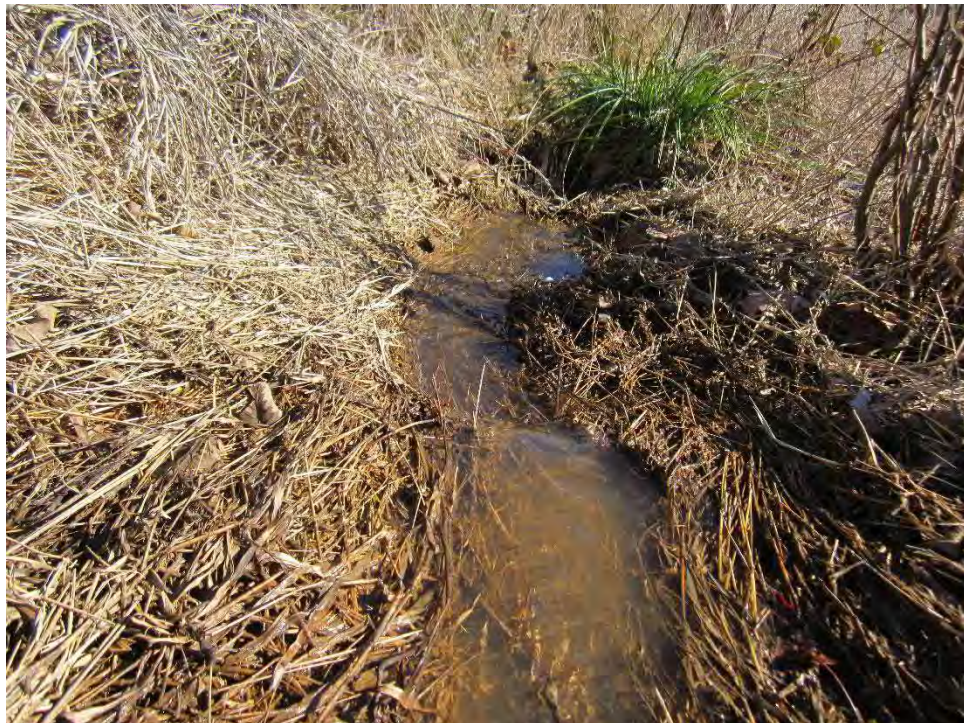
Flow path through vegetation in UT3 near Station 12+00 in January 2020
