Little River Farm Site – Stream Enhancement, Restoration, and Preservation Project Final Year 1 Monitoring Report (2010) Montgomery County, North Carolina

EEP Contract Number 000623

Data Collection Period: Nov. 2010

Submission Date: December 2010

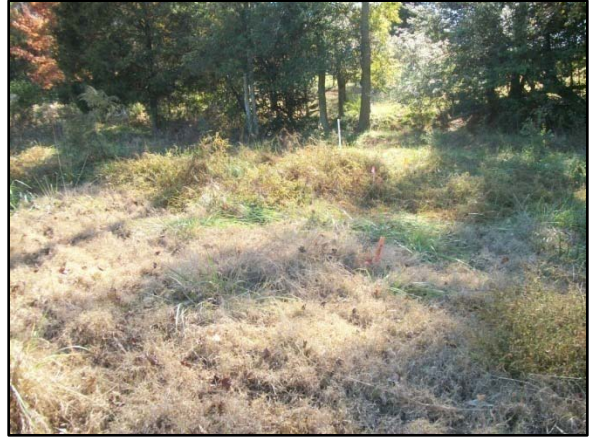
VP-8

Vegetation plot counts were conducted in November 2010. During this assessment, damage to saplings in Veg Plot 13 by cutting was noted. In addition, evidence of herbicide overspray from an adjacent area outside of the easement was noted in Veg Plot 8. Neither incident should result in a significant loss of vegetation within the project area; however, these areas will be monitored to ensure their recovery and success. Supplemental planting may be required.

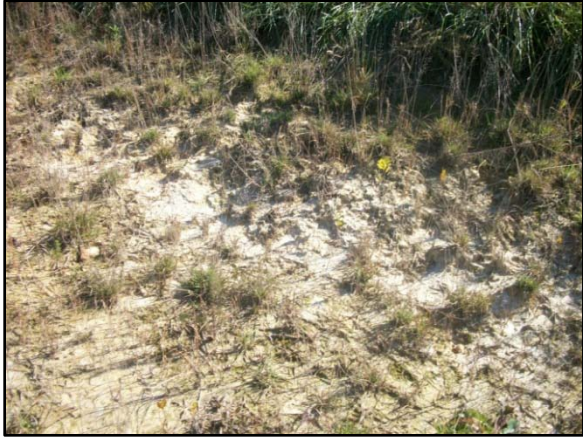
C.6-1. Station 10+00 – 13+50

Though bare and/or areas of sparse vegetation are common along the floodplain bench and slide slopes of UT4, only a few small erosion rills are present. Observations of bare and/or sparse vegetation were noted in the left floodplain at Stations 10+60 to 11+00, 11+25 to 12+00, and 12+50 to 14+50 and in the right floodplain at Stations 10+00 to 13+50 and 13+75 to 14+60.

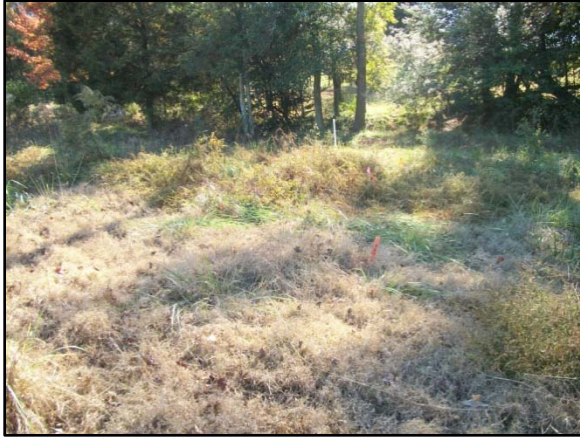
Sprayed Veg Plot 8

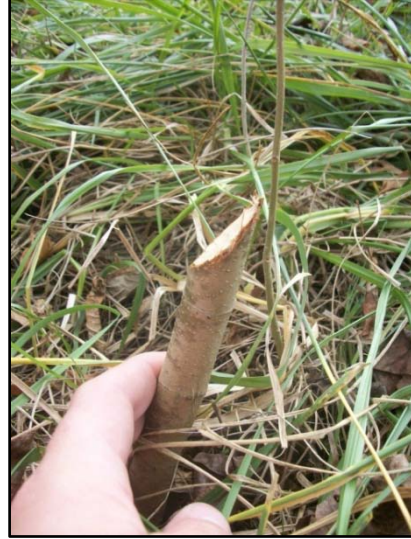
**Cut Tree – *Platanus occidentalis*
Veg Plot 13-6**

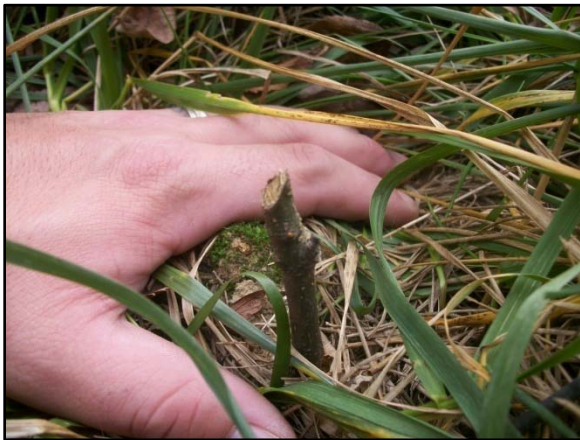
**Cut Tree – *Quercus falcata*
Veg Plot 13-1**

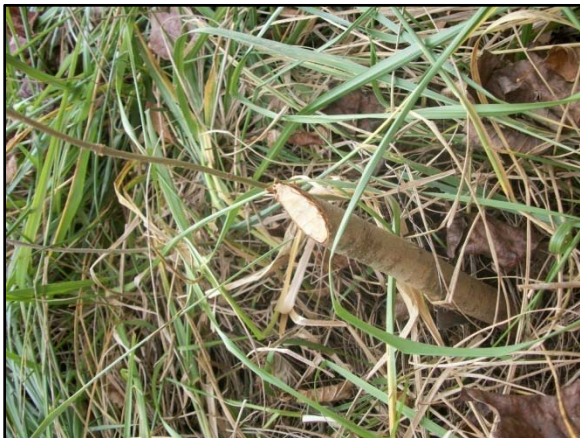
**Cut Tree – *Carpinus caroliniana*
Veg Plot 13-3**
