# Lochill Farm Stream Mitigation Project Year 1 (2019) Monitoring Report Final

DMS Project ID No. 97083, DEQ Contract No. 6828  
USACE Action ID No. SAW-2016-00881, DWR# 16-0370  
Orange County, North Carolina, Neuse River Basin: 03020201-030030  
MY1 Data Collection Period: October 2019

**Subject:** Response to DMS Comments for DRAFT MY1 Report  
Lochill Farm Stream Mitigation Project, Orange County  
DMS Project # 97083, DEQ Contract #6828, Neuse-01 River Basin

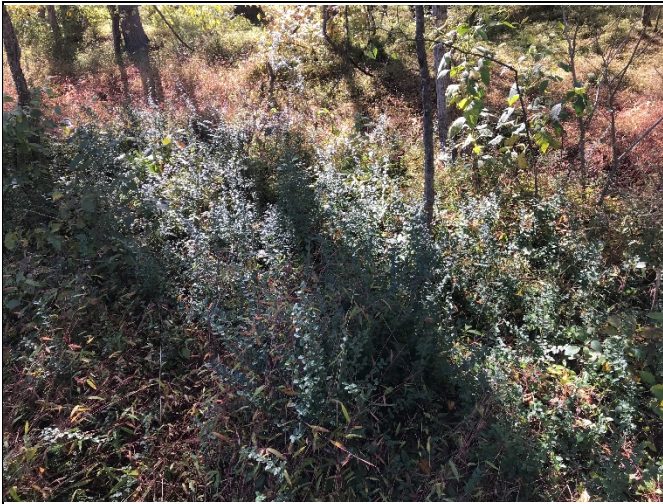
Privet Re-Sprouts along Reach 3 at Station 22+50

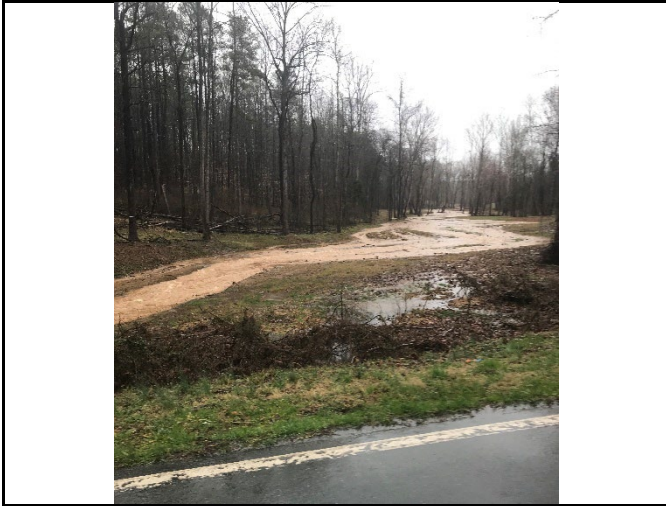
Overbank event on lower R1 (photo: 2/23/19)

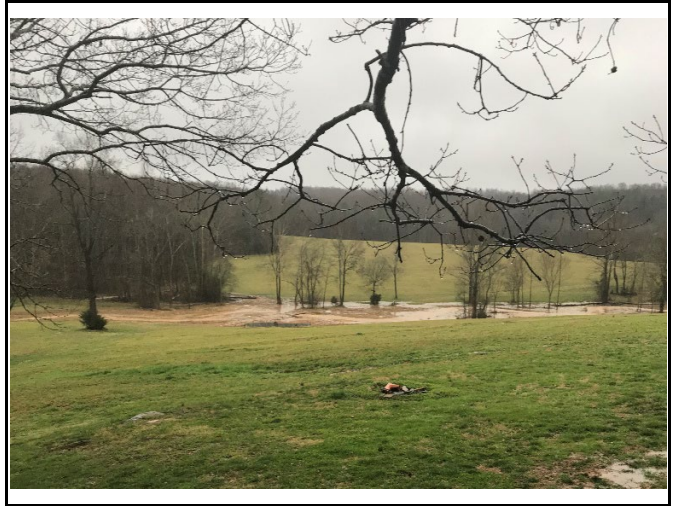
Overbank event on upper R1 (photo: 2/23/19)

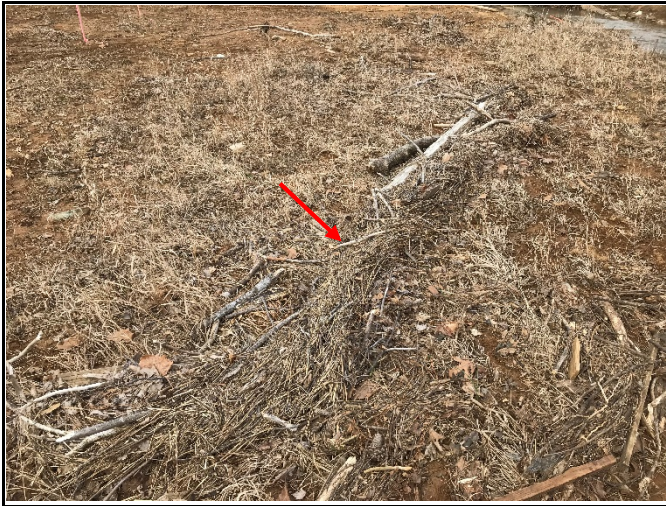
Wrack line on upper R1 floodplain (photo: 3/7/19)

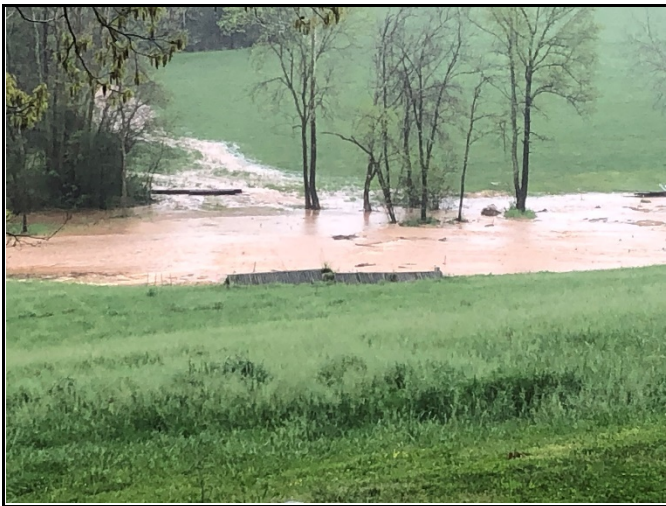
Overbank event on upper R1 (photo: 4/13/19)

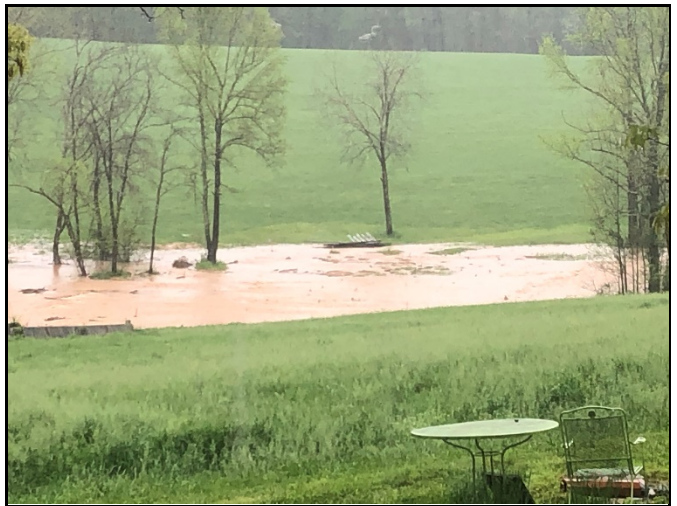
Overbank event on upper R1 (photo: 4/13/19)

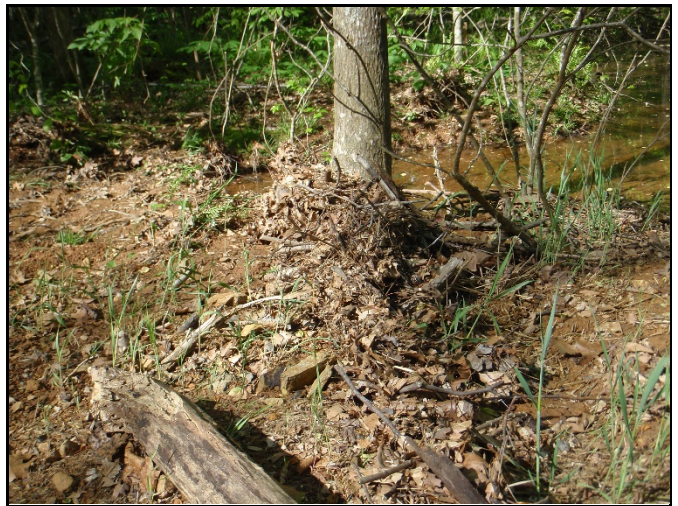
Debris jam on tree in floodplain of upper R3  
(photo: 4/18/19)

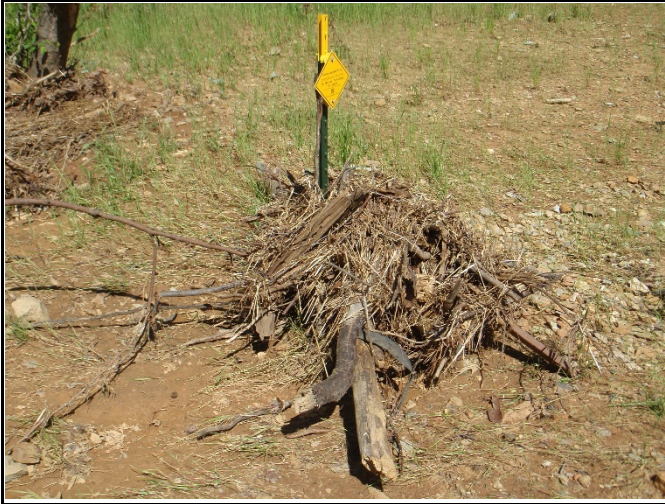
Debris jam in lower R1 (photo: 4/18/19)

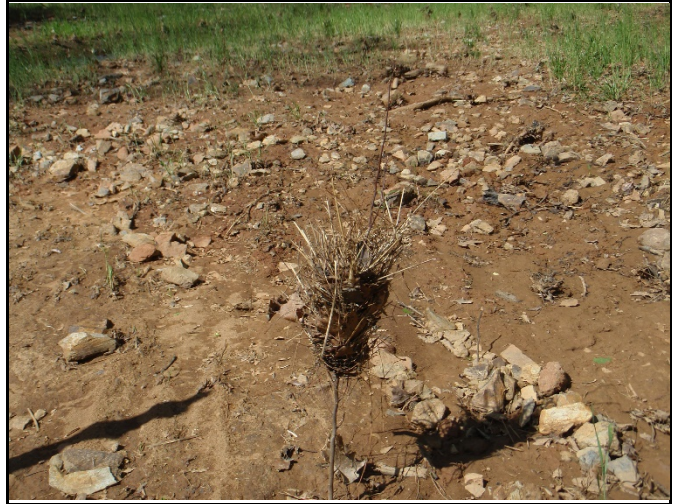
Debris jam on tree stem in upper R1 (photo: 4/18/19)

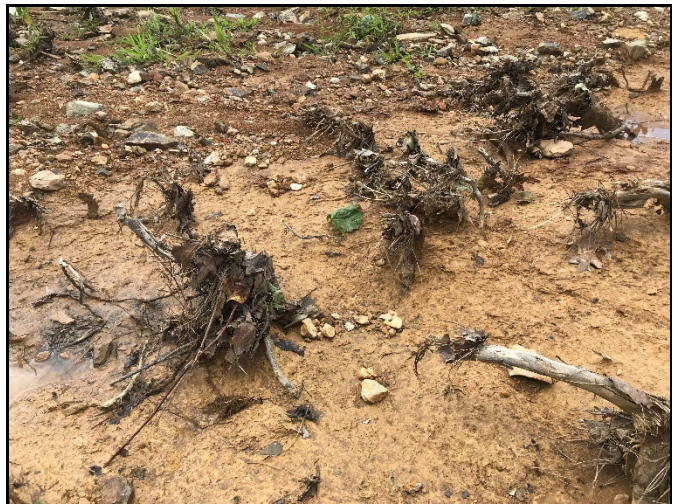
Debris jams on tree stems in upper R1 (photo: 6/19/19)

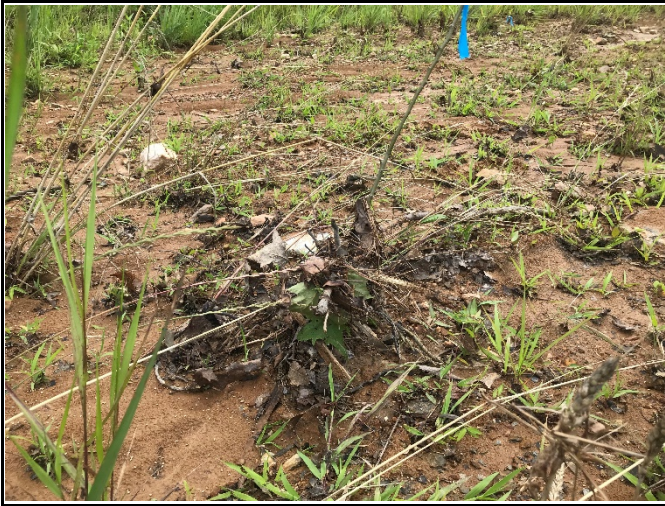
Debris jam on tree stem in upper R1 (photo: 6/19/19)

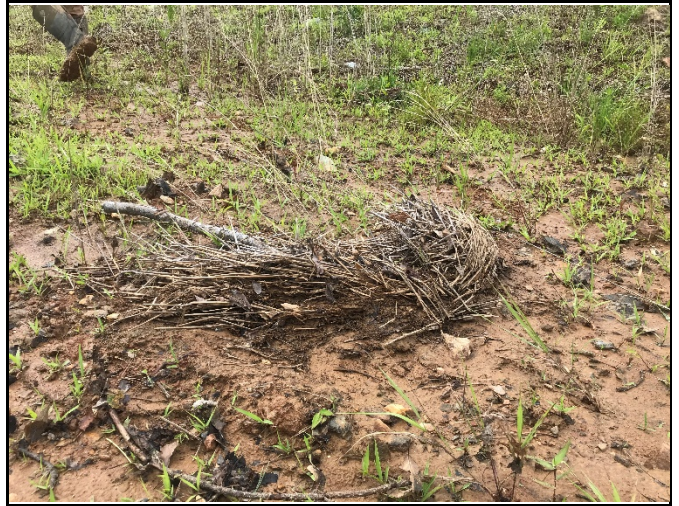
Debris jams in floodplain of upper R1 (photo: 6/19/19)

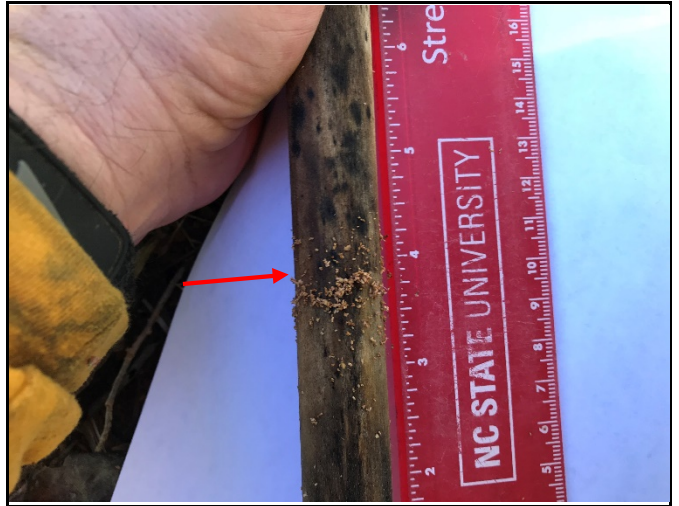
Manual crest gauge on upper R3 reading 0.29 ft (photo: 6/19/19)
