# **Lochill Farm Stream Mitigation Project Year 5 (2023) Monitoring Report FINAL**

DMS Project ID No. 97083, DEQ Contract No. 6828  
USACE Action ID No. SAW-2016-00881, DWR# 16-0370  
Orange County, North Carolina, Neuse River Basin: 03020201-030030  
MY5 Data Collection Period: November 2023

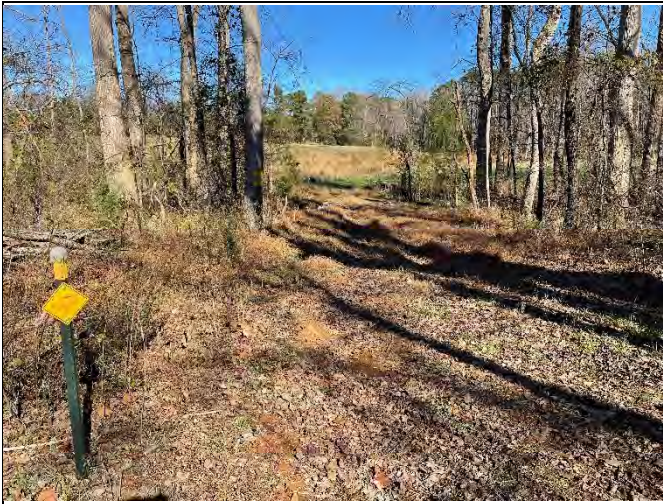
Stable crossing at the top of R1 (3/23/23)

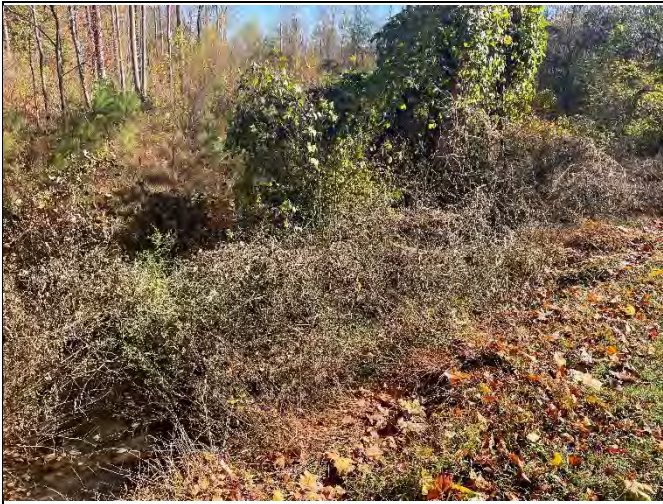
Second kudzu treatment results (11/1/23)

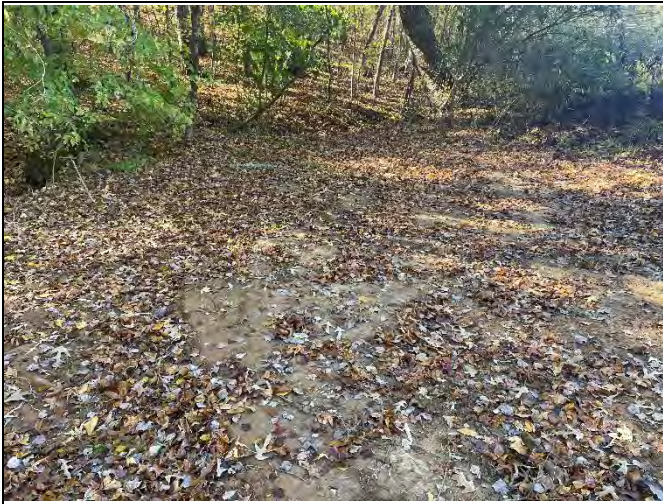
Encroachment area filled back in and graded out (photo from (11/1/23))
