# **Logan Creek Stream Restoration Project Year 1 Monitoring Report**

**Jackson County, North Carolina**

**NCDMS Project ID No. 92515; Contract No. D06046-A**

**Project Info:** Monitoring Year: 1 of 5  
Year of Data Collection: November 2015  
Year of Completed Construction: May 2015  
Submission Date: May 2016

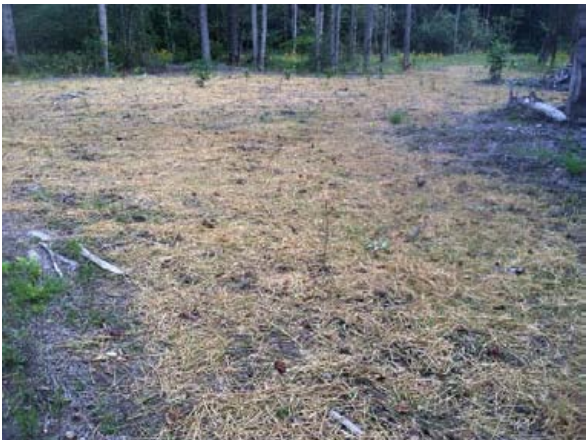
Photo 2. Same area as in Photo 1 but from a different perspective.

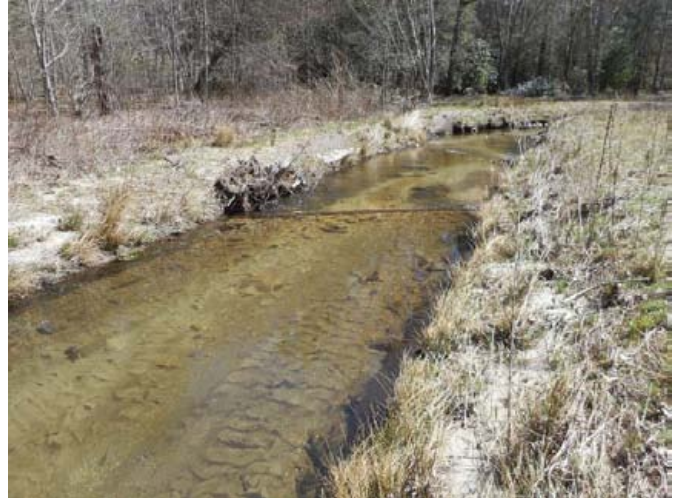
Photo 55. Logan Creek, Photo Point 27 – Station 1+12 (March 2016) downstream view from right bank.

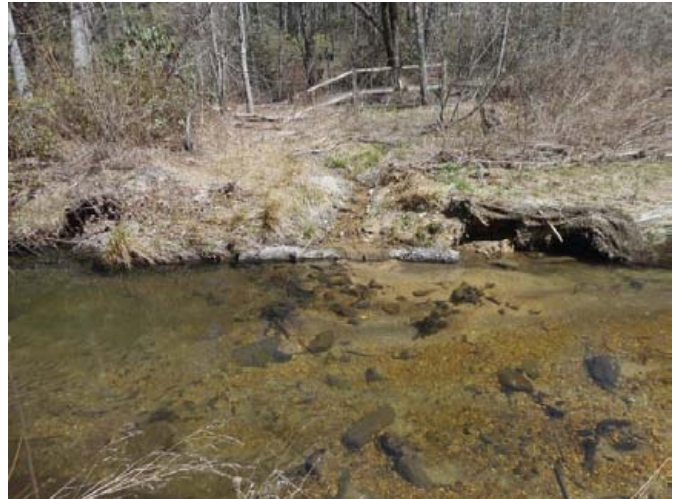
Photo 57. UT1, Photo Point 29 – Station 0+50 (March 2016) view upstream and confluence.

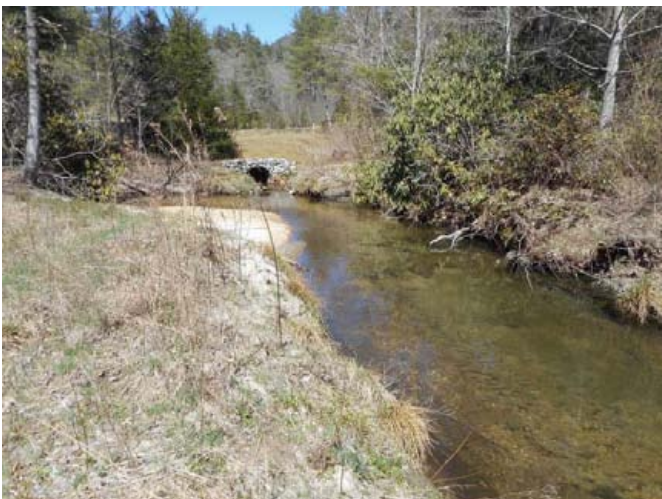
Photo 58. Logan Creek, Photo Point 30 – Station 0+50 (March 2016) upstream view from right bank.

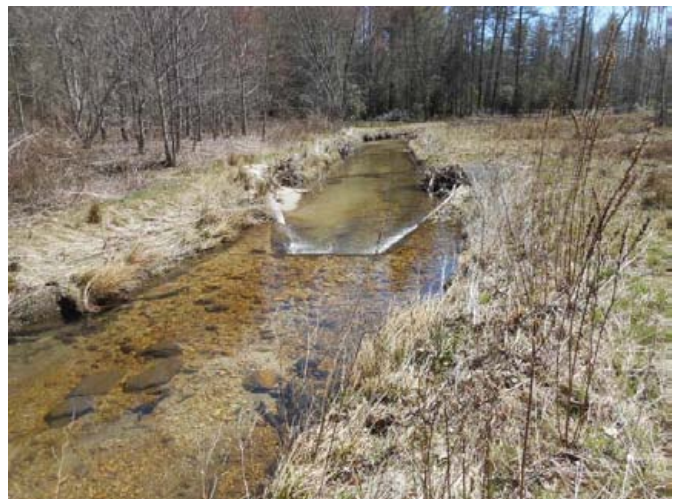
Photo 59. Logan Creek, Photo Point 30 – Station 0+50 (March 2016) downstream view from right bank.

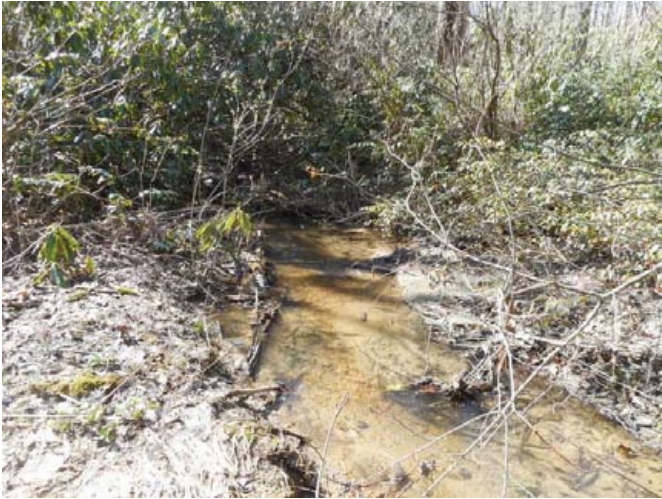
Photo 62. UT5 - Preservation, Photo Point 32 – (March 2016) downstream view from right bank.

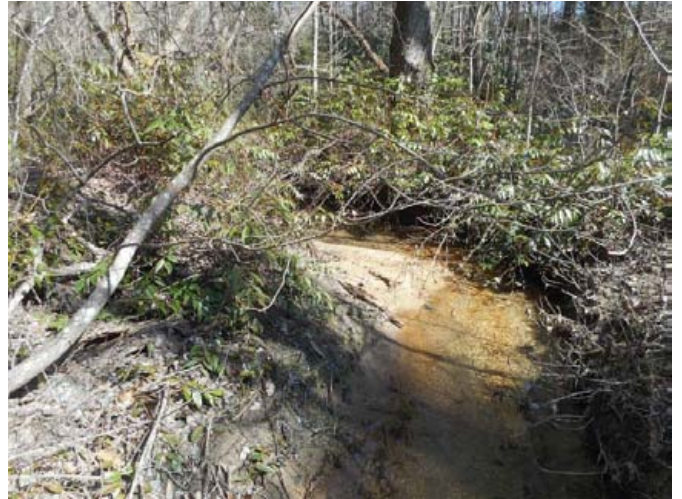
Photo 63. UT5 - Preservation, Photo Point 32 – (March 2016) upstream view from right bank.

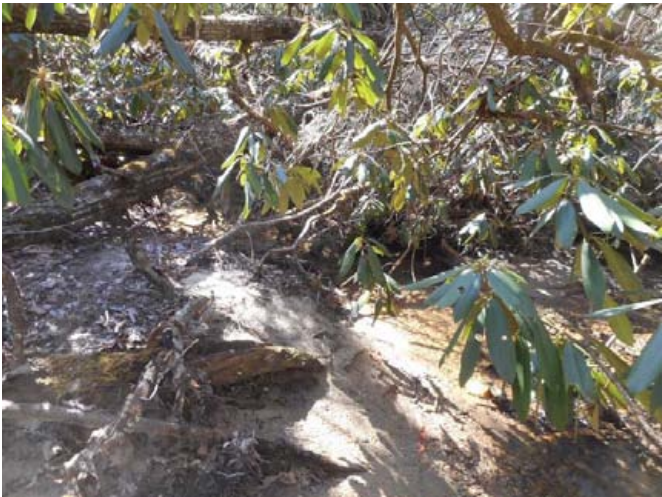
Photo 64. UT5 - Preservation, Photo Point 33 – (March 2016) downstream view from right bank.

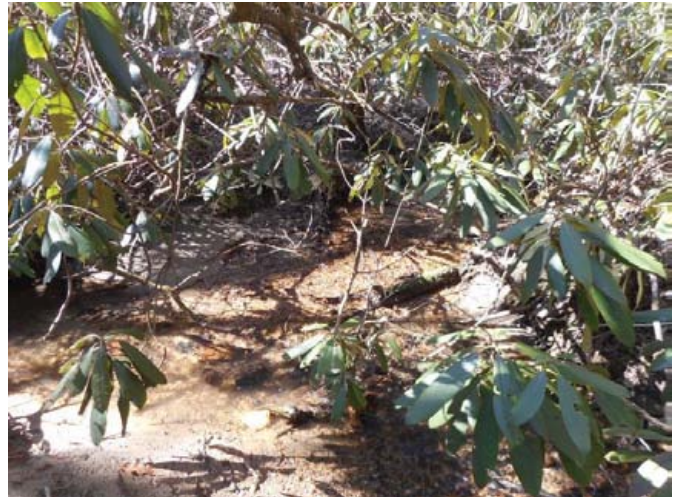
Photo 65. UT5 - Preservation, Photo Point 33 – (March 2016) downstream view from right bank.

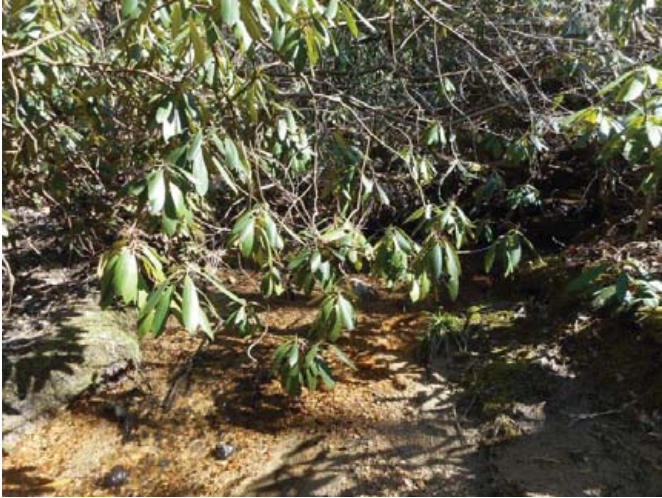
Photo 64. UT5 - Preservation, Photo Point 33 – (March 2016) upstream view from right bank.

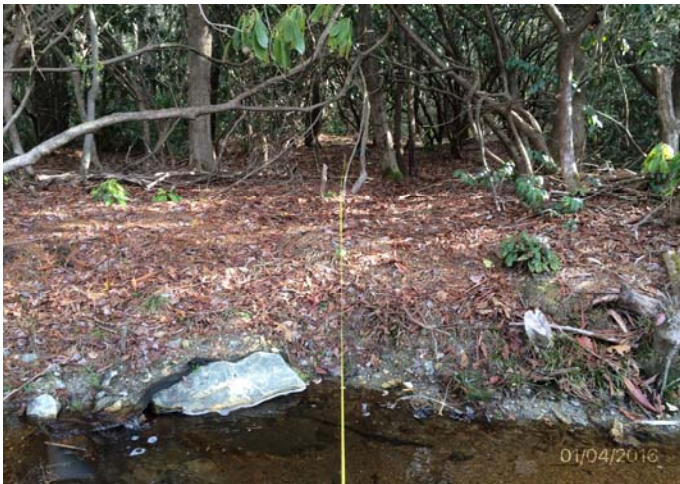
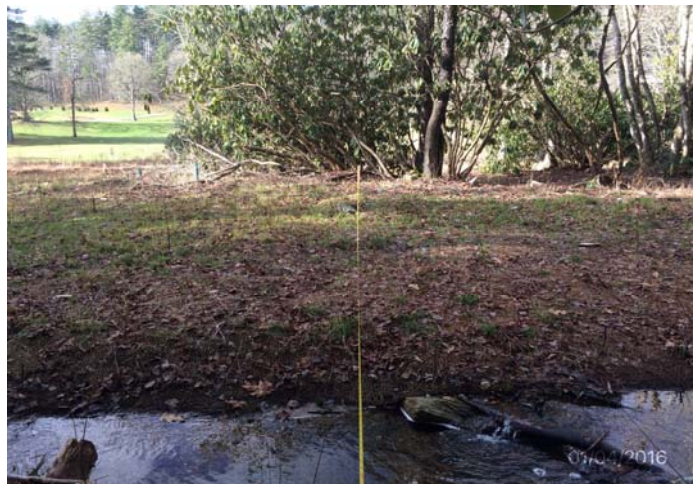
Permanent Cross-section 8.5  
(MY1 Data - collected January, 2016)

\* This Pool cross-section was not taken for the baseline but was added during MY1 survey and will be continued each year going forward.
