Logan Creek Stream Restoration Project Year 4 Monitoring Report - Final

Jackson County, North Carolina

NCDMS Project ID No. 92515; Contract No. D06046-A

Project Info: Monitoring Year: 4 of 5
Year of Data Collection: 2018
Year of Completed Construction: May 2015
Submission Date: December 2018

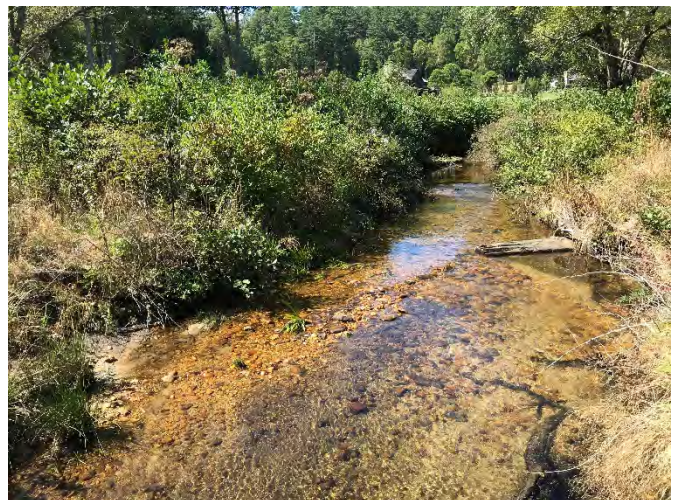
Photo 18. Logan Creek Photo Point 9 – Station 26+75 (October 5, 2018) upstream view from left bank.

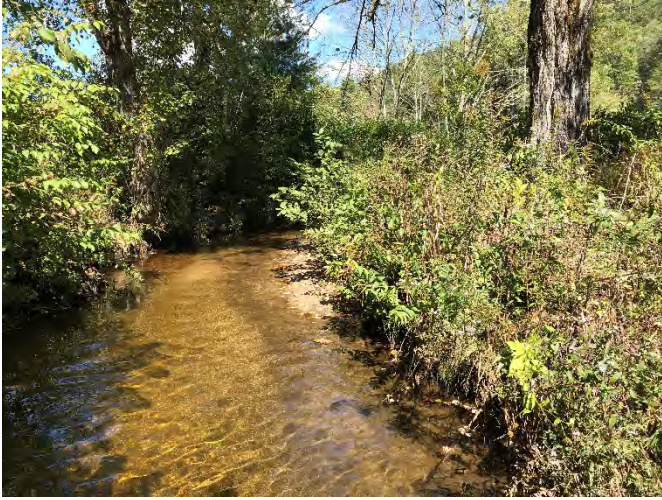
Photo 19. Logan Creek Photo Point 10 – Station 25+25 (October 5, 2018) upstream view from right bank.

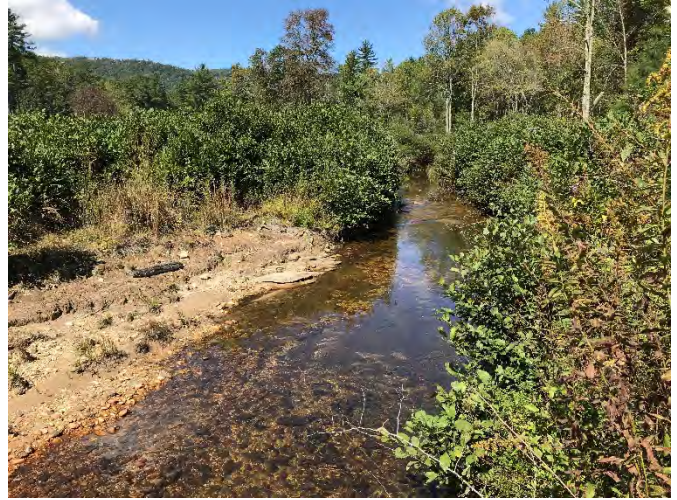
Photo 22. Logan Creek Photo Point 11 – Station 23+20 (October 5, 2018) upstream view from left bank.

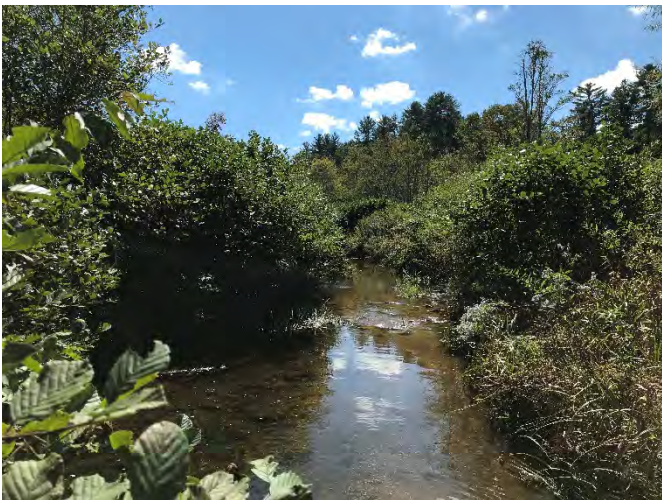
Photo 23. Logan Creek Photo Point 12 – Station 21+20 (October 5, 2018) downstream view from left bank.

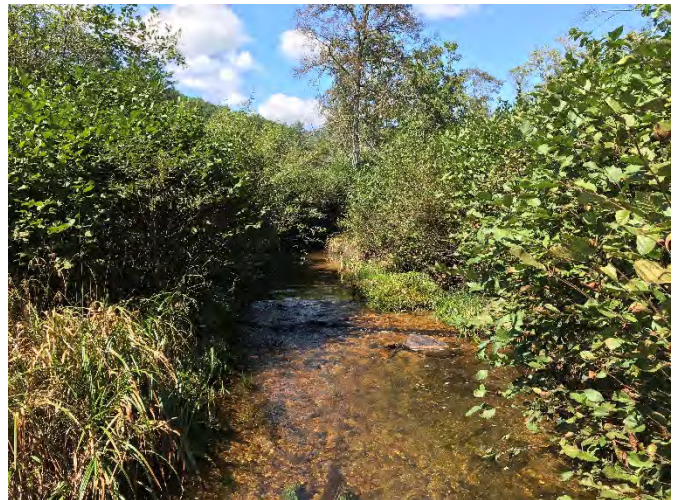
Photo 24. Logan Creek Photo Point 12 – Station 21+20 (October 5, 2018) upstream view from left bank.

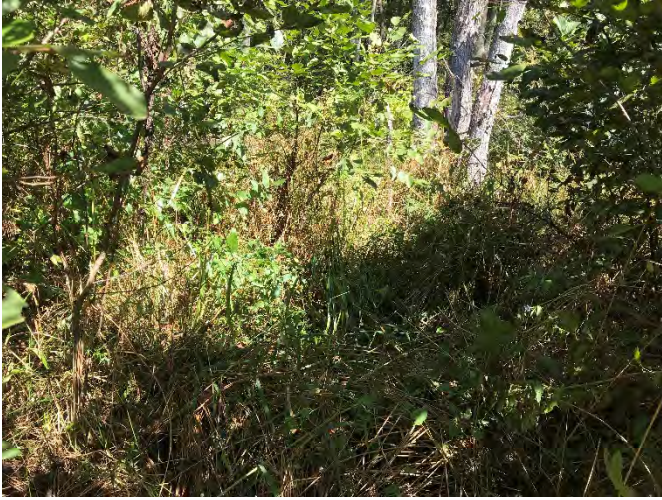
Photo 25. UT7 Photo Point 13 – (October 5, 2018)
upstream view from left bank.

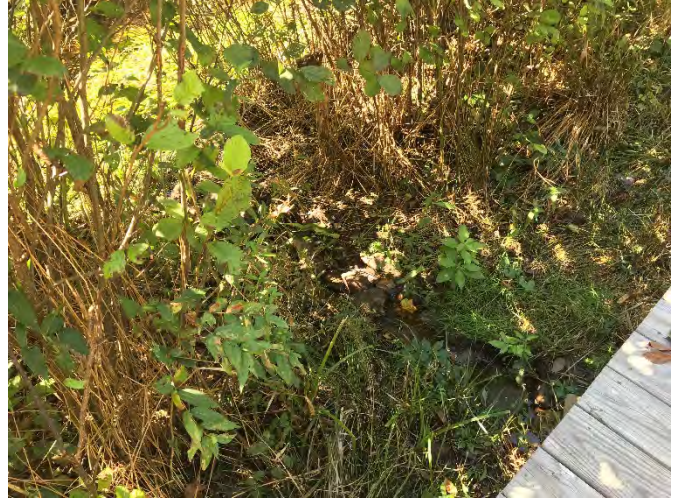
Photo 26. UT7 Photo Point 13 – (October 5, 2018)
downstream view from left bank.

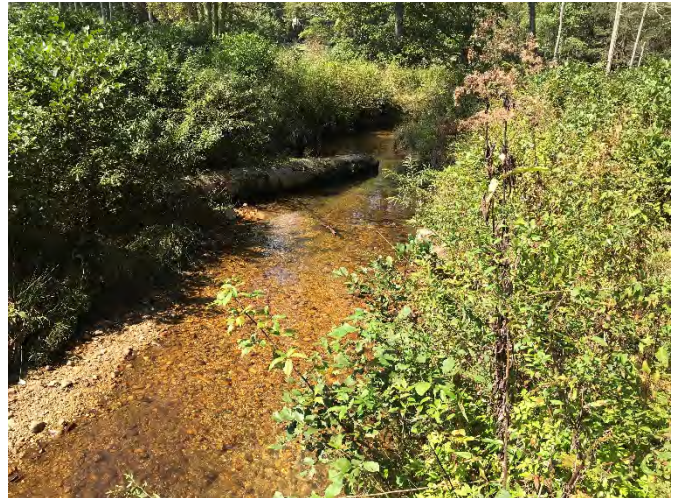
Photo 28. Logan Creek Photo Point 14 – Station 19+45
(October 5, 2018) upstream view from left bank.

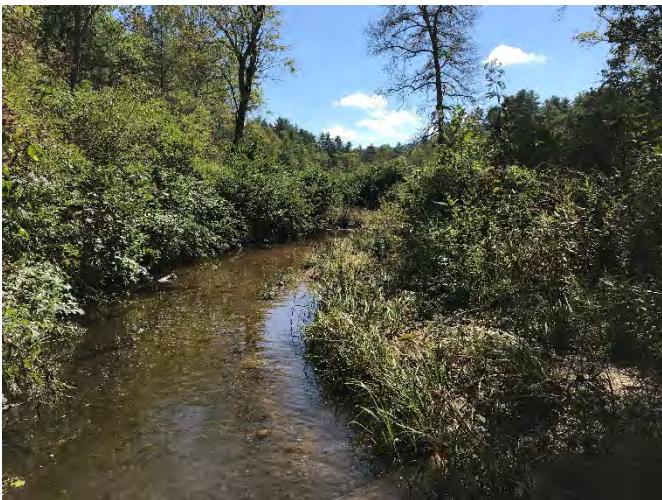
Photo 29. Logan Creek Photo Point 15 – Station 17+45
(October 5, 2018) downstream view from left bank.

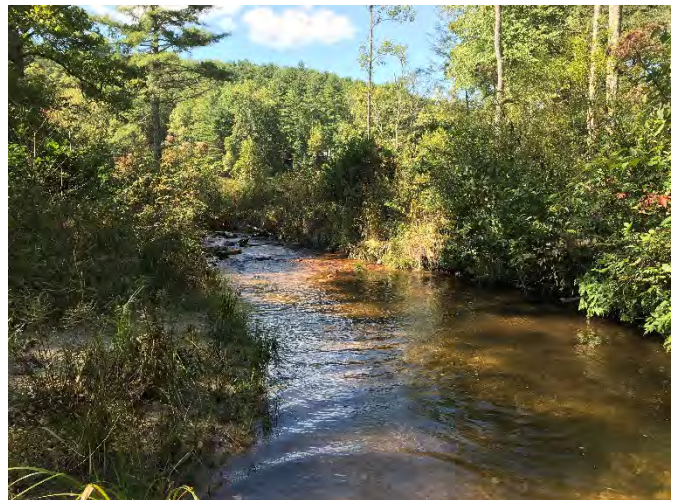
Photo 30. Logan Creek Photo Point 15 – Station 17+45
(October 5, 2018) upstream view from left bank.

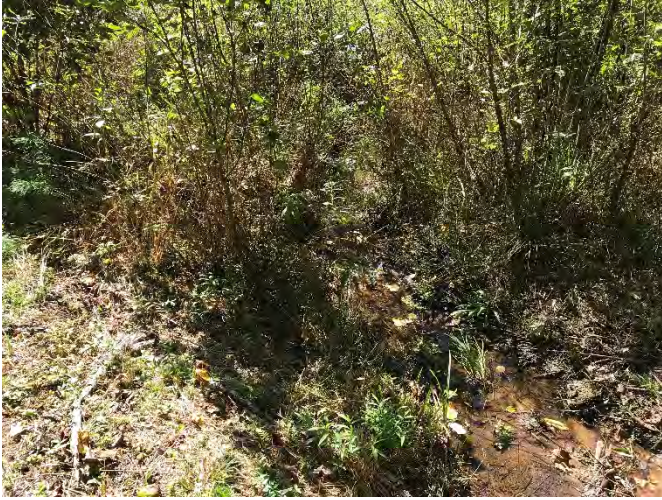
Photo 31. UT4 Photo Point 16 – Station 0+40
(October 5, 2018) downstream view from left bank.

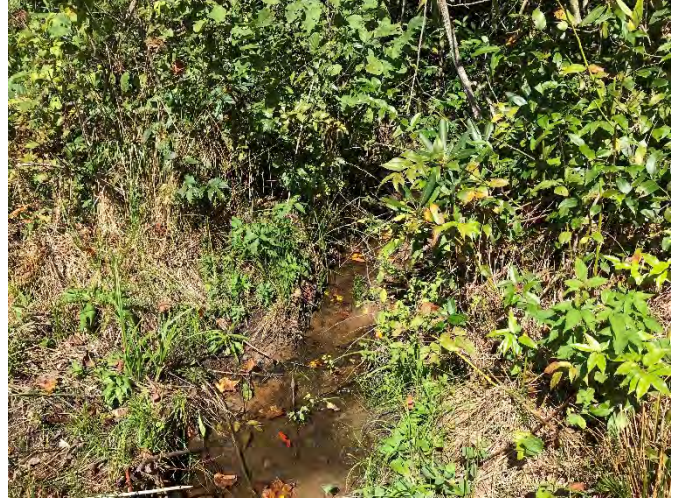
Photo 32. UT4 Photo Point 16 – Station 0+40
(October 5, 2018) upstream view from left bank.

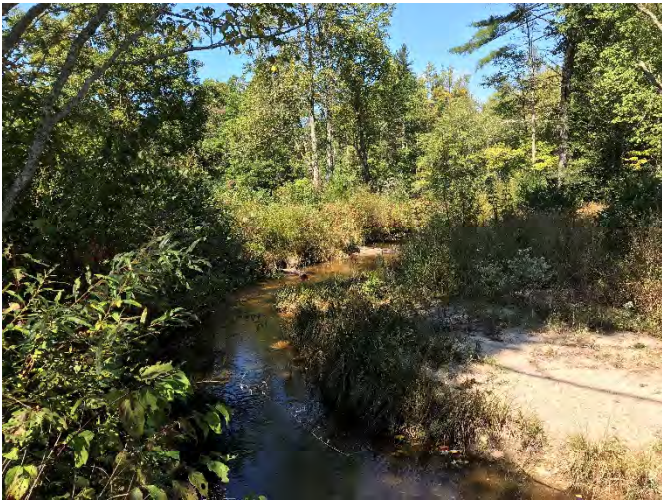
Photo 33. Logan Creek Photo Point 17 – Station 15+50
(October 5, 2018) upstream view from right bank.

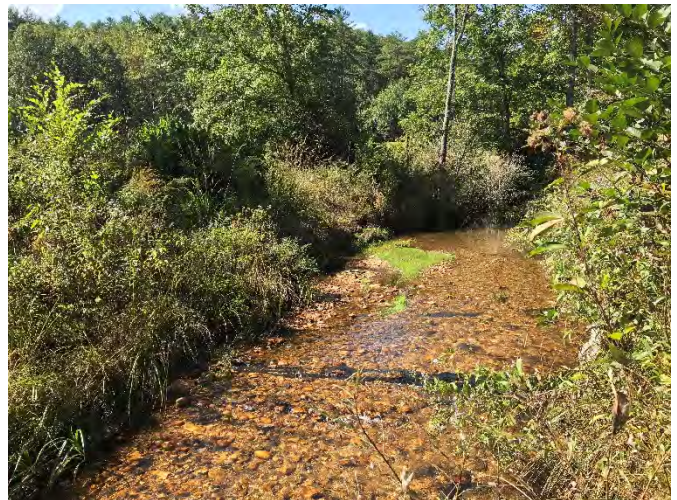
Photo 36. Logan Creek Photo Point 18 – Station 12+90
(October 5, 2018) upstream view from left bank.

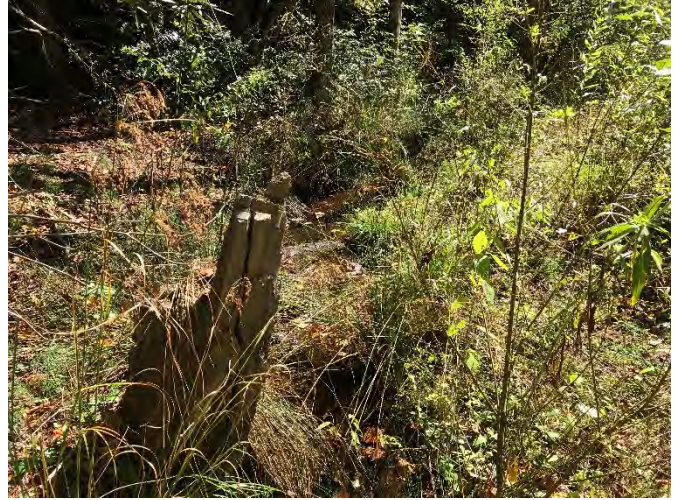
Photo 38. UT3 Photo Point 19 – Station 00+60 (October 5, 2018) downstream from left bank.

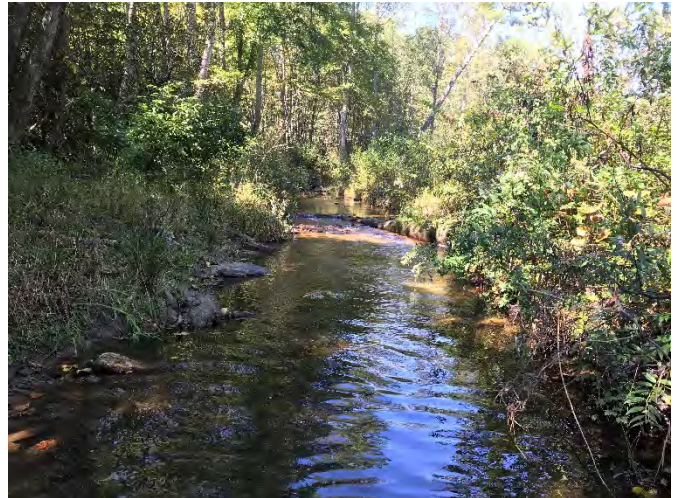
Photo 41. Logan Creek Photo Point 20 – Station 10+60 (October 5, 2018) upstream view from left bank.

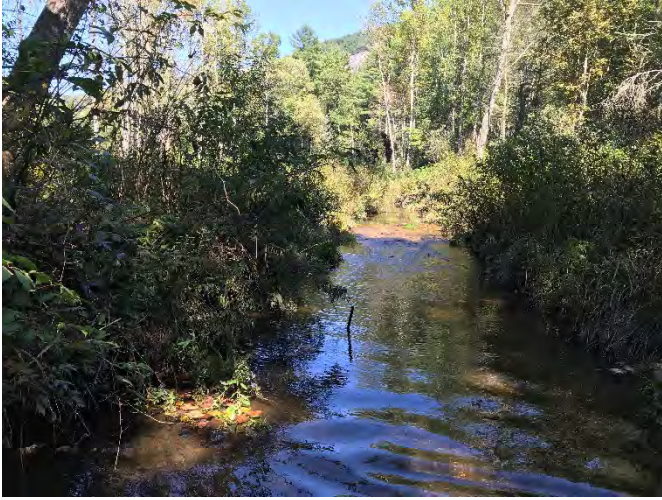
Photo 42. Logan Creek Photo Point 21 – Station 9+40 (October 5, 2018) upstream view from right bank.

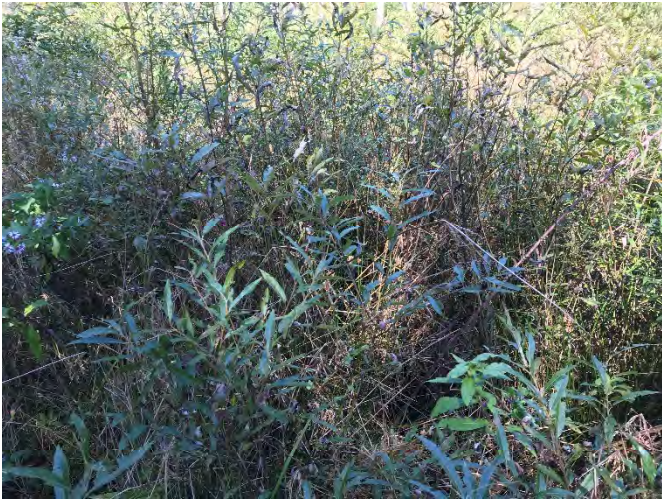
Photo 44. UT6 Photo Point 22 – Station 0+75 (October 5, 2018) upstream view from right bank.

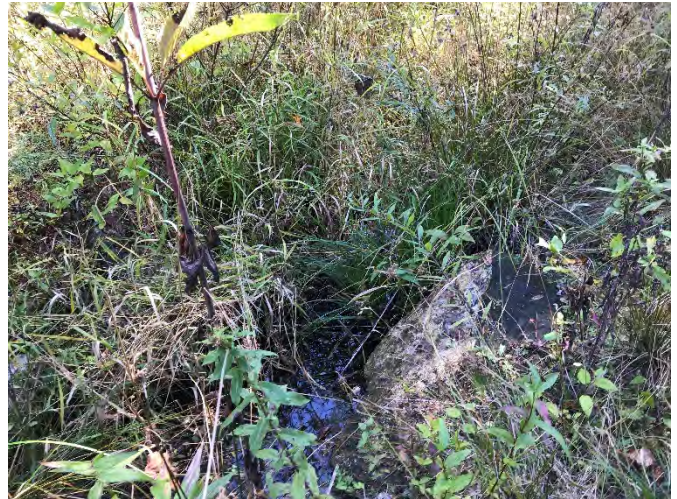
Photo 45. UT6 Photo Point 22 – Station 0+75 (October 5, 2018) downstream view from right bank.

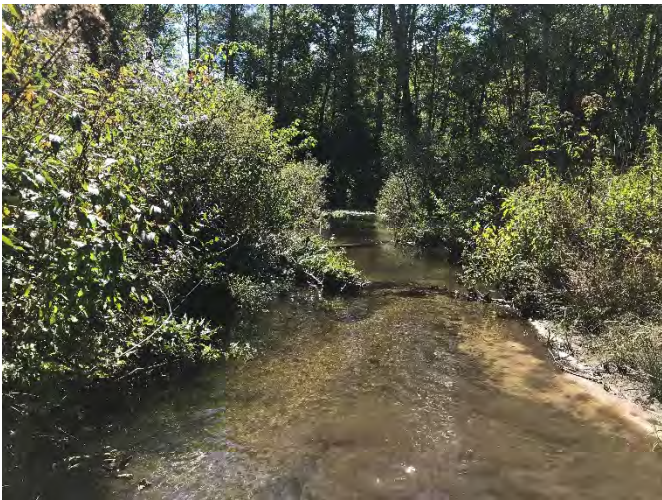
Photo 46. Logan Creek Photo Point 23 – Station 7+70 (October 5, 2018) downstream view from left bank.

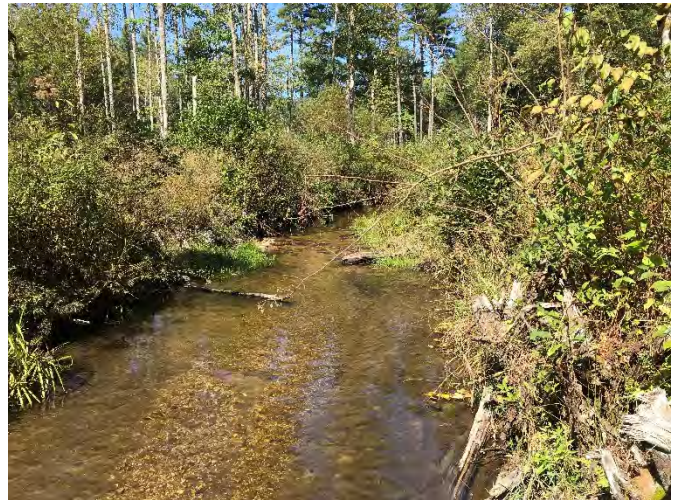
Photo 47. Logan Creek Photo Point 23 – Station 7+70 (October 5, 2018) upstream view from left bank.

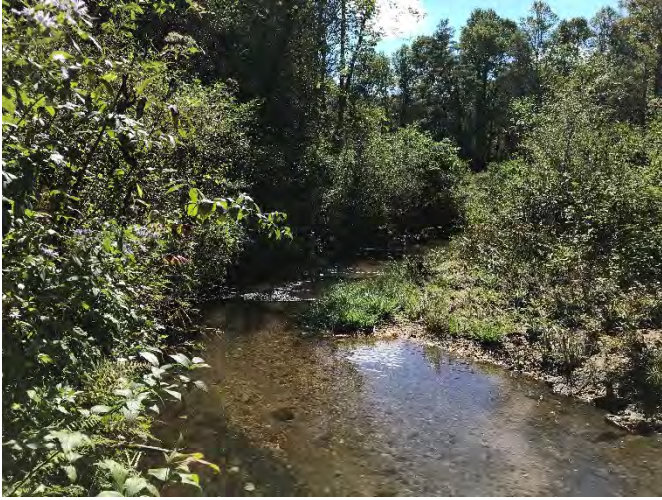
Photo 48. Logan Creek, Photo Point 24 – Station 5+70 (October 5, 2018) downstream view from left bank.

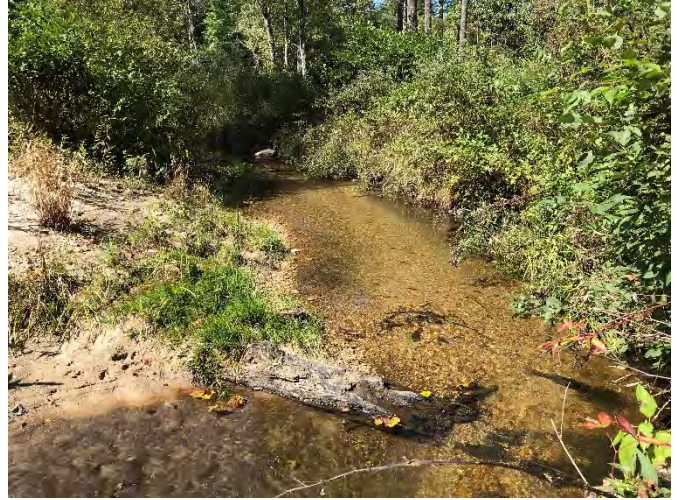
Photo 49. Logan Creek, Photo Point 24 – Station 5+70 (October 5, 2018) upstream view from left bank.

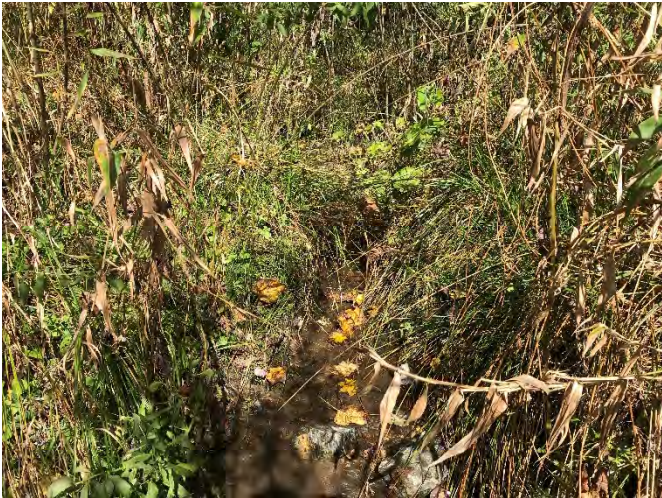
Photo 50. UT2, Photo Point 25 – Station 0+65 (October 5, 2018) upstream view from left bank.

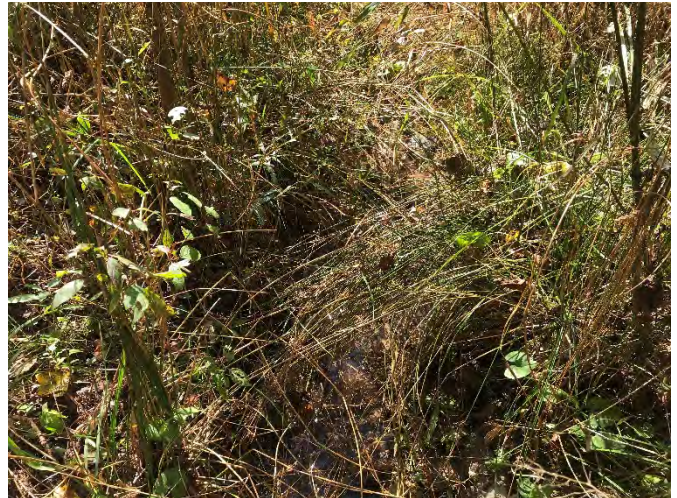
Photo 51. UT2, Photo Point 25 – Station 0+65 (October 5, 2018) downstream view from left bank.

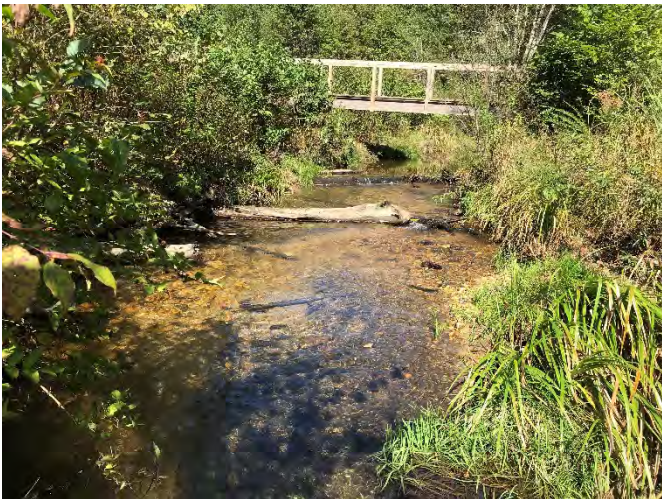
Photo 52. Logan Creek, Photo Point 26 – Station 3+80 (October 5, 2018) upstream view from right bank.

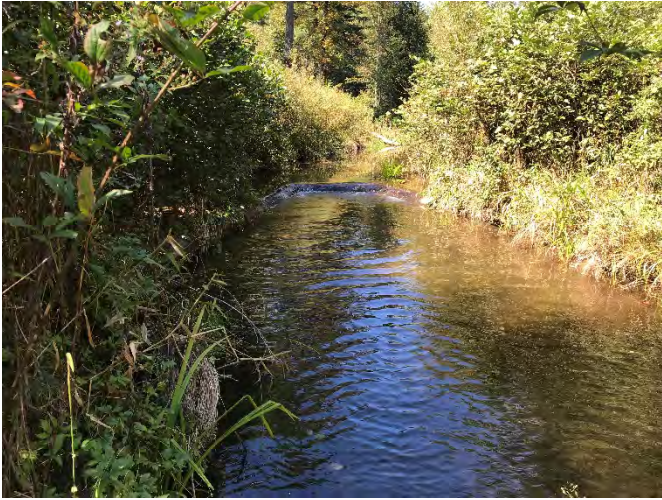
Photo 54. Logan Creek, Photo Point 27 – Station 1+12 (October 5, 2018) upstream view from right bank.

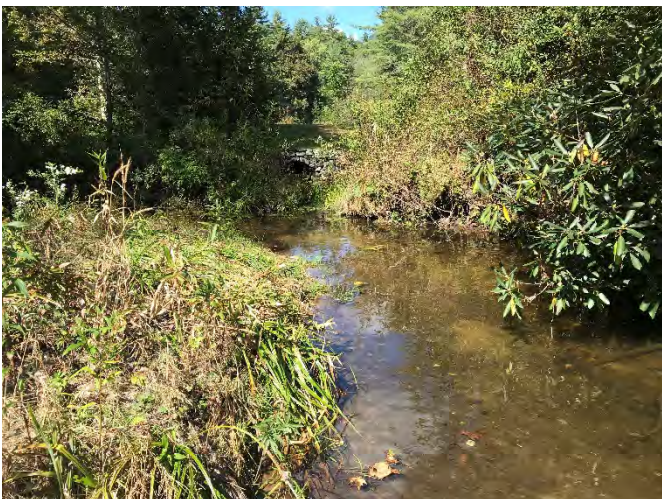
Photo 58. Logan Creek, Photo Point 30 – Station 0+50 (October 5, 2018) upstream view from right bank.

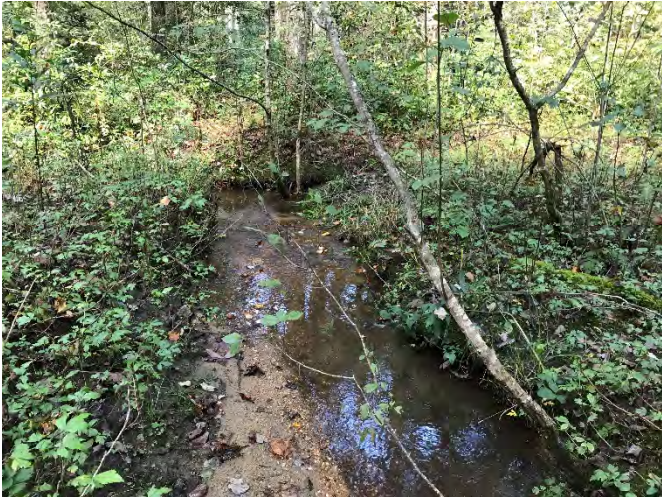
Photo 62. UT5 - Preservation, Photo Point 32 – (October 5, 2018) downstream view from right bank.

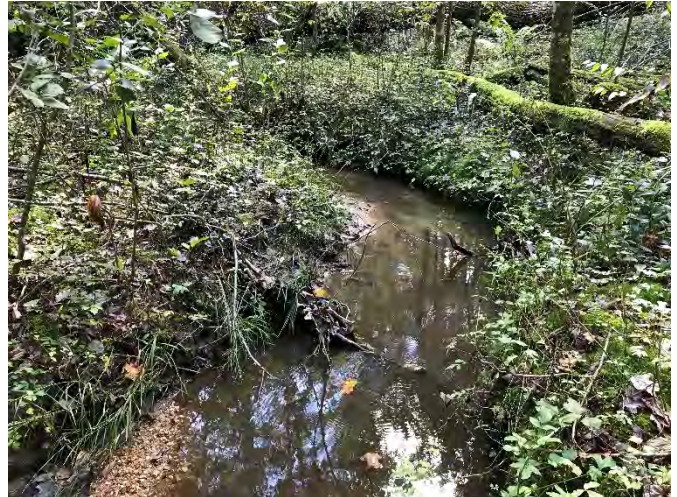
Photo 63. UT5 - Preservation, Photo Point 32 – (October 5, 2018) upstream view from right bank.

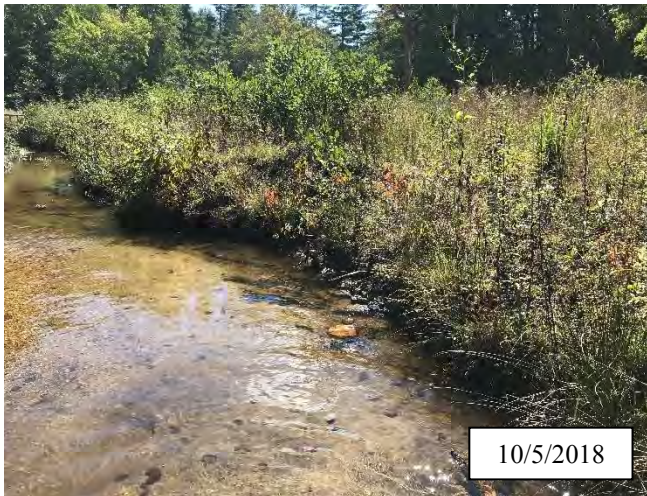
Photo 18. CPA 2-6 – Station 27+00, scour area has revegetated and stabilized in 2018.
