Subject: Response to DMS comments on the Year 5 Monitoring Report Draft review for the Logan Creek Stream Restoration Project; Savannah River Basin - CU# 03060101; Jackson County, North Carolina; NCDMS Project # 92515; Contract No. D06046-A

**Figure 2 - Overview
 Current Conditions Plan View
 Monitoring Year 5
 Logan Creek Site**

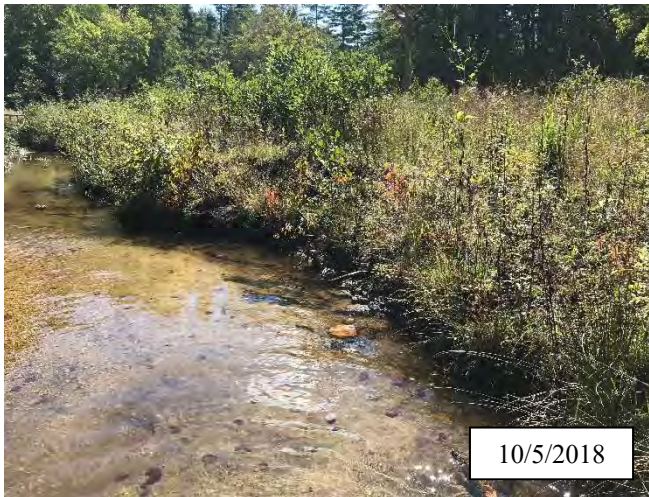
Photo 23. CPA 2-6 – Station 27+00, scour area has revegetated and stabilized in 2018.

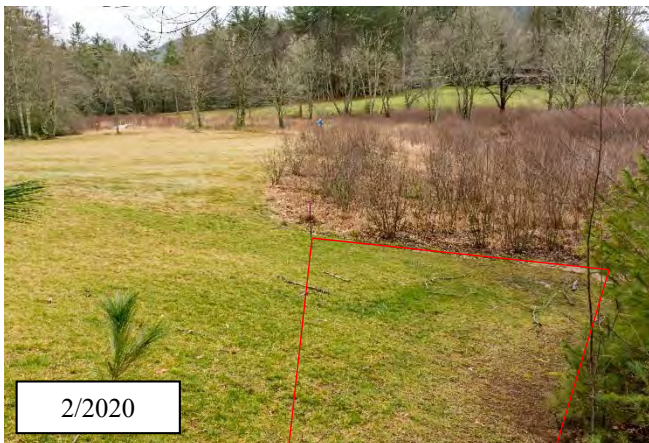
Photo 35. EA 3. Landowner is mowing a small triangular area into the easement.
