Lyle Creek Stream Restoration 2004 Annual Monitoring Report

February, 2005

2004 Lyle Creek Monitoring Abstract

This is the 2nd year of the 5-year monitoring plan for Lyle Creek.

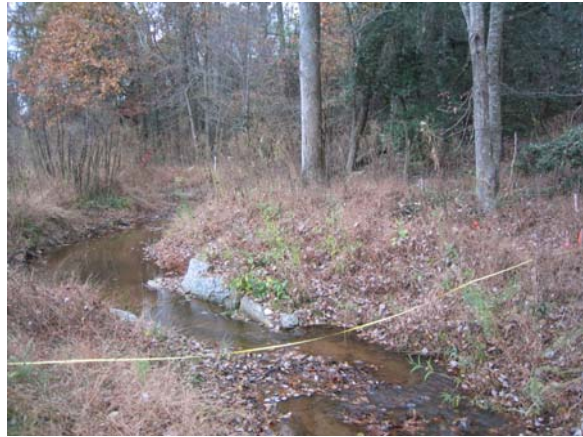
Typical Pool on Lyle Creek

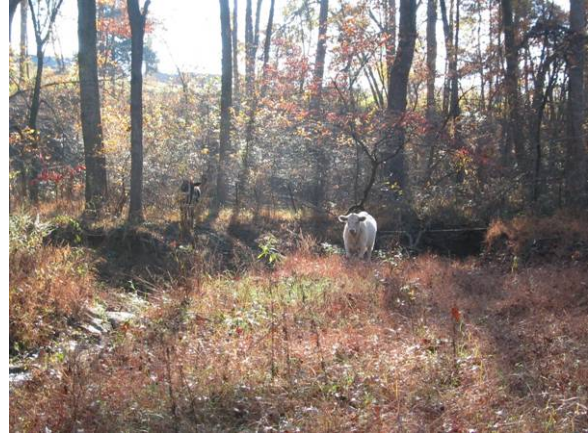
Issue Photo 4
Cattle within the Lyle Creek Easement.

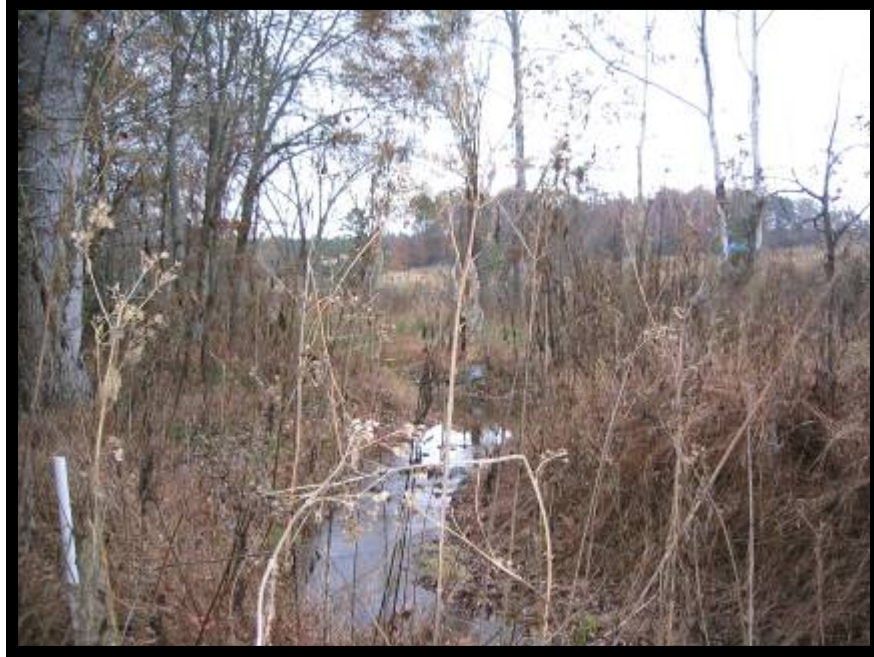
Photo Point 9 Downstream 2004 Station 13+25

- Areas lacking stream pattern
 - There are two areas that have shown a significant change in stream pattern from the as-built conditions.
 - The first section is from station 12+25 to 13+25 there is half of a meander wavelength that has been straightened into a long run this is the result of the head cut mentioned above.
