**Lyle Creek Stream Restoration**  
**Project No. 423**  
**2007 Monitoring Report (Final): Year 5 of 5**

**March 2008**

Prepared by: Jordan, Jones, and Goulding, Inc.  
9101 Southern Pine Blvd., Suite 160  
Charlotte, NC 28273

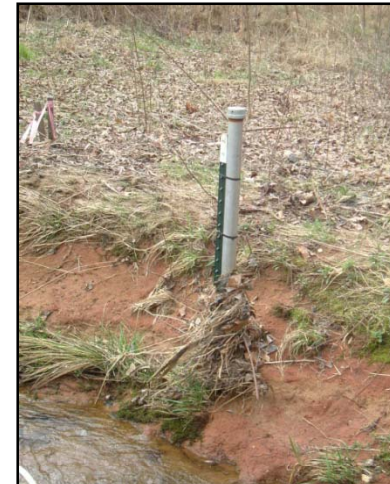
4. Vegetation Cover Poor-3/22/2007

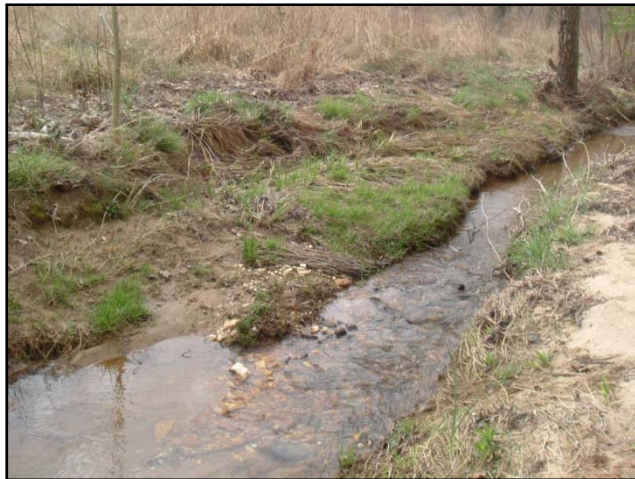
3. Bank Slump-3/22/2007

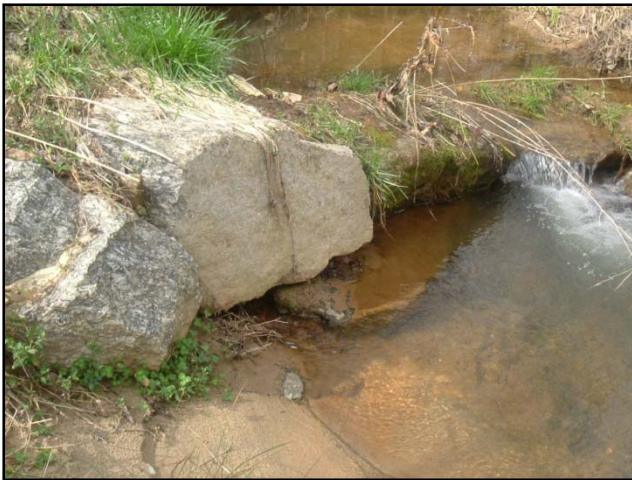
7. Structure Stressed-3/22/2007
