MONITORING YEAR 3 ANNUAL REPORT FINAL

LYON HILLS MITIGATION SITE

Wilkes County, NC
Yadkin River Basin
HUC 03040101

DMS Project No. 100085
NCDEQ Contract No. 7620
USACE Action ID No. SAW-2018-01784
DWR Project No. 2018-1274 v1
Data Collection Dates: January-November 2023

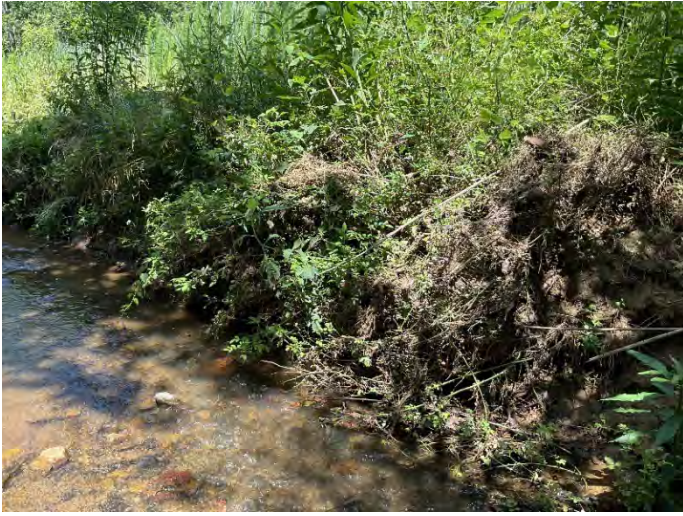
**Crest gage 1 (CG1) on Hanks Branch Reach 3 was washed away after multiple large storm events. Though a bankfull event was not recorded by an automated pressure transducer in MY3, bankfull indicators, such as wrack lines were observed and documented in June and October 2023.

Hanks Branch R3, station 232+61 – Right Bank Wrack Line
(6/18/2023)
