**MONITORING REPORT**  
**2023 (Year 5)**

**MAJOR HILL STREAM AND WETLAND MITIGATION SITE**

Alamance County, North Carolina

DMS Project ID No. 100015  
Full Delivery Contract No. 7193  
USACE Action ID No. SAW-2017-01472  
DWR No. 17-0921  
RFP No. 16-006990

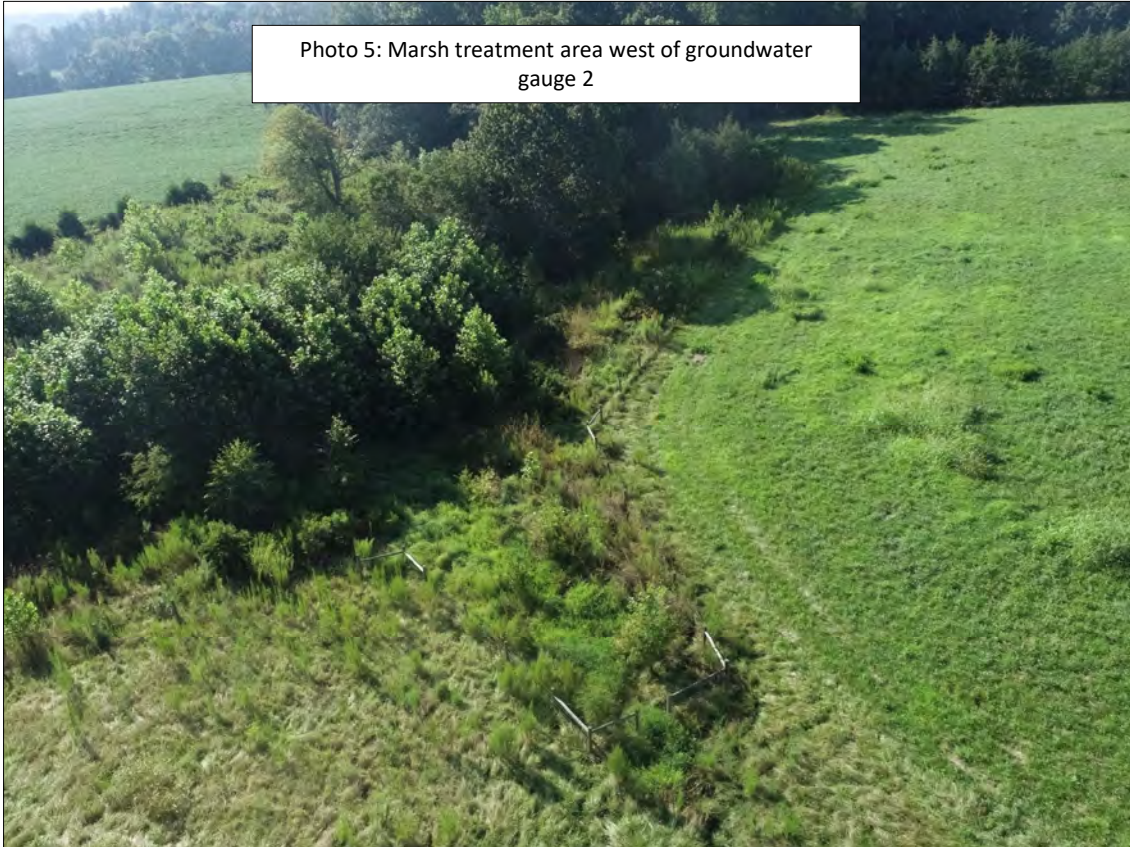
Photo 5: Marsh treatment area west of groundwater gauge 2

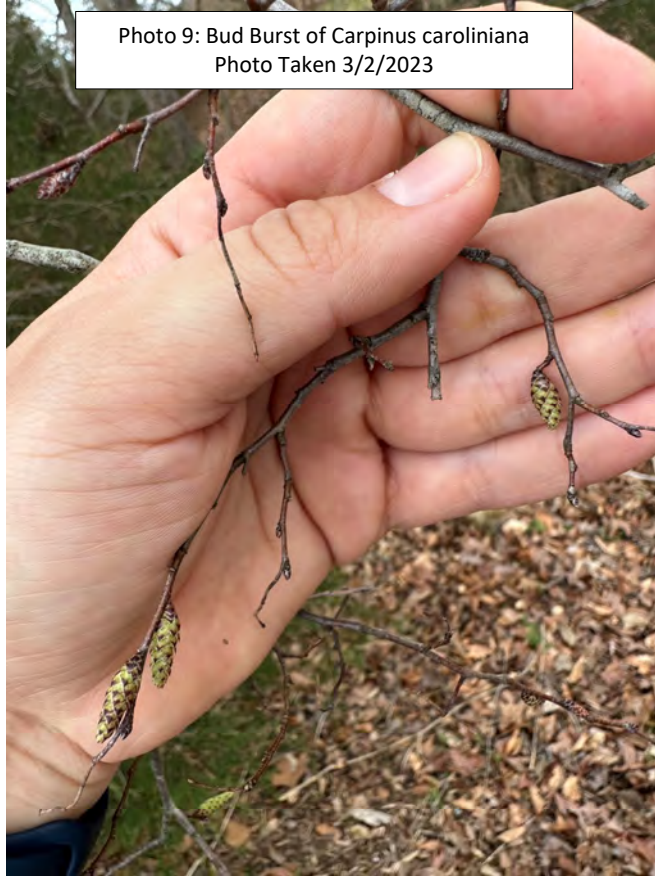
Photo 9: Bud Burst of *Carpinus caroliniana*  
Photo Taken 3/2/2023

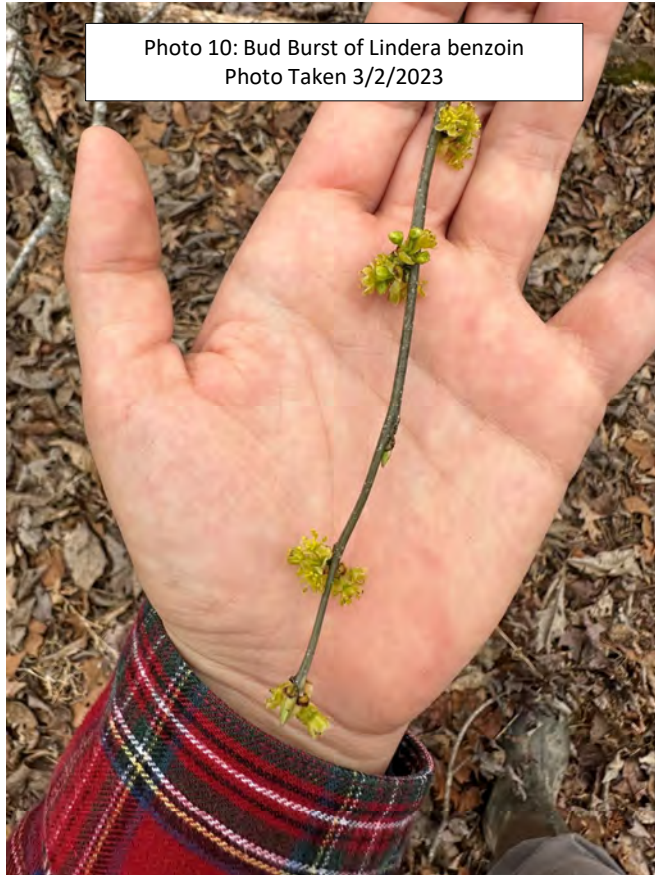
Photo 10: Bud Burst of *Lindera benzoin*  
Photo Taken 3/2/2023

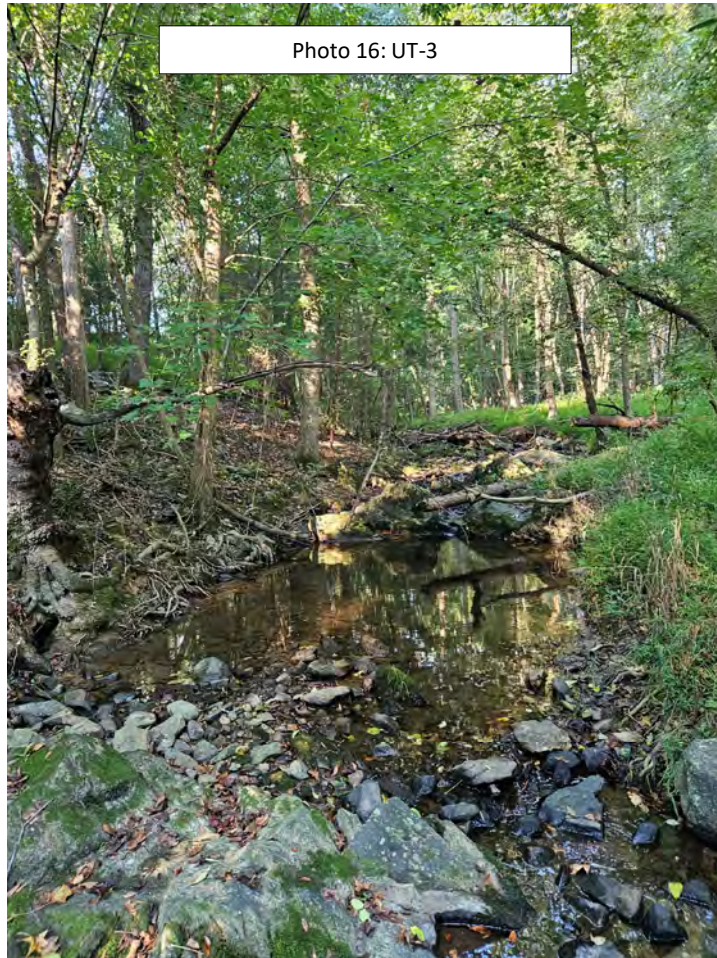
Photo 16: UT-3

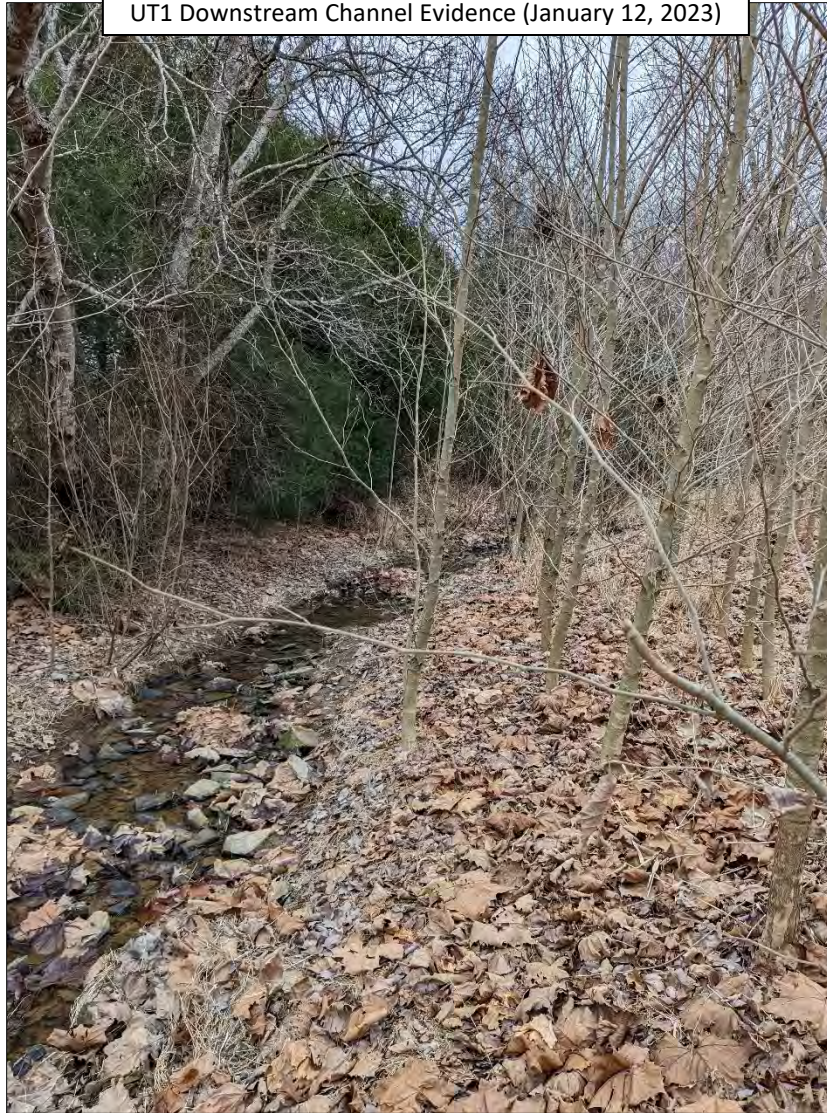
UT1 Downstream Channel Evidence (January 12, 2023)

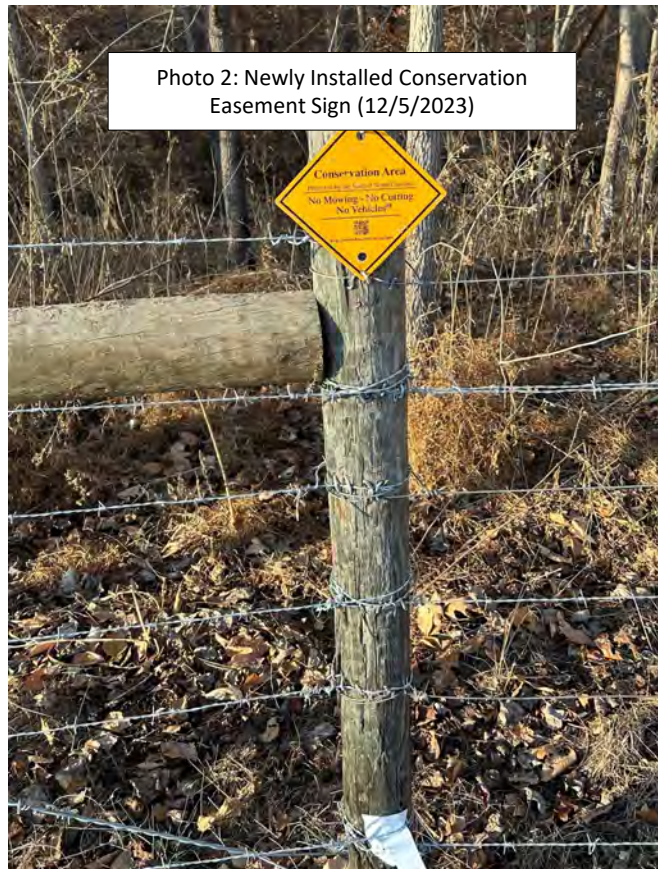
Photo 2: Newly Installed Conservation Easement Sign (12/5/2023)
