**Submission Date:**  
December 2021

NCDEQ Contract No. 7184  
DMS ID No. 100024  
RFP No. 16-006993  
USACE Action ID No. SAW-2017-01509  
NCDWR ID: 2018-0919

DMS Project ID #100024

**MEADOW BROOK STREAM MITIGATION PROJECT**  
 CURRENT CONDITION PLAN VIEW: OVERVIEW  
 MY2: 2021

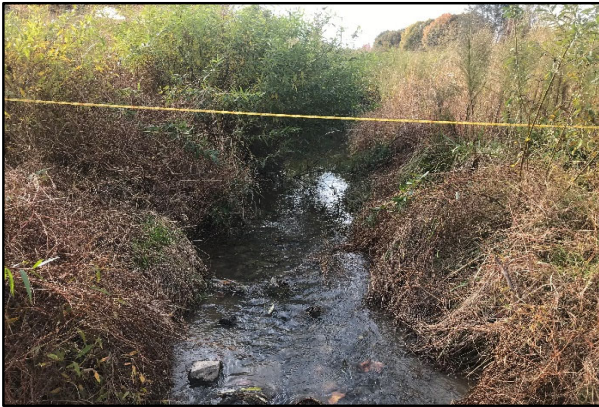
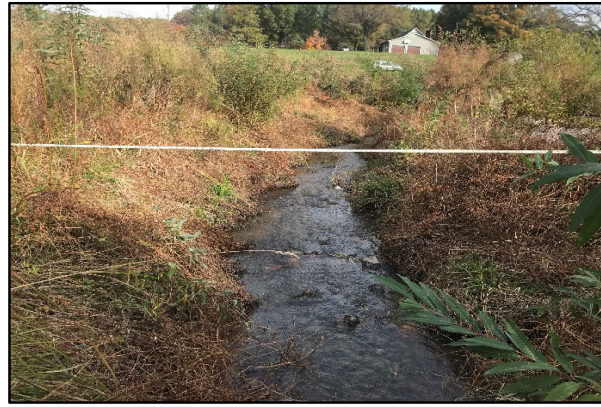
**Cross Section Plots - MY2**  
**XS1 - Reach 1**  
**Rosgen Stream Type - C4**  
**Station 10+87 - Riffle**

MY0	MY1	MY2	MY3	MY4	MY5	MY+
<b>Bankfull Elevation - Based on AB Bankfull Area</b>	1042.89	1043.43	1043.72				
<b>Bank Height Ratio - Based on AB-Bankfull Area</b>	1.00	0.84	0.84				
<b>Thalweg Elevation</b>	1041.08	1041.41	1041.29				
<b>LTOB Elevation</b>	1042.89	1043.11	1043.32				
<b>LTOB Max Depth</b>	1.81	1.70	2.03				
<b>LTOB Cross Sectional Area</b>	19.79	14.06	15.02				
<b>Entrenchment Ratio</b>	>3.5	>4.52	>6.14

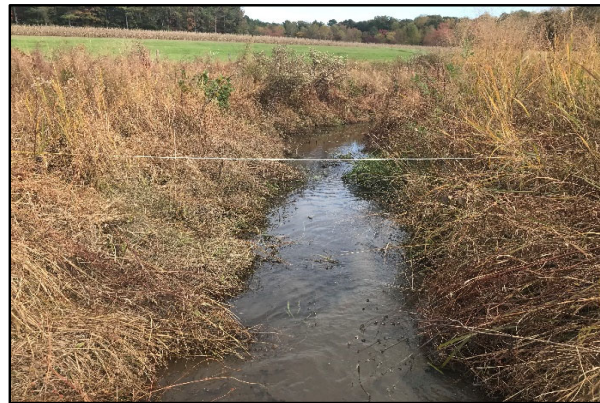
**XS2 looking downstream**

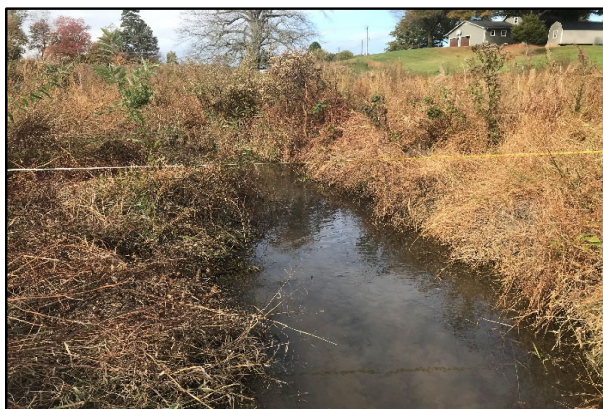
**XS3 looking upstream**

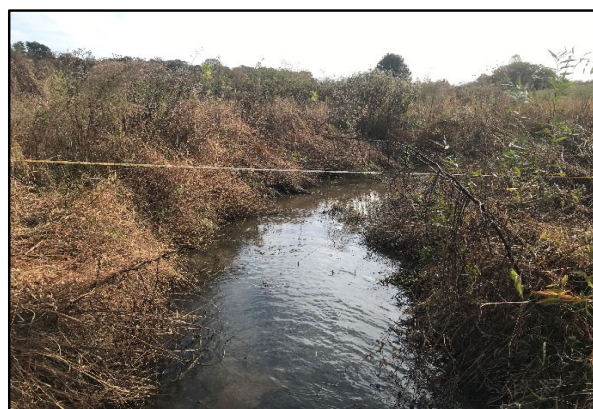
**XS3 looking downstream**

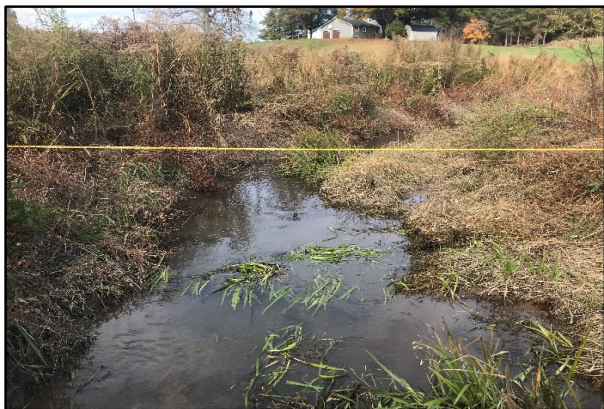
**XS4 looking upstream**

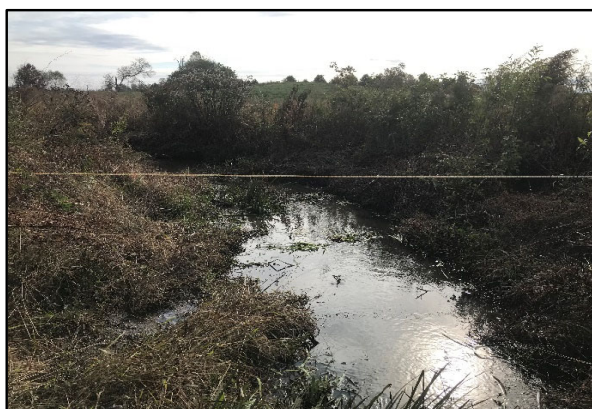
**XS4 looking downstream**

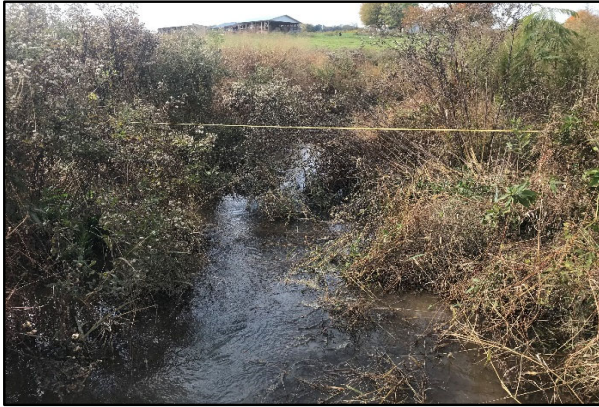
**XS5 looking upstream**

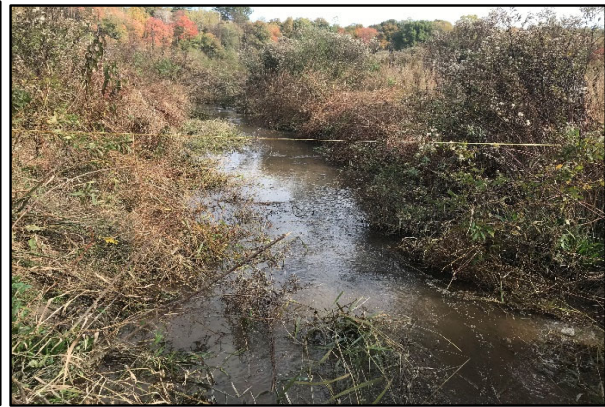
**XS5 looking downstream**

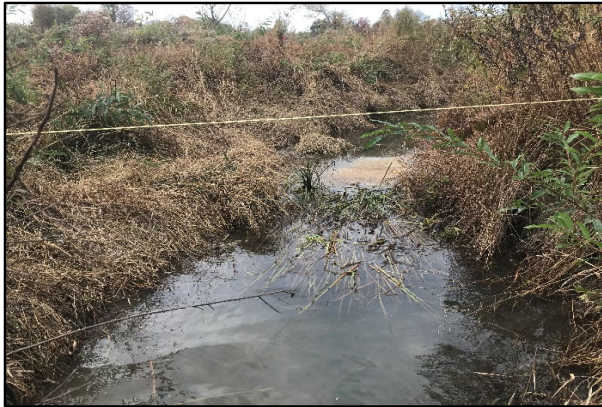
**XS6 looking upstream**

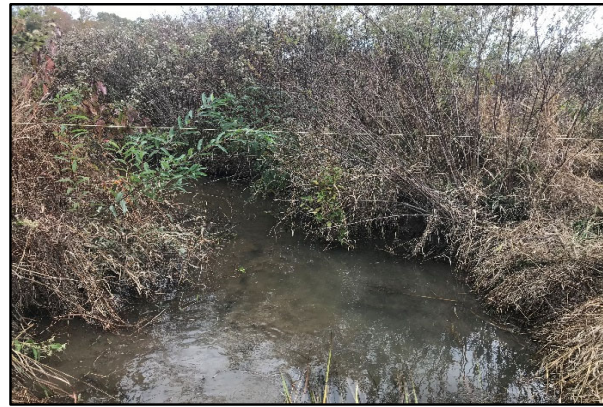
**XS6 looking downstream**

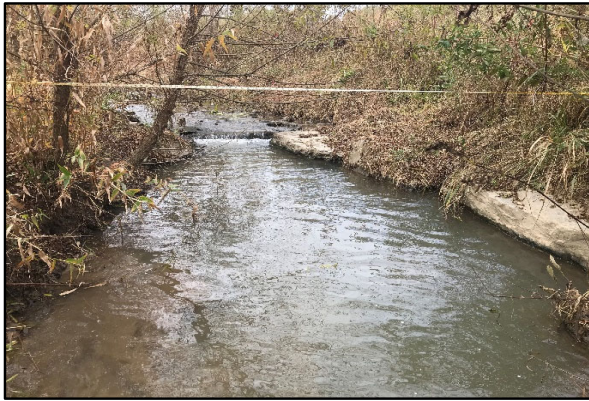
**XS7 looking upstream**

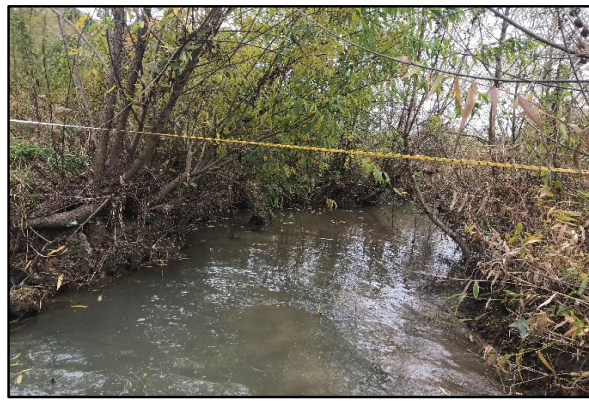
**XS7 looking downstream**

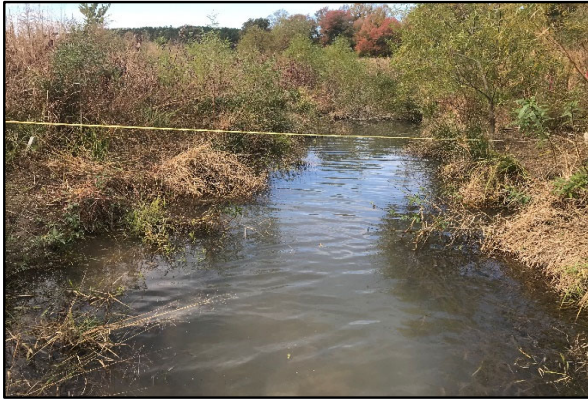
**XS8 looking upstream**

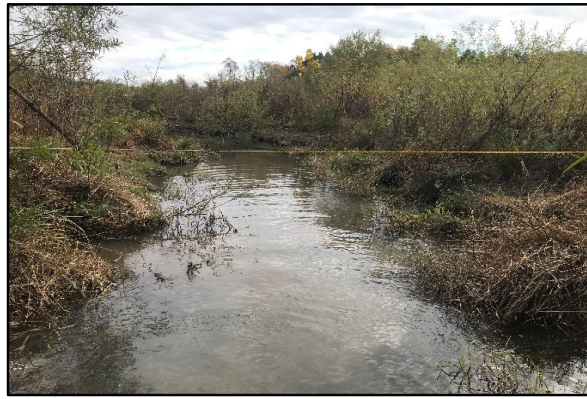
**XS8 looking downstream**

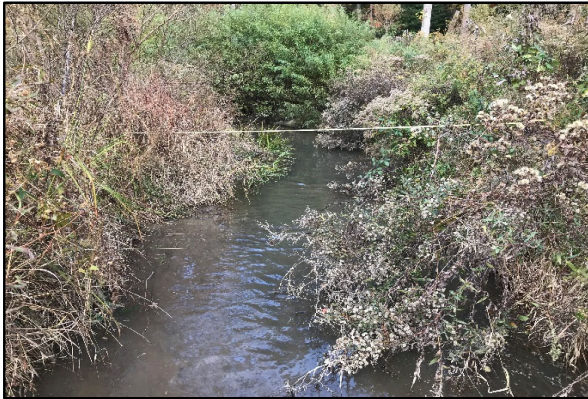
**XS9 looking upstream**

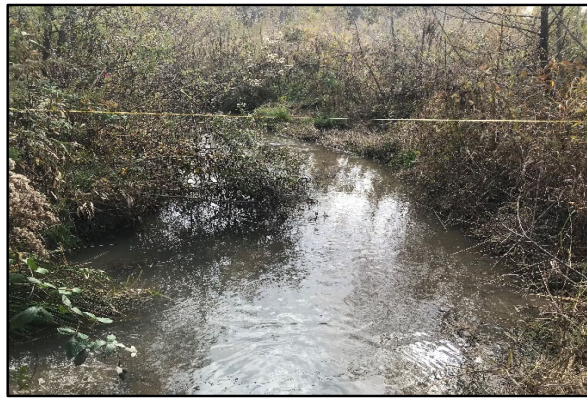
**XS9 looking downstream**

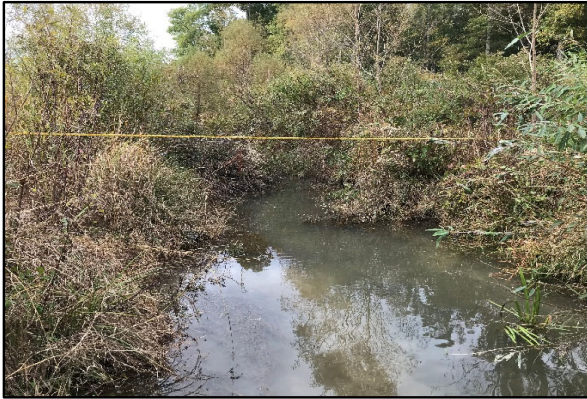
**XS10 looking upstream**

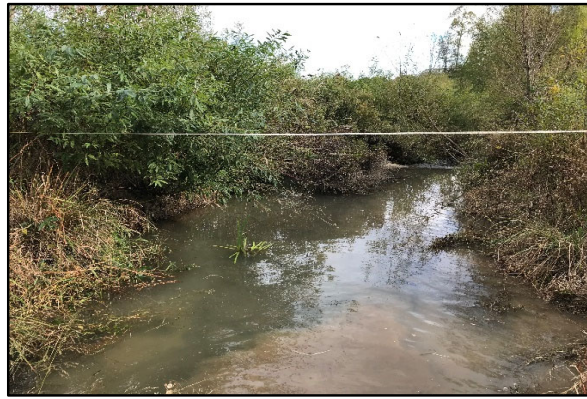
**XS10 looking downstream**

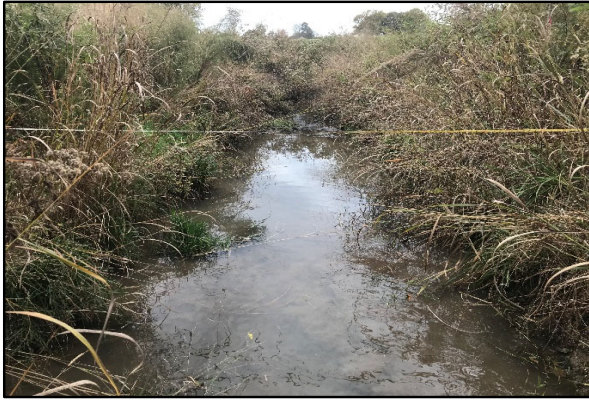
XS11 looking upstream

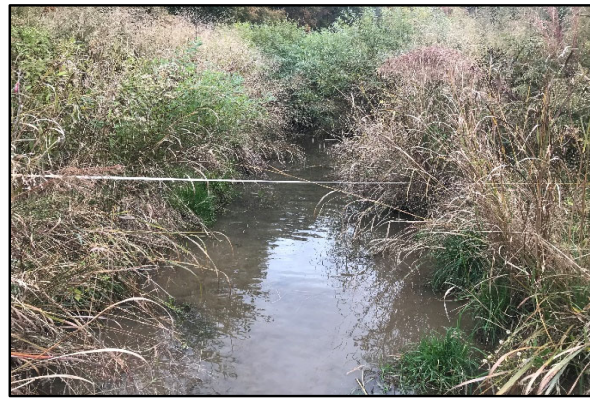
XS11 looking downstream

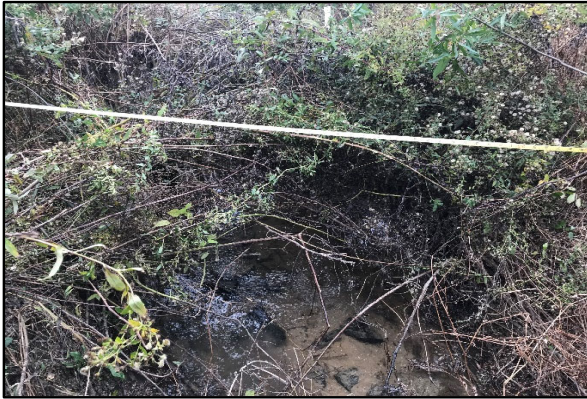
**XS12 looking upstream**

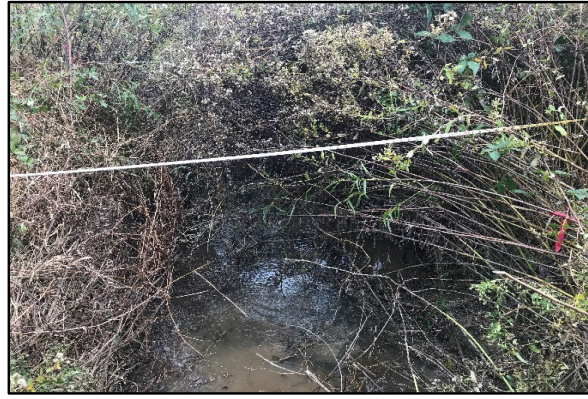
**XS12 looking downstream**

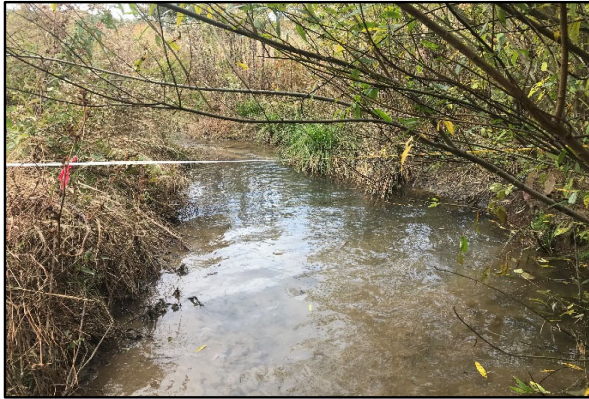
**XS13 looking upstream**

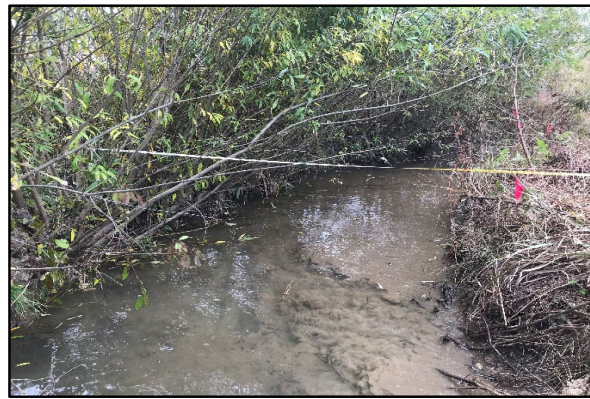
**XS13 looking downstream**
