Meredell Farm Draft Monitoring Report Year 2 of 5 (2009)

Randolph County, North Carolina

Project ID No. 247

Submitted November 2009

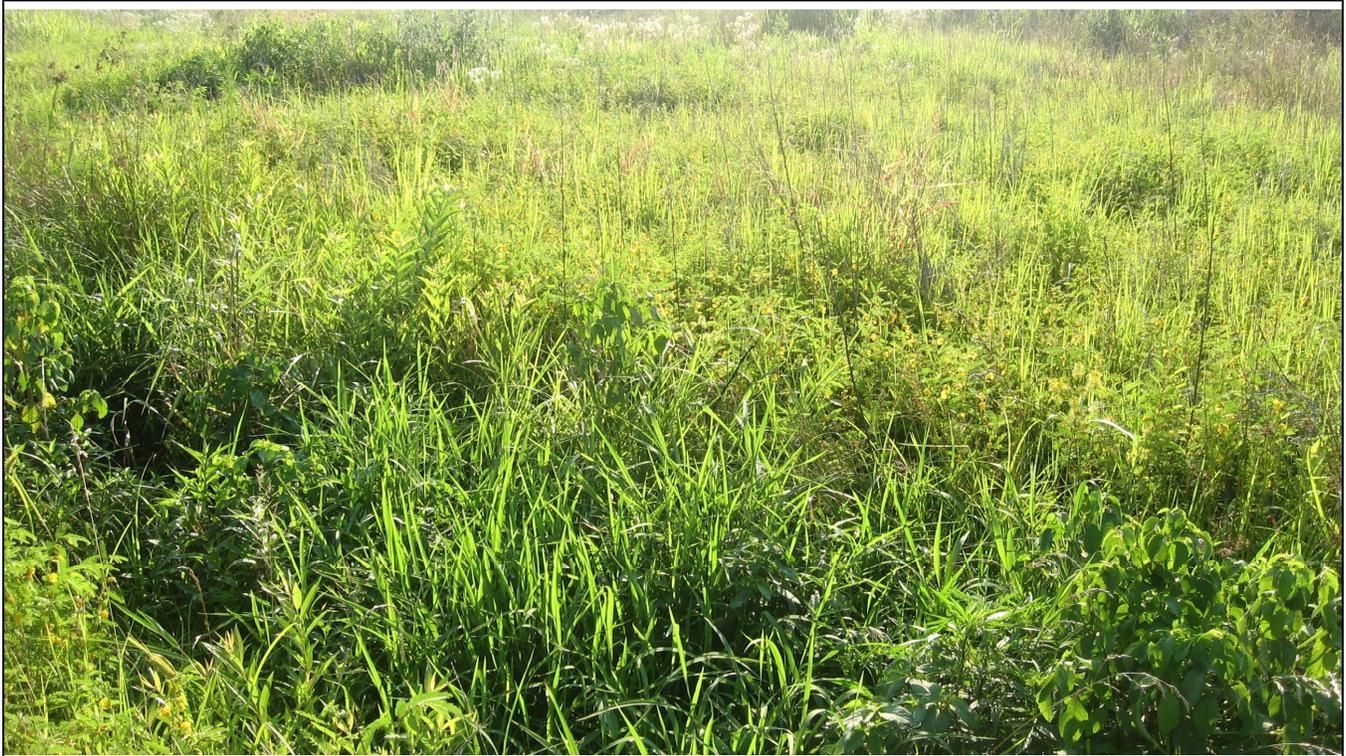
M1 – Typical view of riparian area
Taken: 06-25-2009

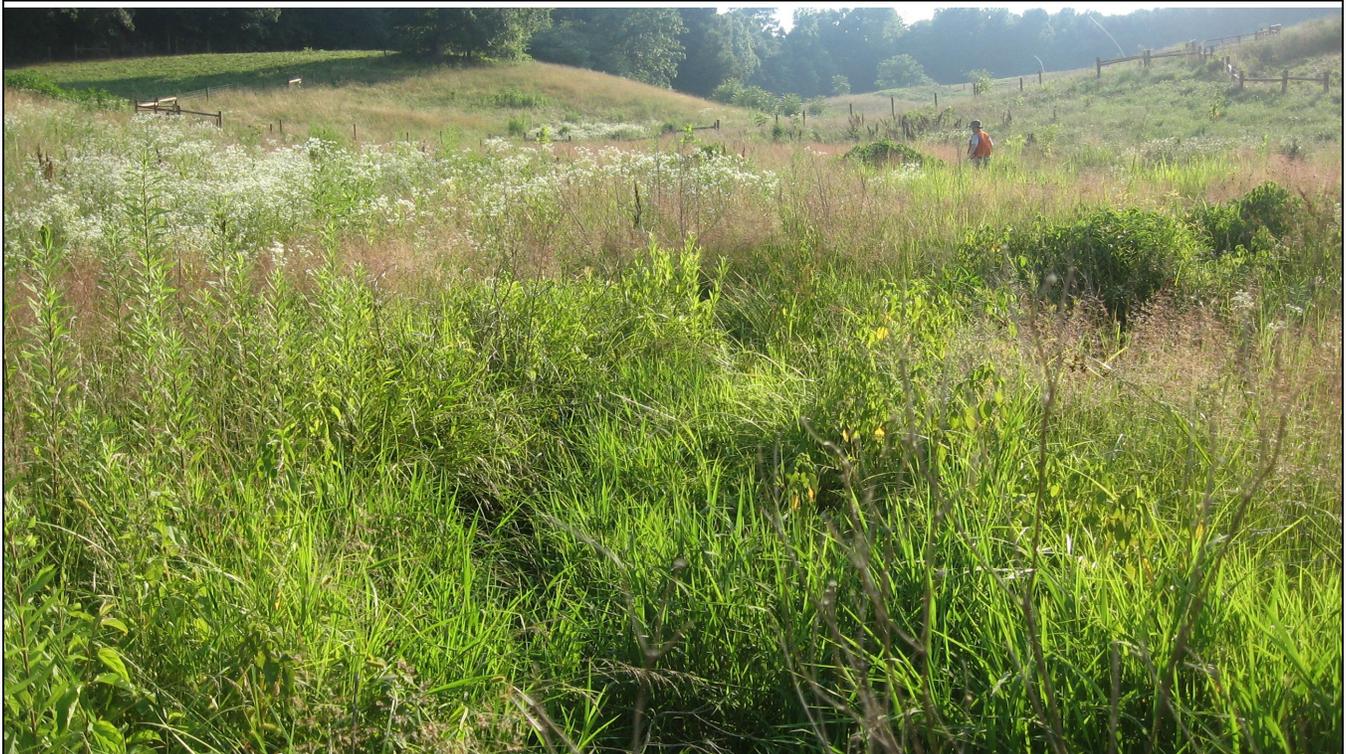
UT1 – Typical view of riparian area
Taken: 06-25-2009
