Annual Monitoring Report

Monitoring Year 4 of 5

Middle South Muddy Stream Restoration Site

McDowell County, North Carolina

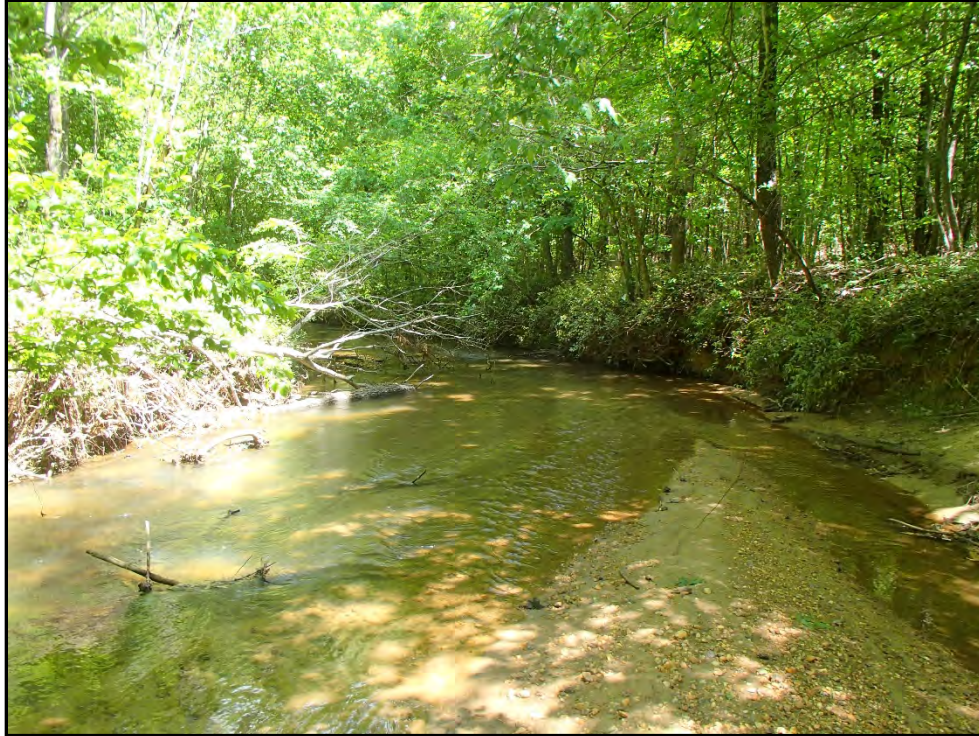
Haney Tract – Permanent Photo Station 27
Looking Upstream South Muddy Creek

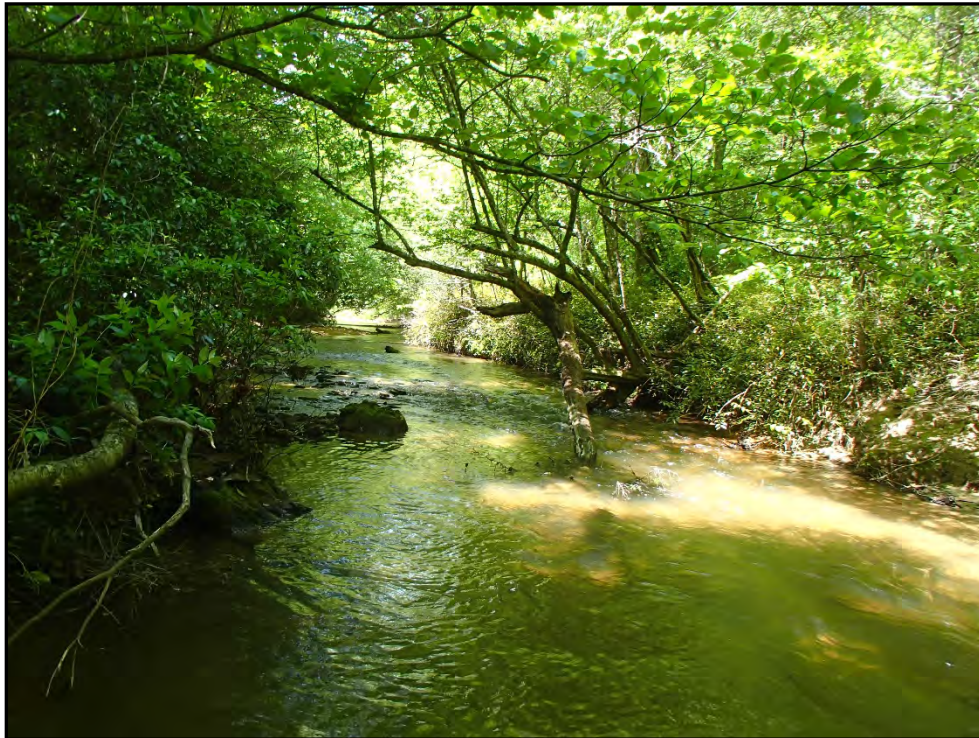
Haney Tract – Permanent Photo Station 27
Looking Downstream South Muddy Creek

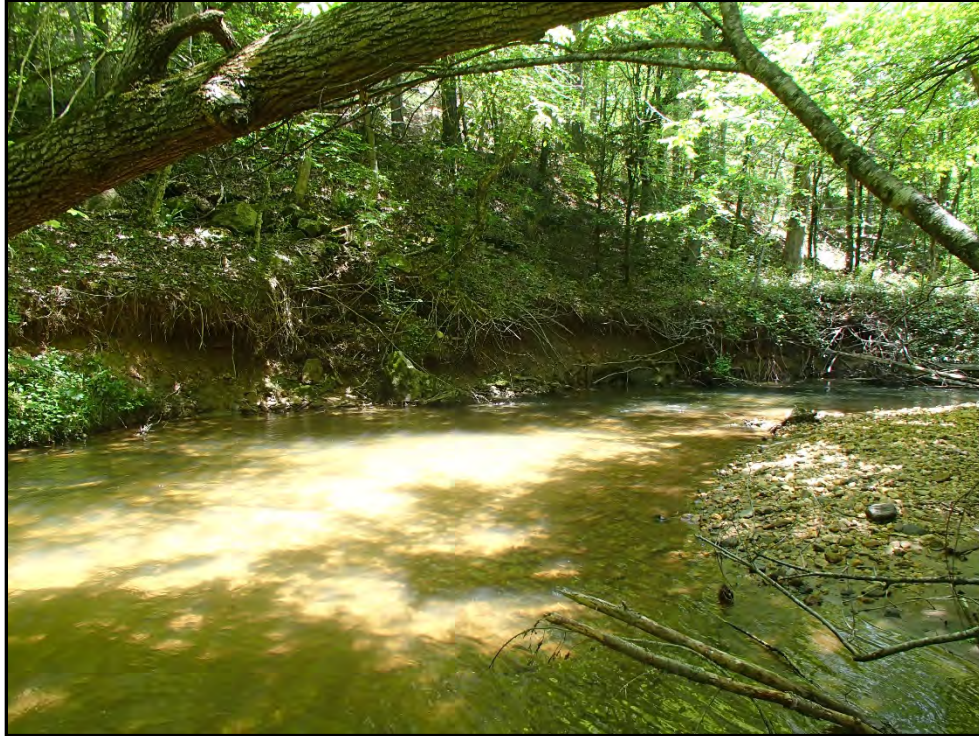
Haney Tract – Permanent Photo Station 28
Looking Upstream South Muddy Creek

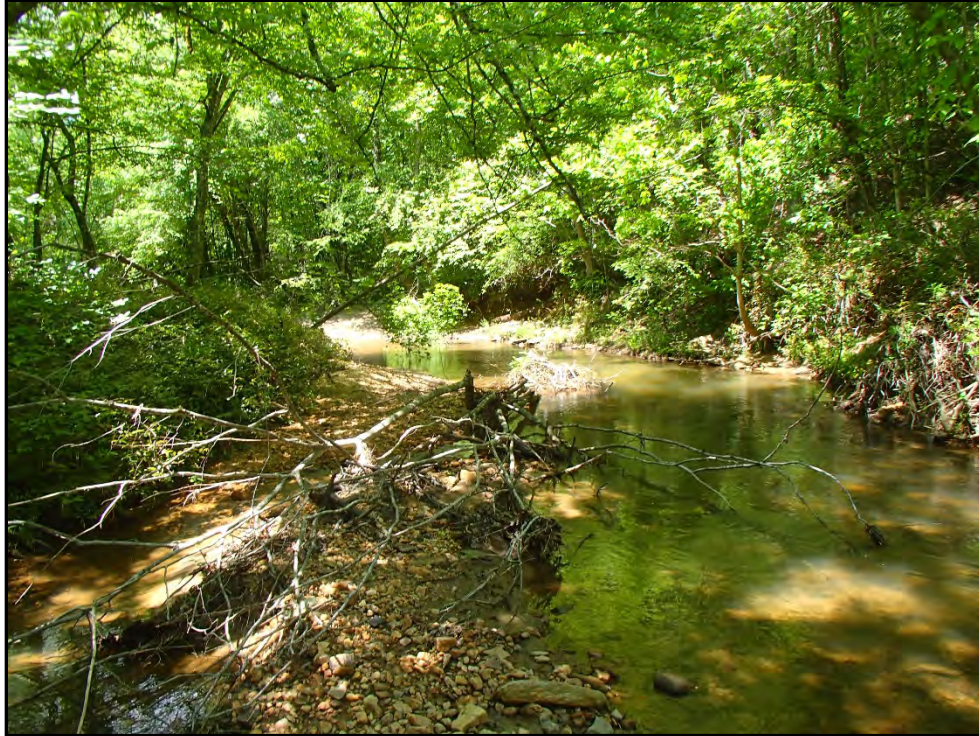
Haney Tract – Permanent Photo Station 28
Looking Upstream Tributary to South Muddy Creek

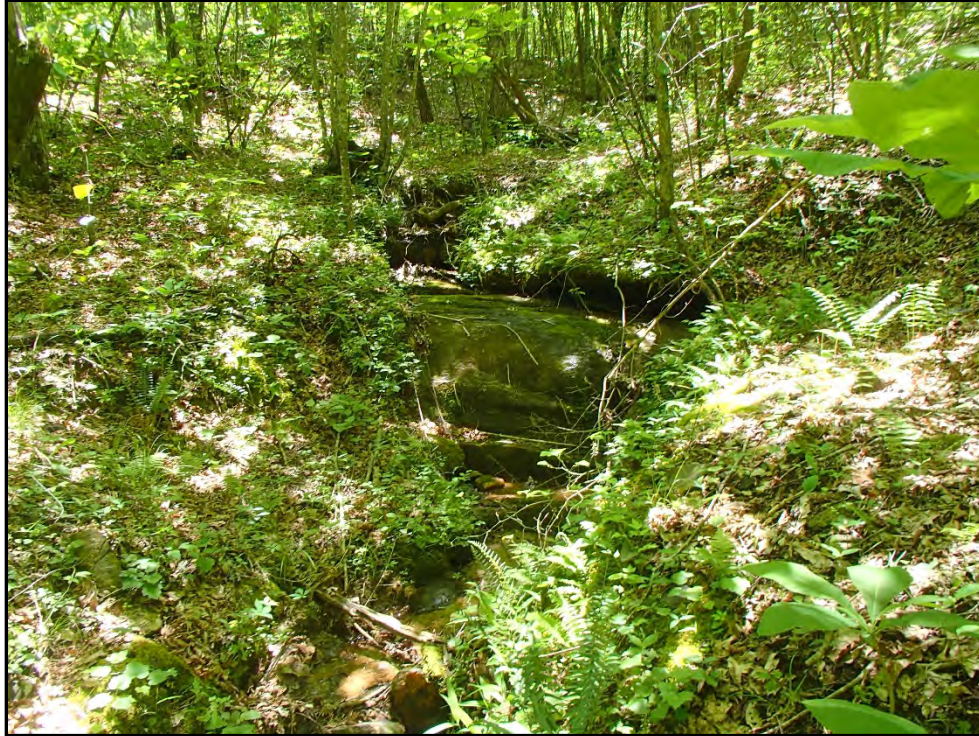
Haney Tract – Permanent Photo Station 30
Looking Downstream Tributary to South Muddy Creek
