# **Annual Monitoring Report**

**Mill Dam Creek Restoration Site**

**Monitoring Year 01**

**DMS Project Number 97136**

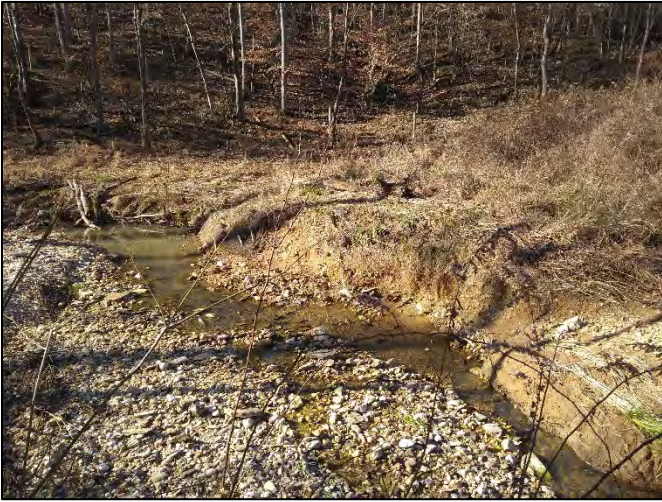
Outer bend erosion, Sta 39+50, 12/18/20

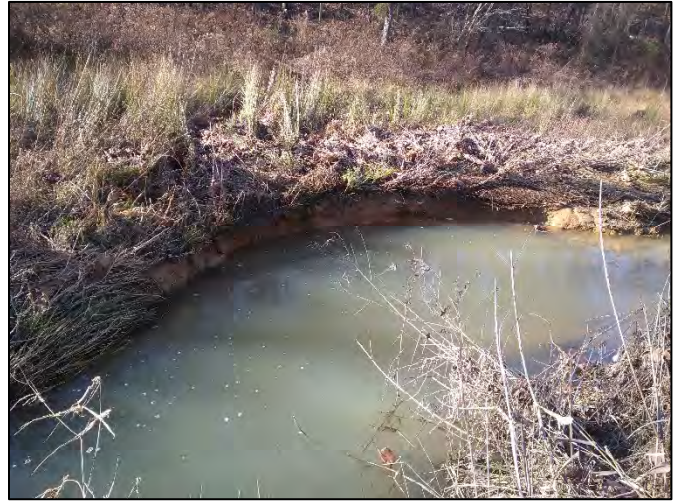
Outer bend erosion, Sta 46+25, 12/18/20

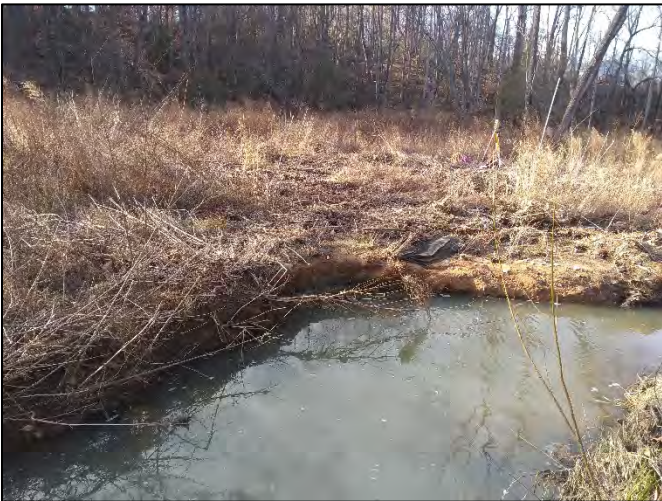
Outer bend erosion, Sta 50+75, 12/18/20

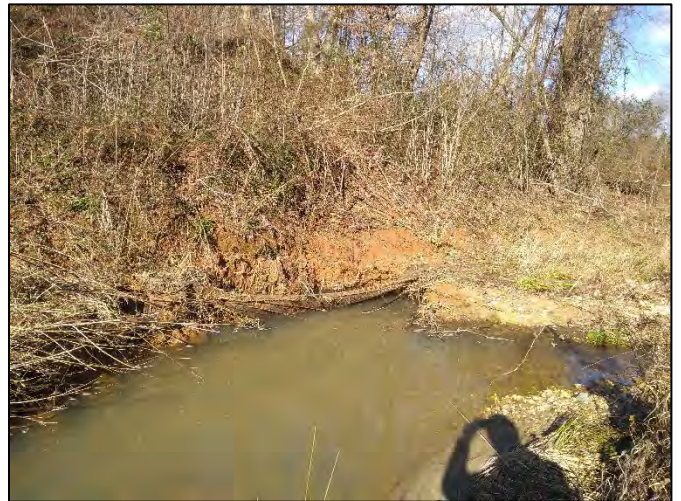
Outer bend erosion, Sta 54+25, 12/18/20

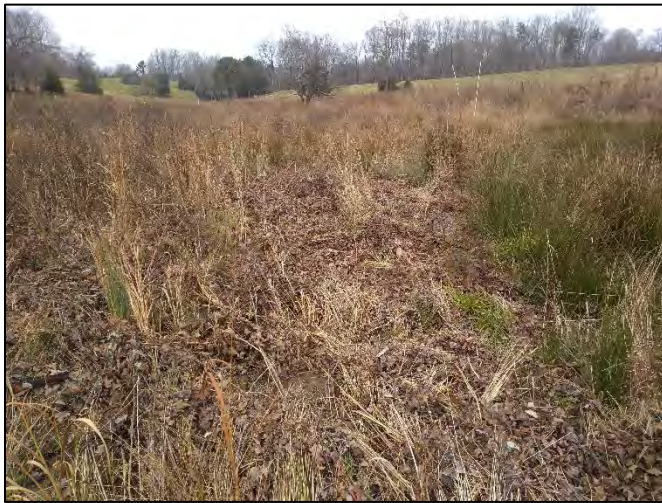
Photo 1. Wrack lines above bankfull, UTHC1 – 12/18/2020

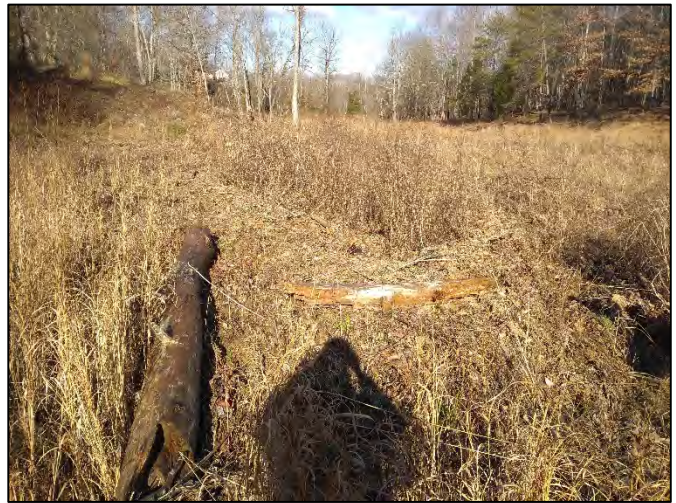
Photo 2. Wrack lines above bankfull, UTHC3 – 12/18/2020

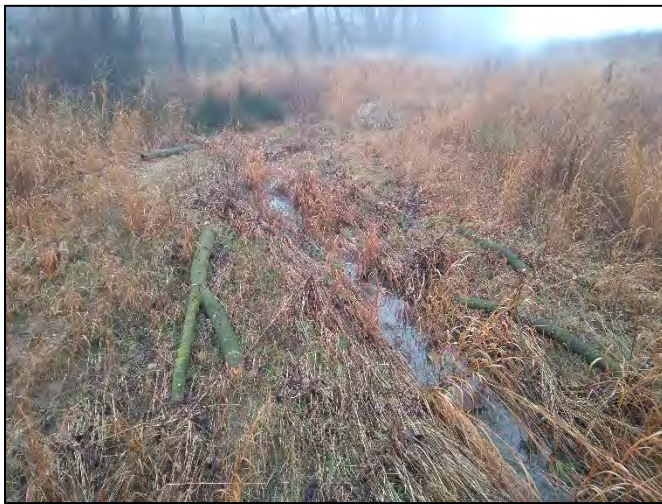
Photo 3. Wrack lines above bankfull, T1 – 12/18/2020

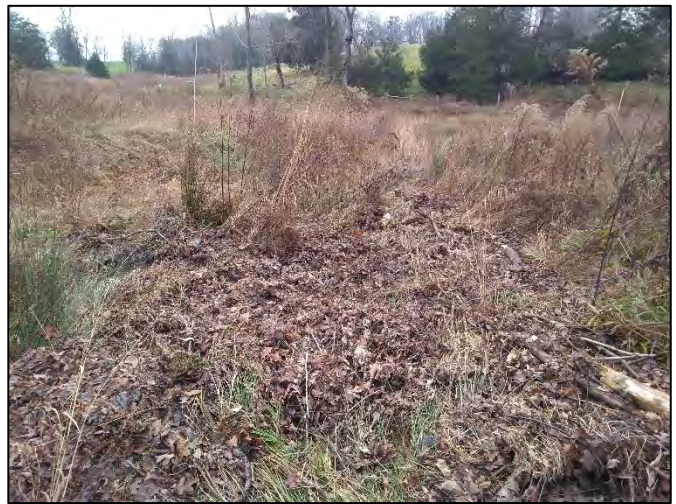
Photo 4. Wrack lines above bankfull, T2 – 12/18/2020

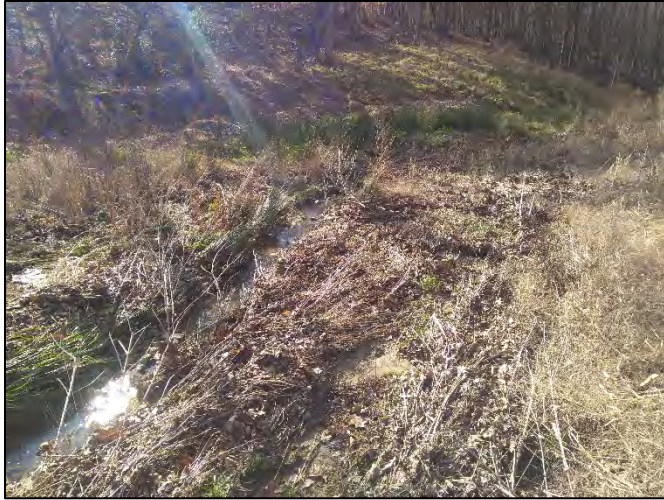
Photo 5. Wrack lines above bankfull, T6 – 12/18/2020

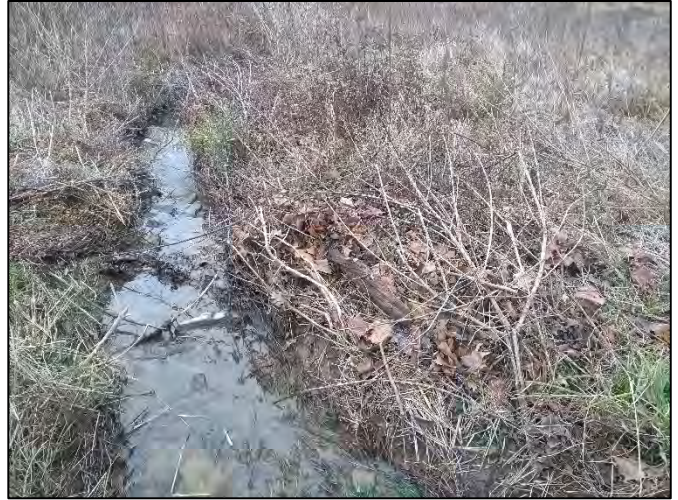
Photo 6. Wrack lines above bankfull, T8 – 12/18/2020

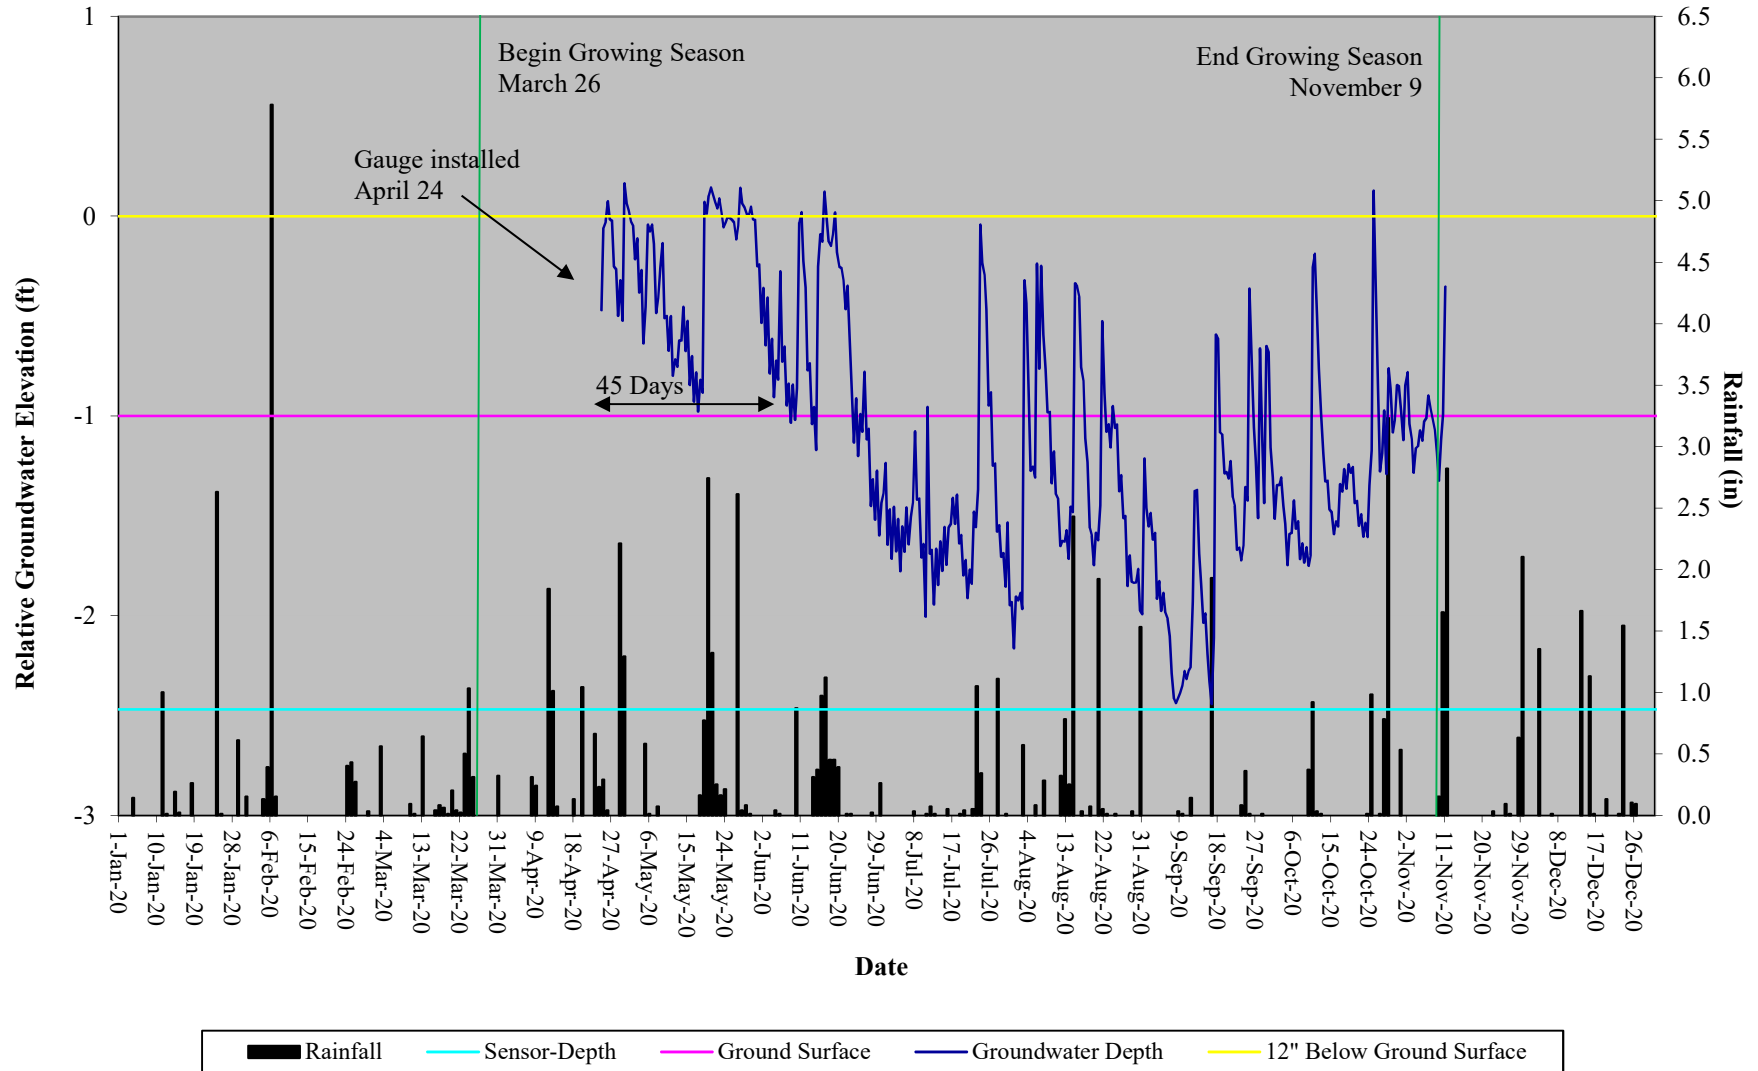
Mill Dam Creek Restoration Site  
Hydrograph  
Wetland Gauge 1, T7

<b>Table 13. Wetland Hydrology Verification</b> <b>Mill Dam Creek Restoration Site, DMS Project #97136</b>								
		Max Consecutive Days During Growing Season (Percentage)						
Gauge #	Location	MY-01 2020	MY-02 2021	MY-03 2022	MY-04 2023	MY-05 2024	MY-06 2025	MY-07 2026
Gauge 1	T7	45 (19.7%)						
Gauge 2	T8	Gauge malfunction
