# MILL BRANCH STREAM RESTORATION PROJECT

## MONITORING REPORT (YEAR 1 OF 5)

Columbus County, North Carolina  
SCO Project Number 020611301A  
EEP Project Number 0251

Status of Plan: Final  
Submission Date: August 2008

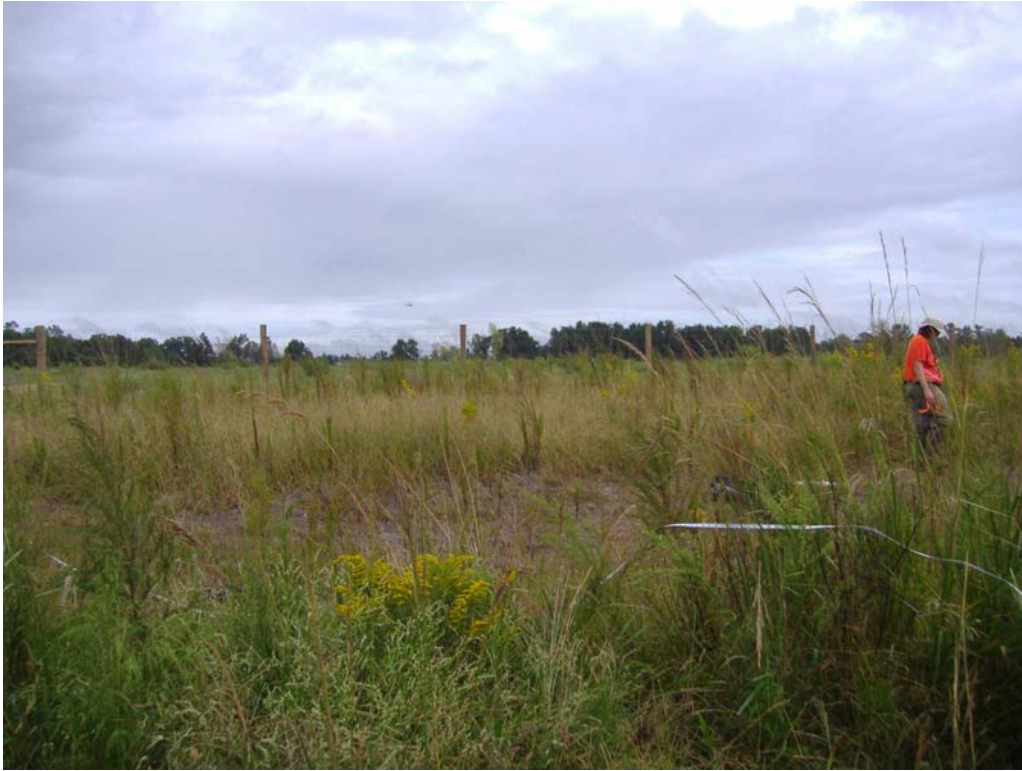
Photo Station 7 - Veg Plot 1 – looking north

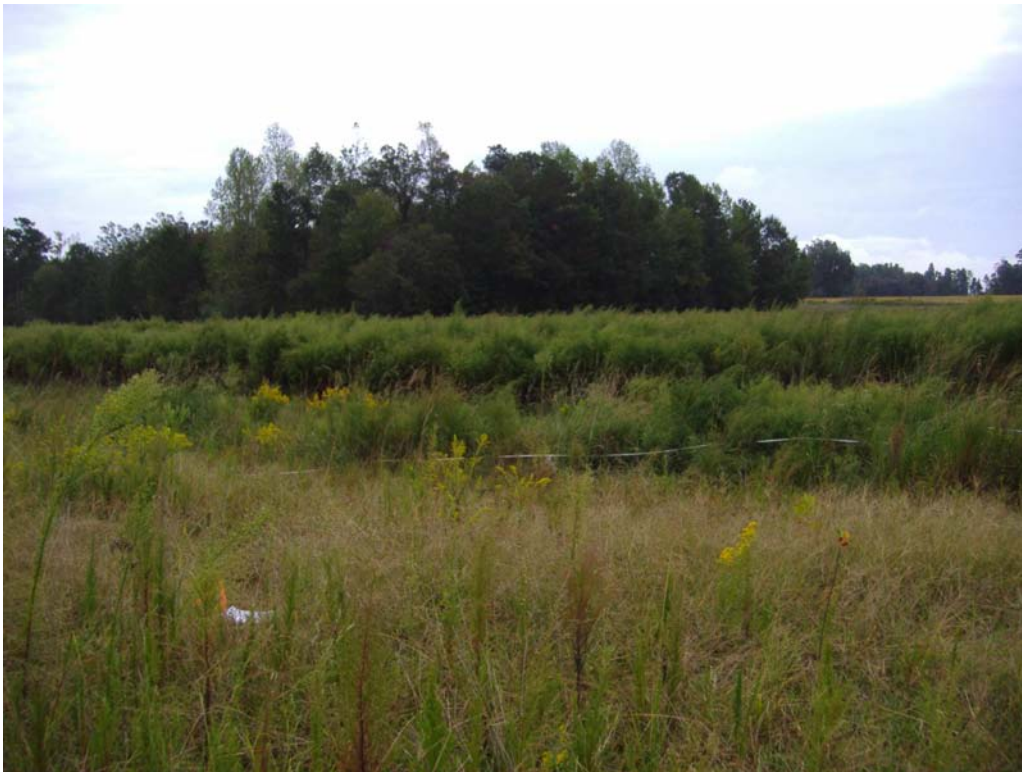
Photo Station 8 - Veg Plot 1 – looking south

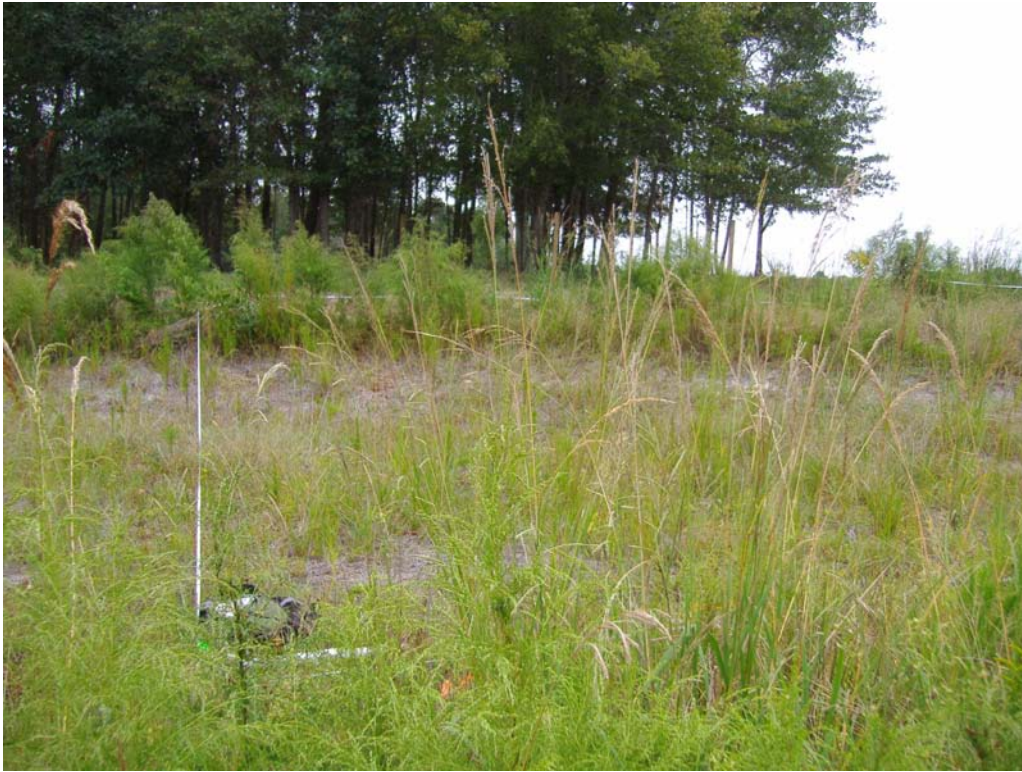
Photo Station 15 - Veg Plot 2 – looking northeast (October 4, 2007)

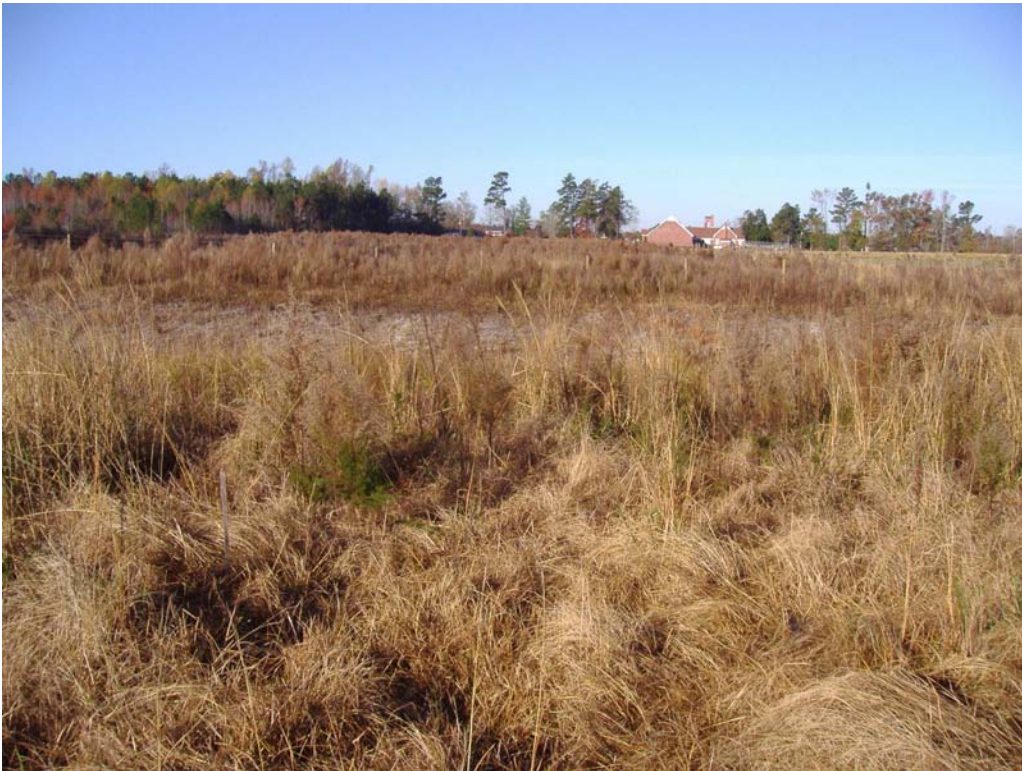
Photo Station 16 - Veg Plot 2 – looking west (November 28, 2007)

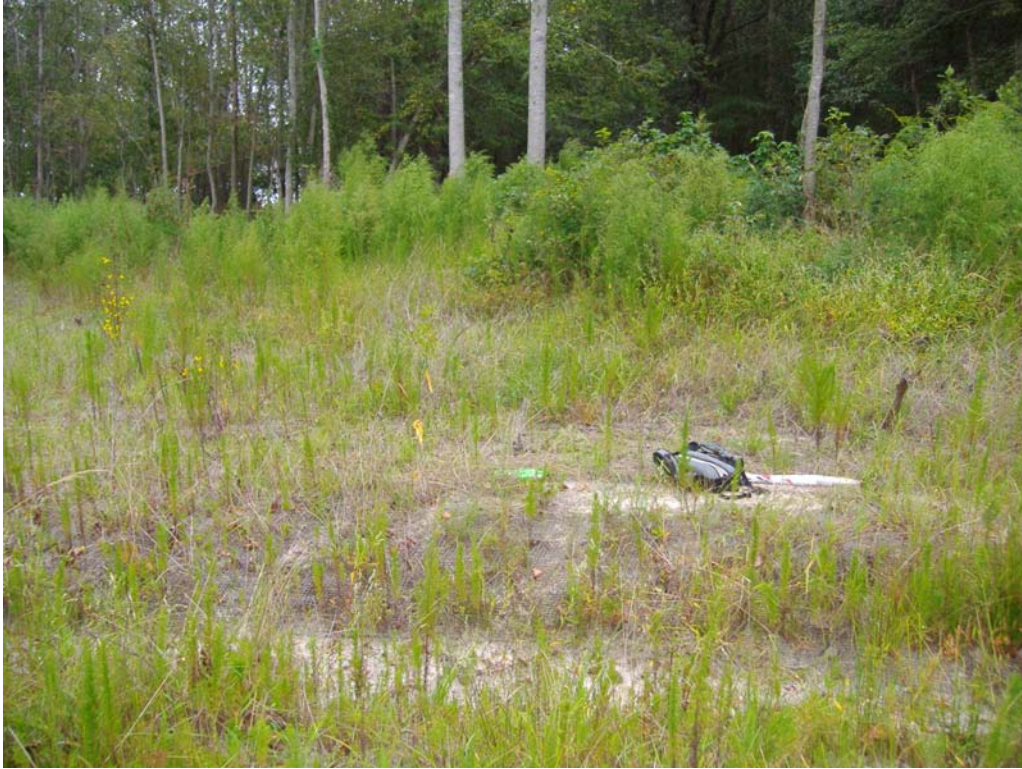
Photo Station 21 - Veg Plot 3 – looking east

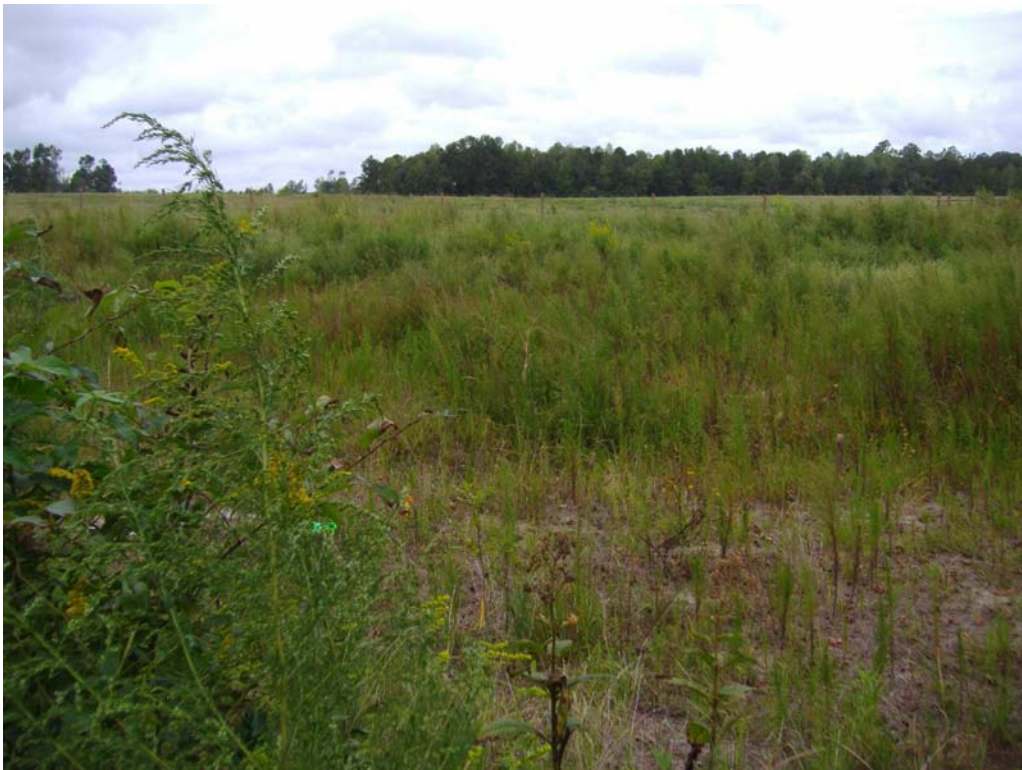
Photo Station 22 - Veg Plot 3 – looking west

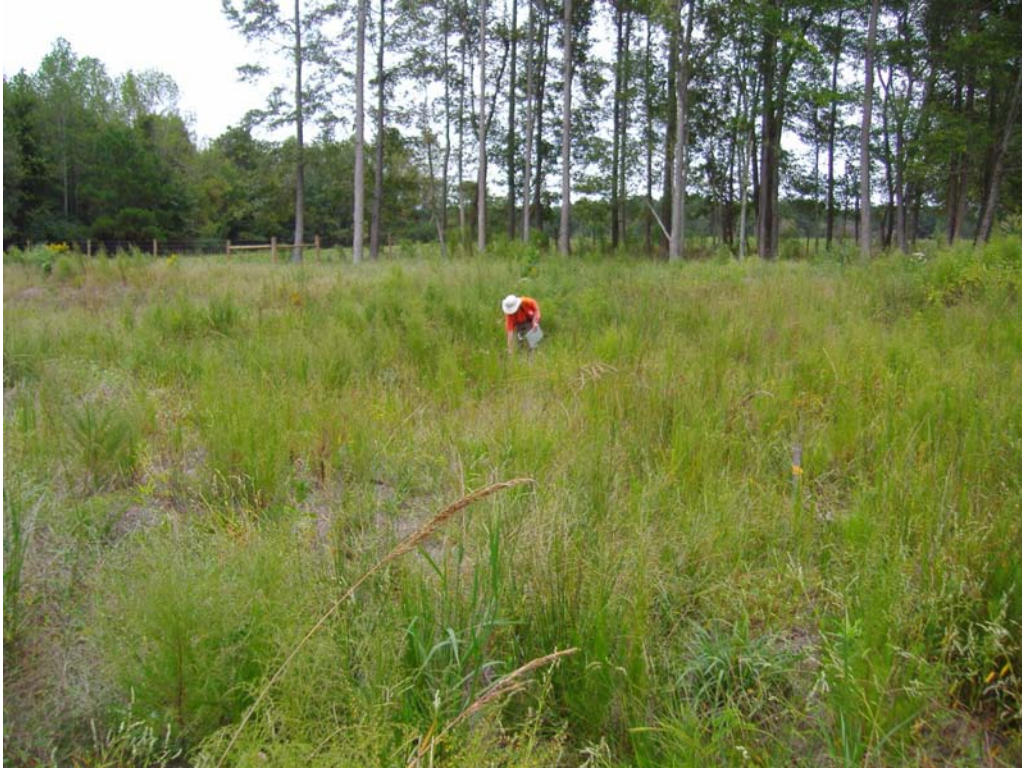
Photo Station 29 - Veg Plot 4 – looking northeast

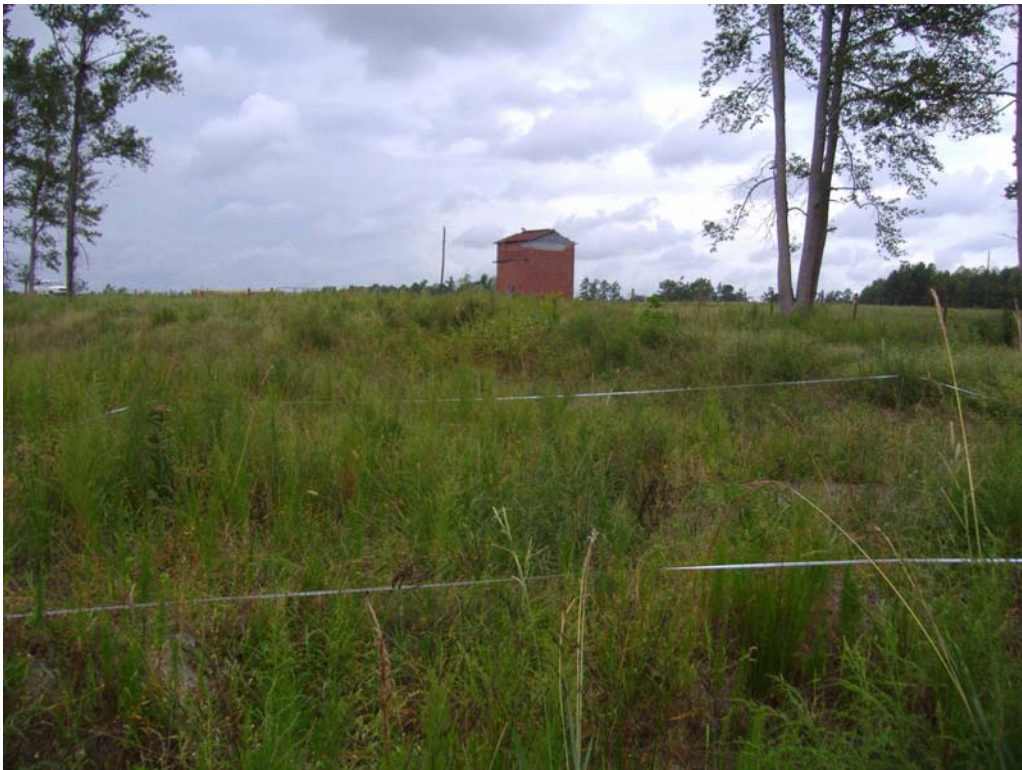
Photo Station 30 - Veg Plot 4 – looking southwest

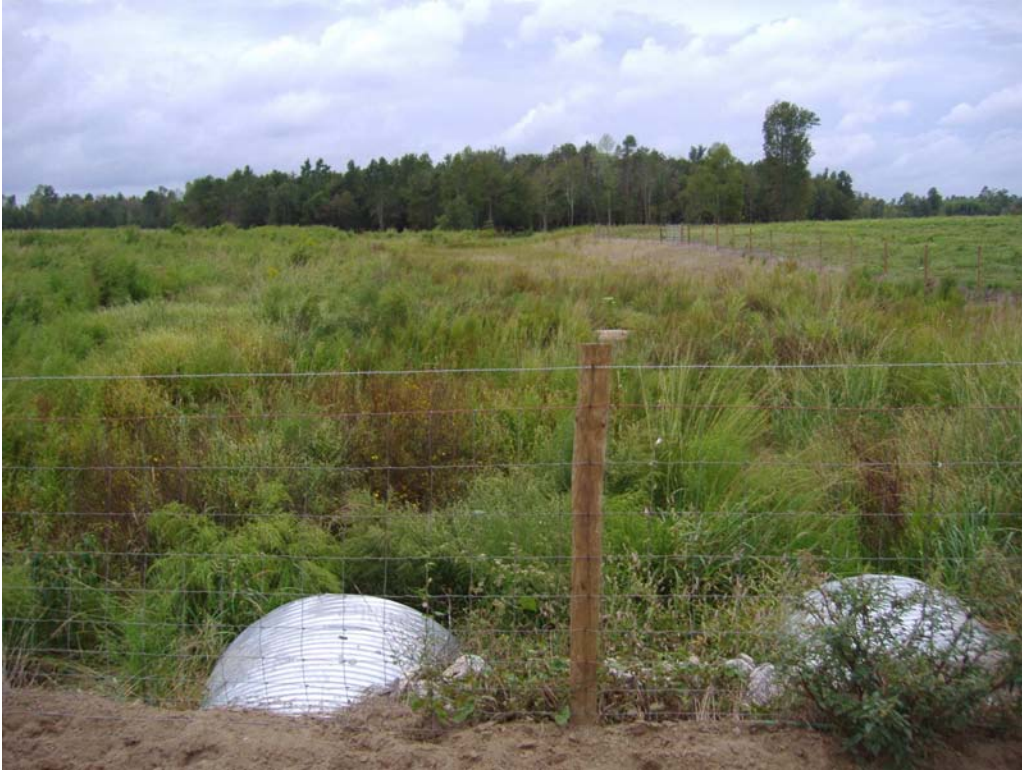
Photo Station 27. Road Crossing – Upstream – Looking at Middle Reach

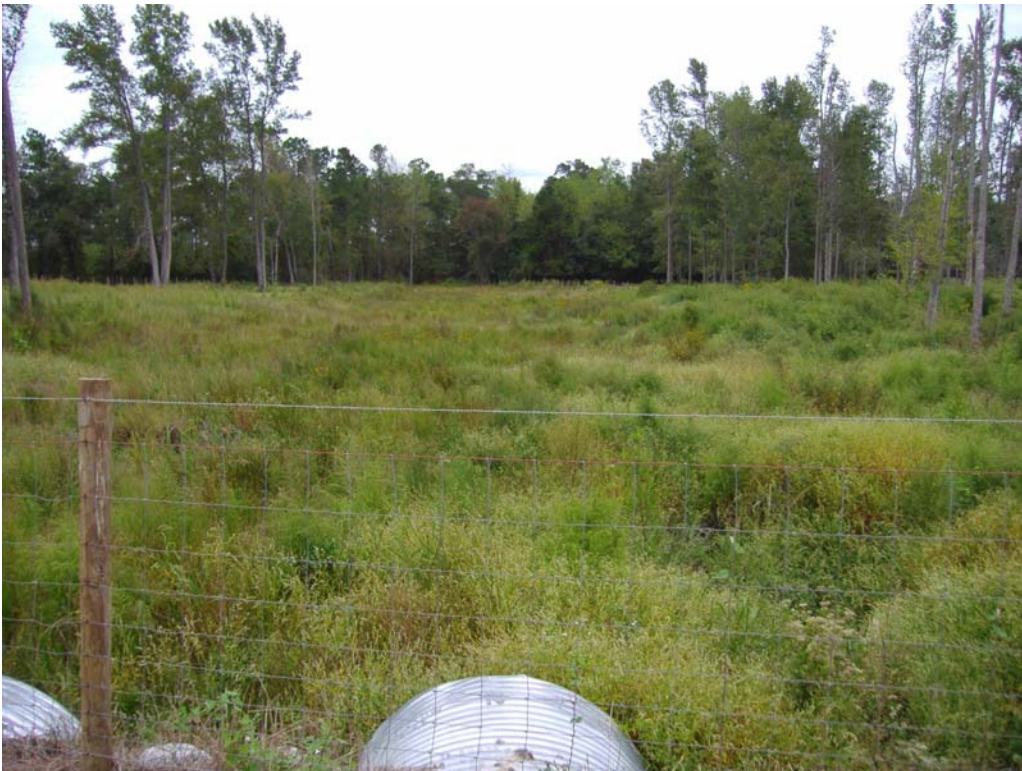
Photo Station 28. Road Crossing – Downstream – Looking at Lower Reach

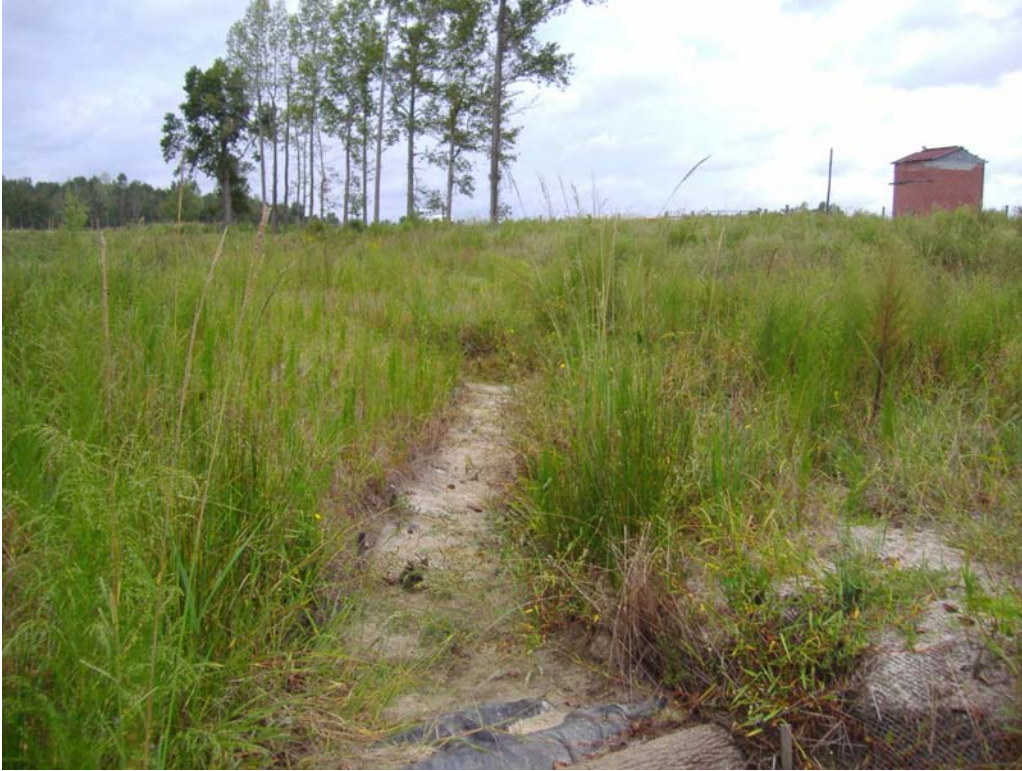
Photo Station 31. Riffle Cross-section 7 – Upstream – Lower Reach

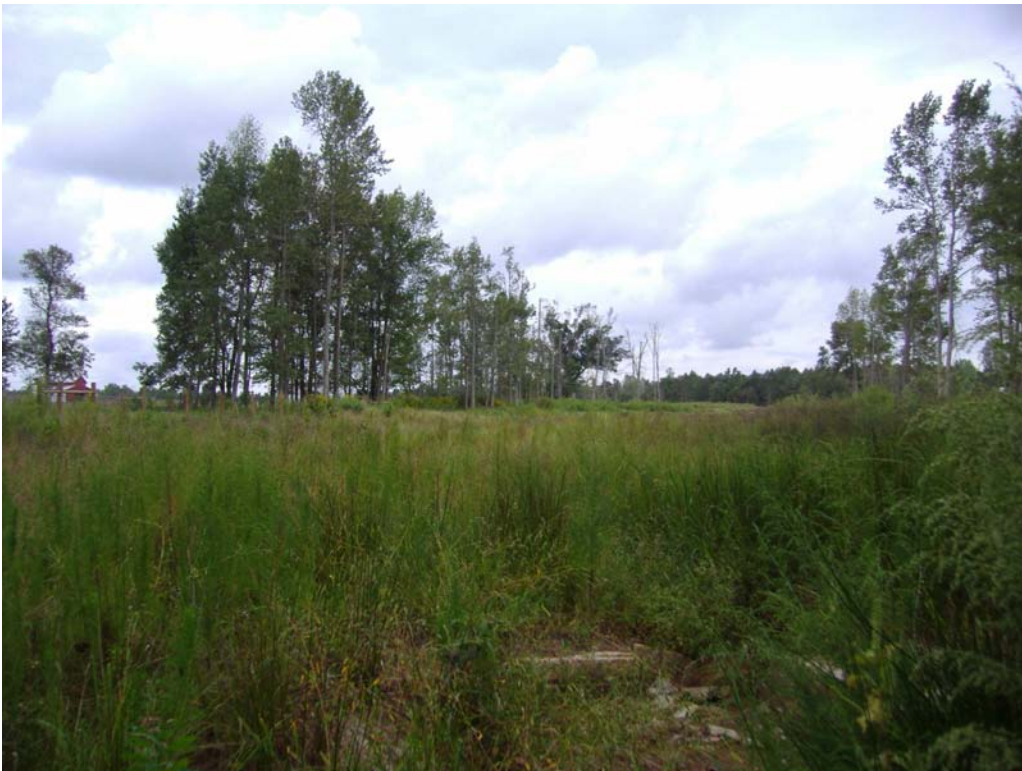
Photo Station 34. End of Project – Upstream – Lower Reach
