Morgan Creek Stream Restoration Site

Year 1 Final Monitoring Report
Project ID Number: 16-D06027

Prepared by:
Equinox Environmental Consultation and Design, Inc.

Submitted to:
NCDENR - Ecosystem Enhancement Program

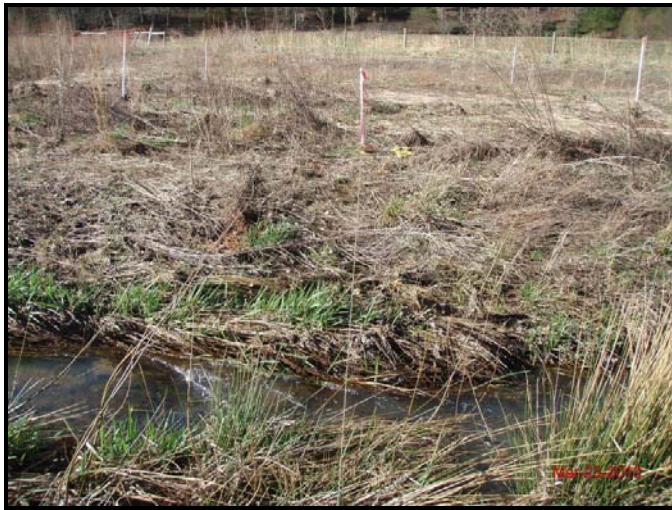
Morgan Creek Upper – Riffle 1 Cross-Section 1

Looking at Left Bank

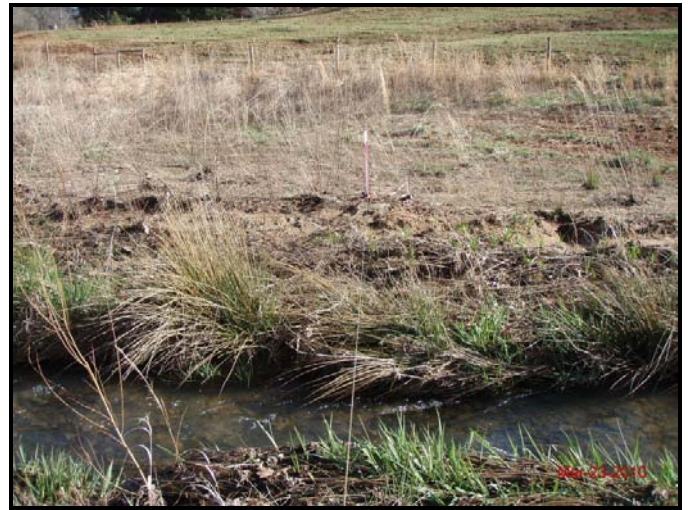
Looking at Right Bank

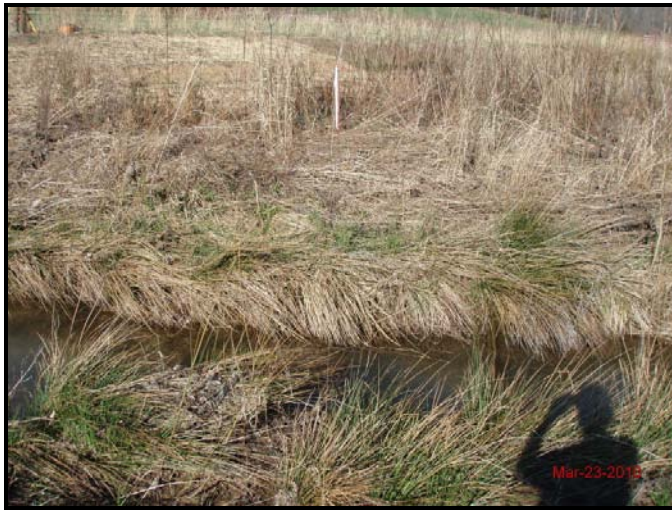
Morgan Creek Upper – Riffle 2 Cross-Section 2

Looking at Left Bank

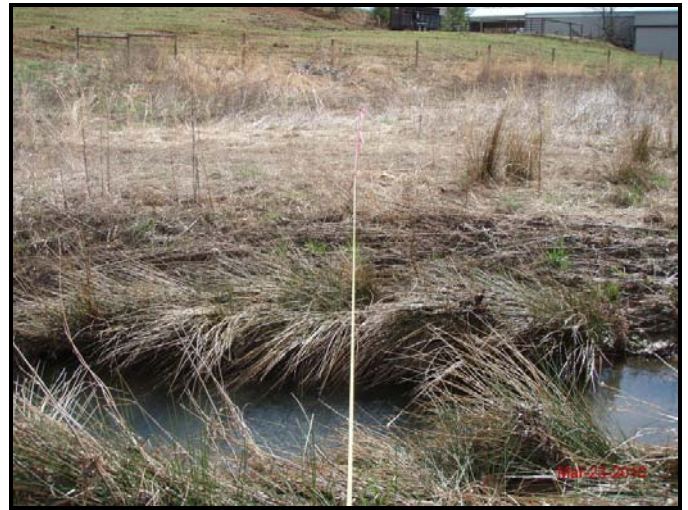
Looking at Right Bank

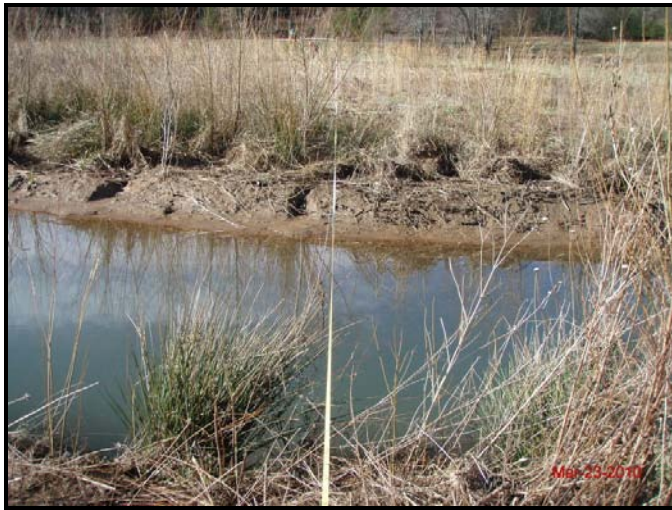
Morgan Creek Upper – Pool 1 Cross-Section 3

Looking at Left Bank

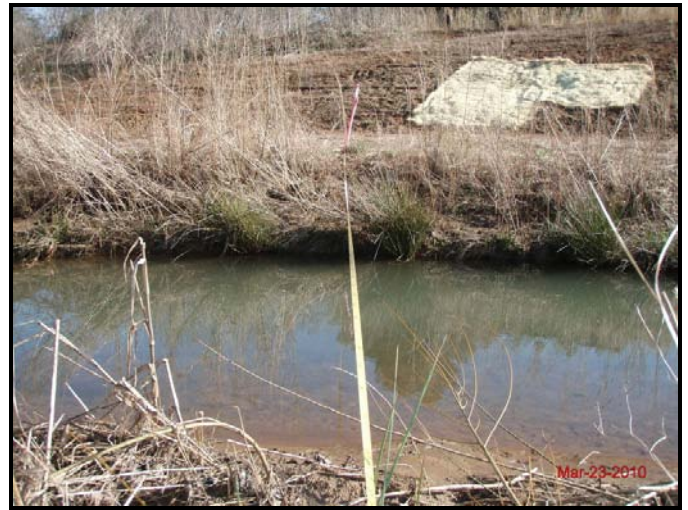
Looking at Right Bank

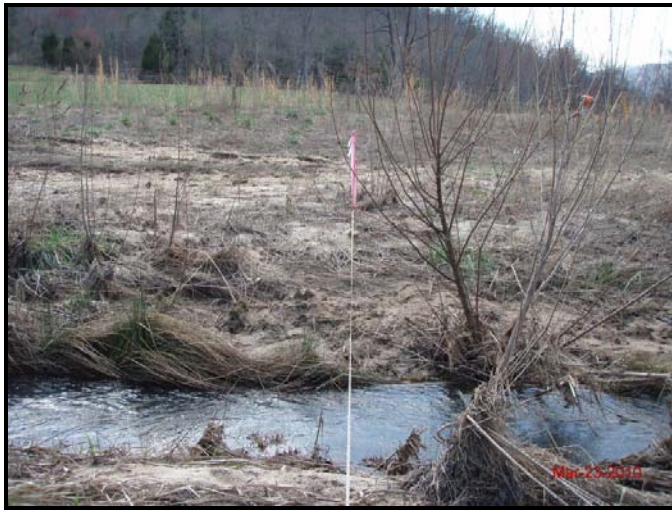
Morgan Creek Upper – Riffle 3 Cross-Section 4

Looking at Left Bank

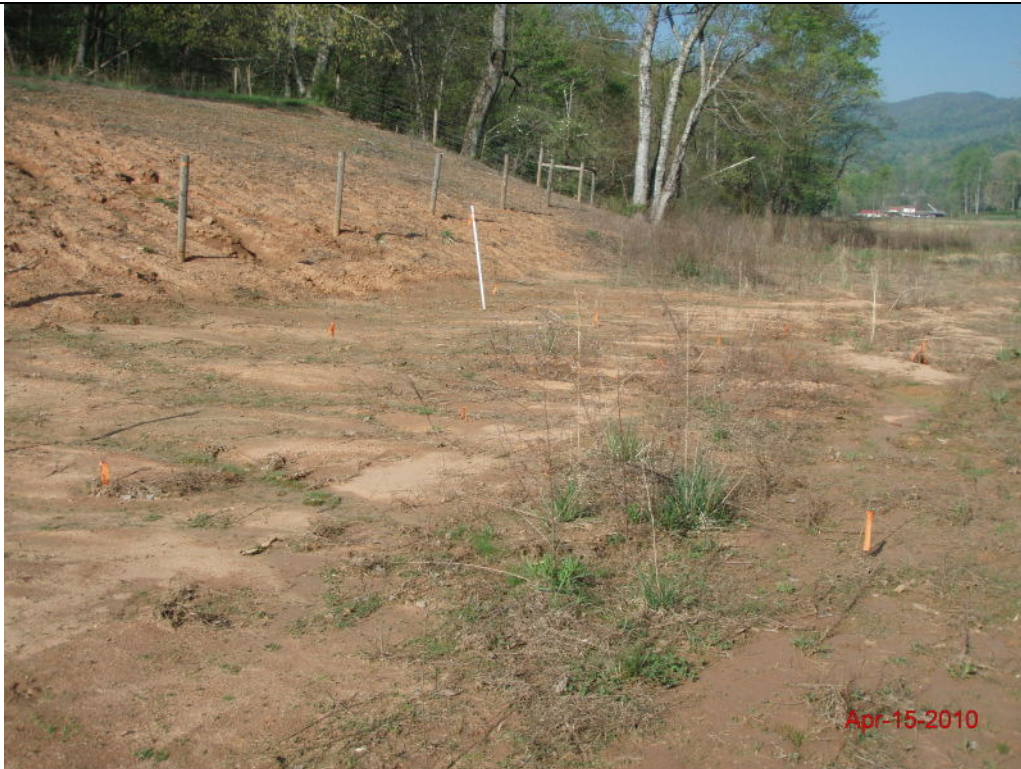
Morgan Creek – Bare Bench

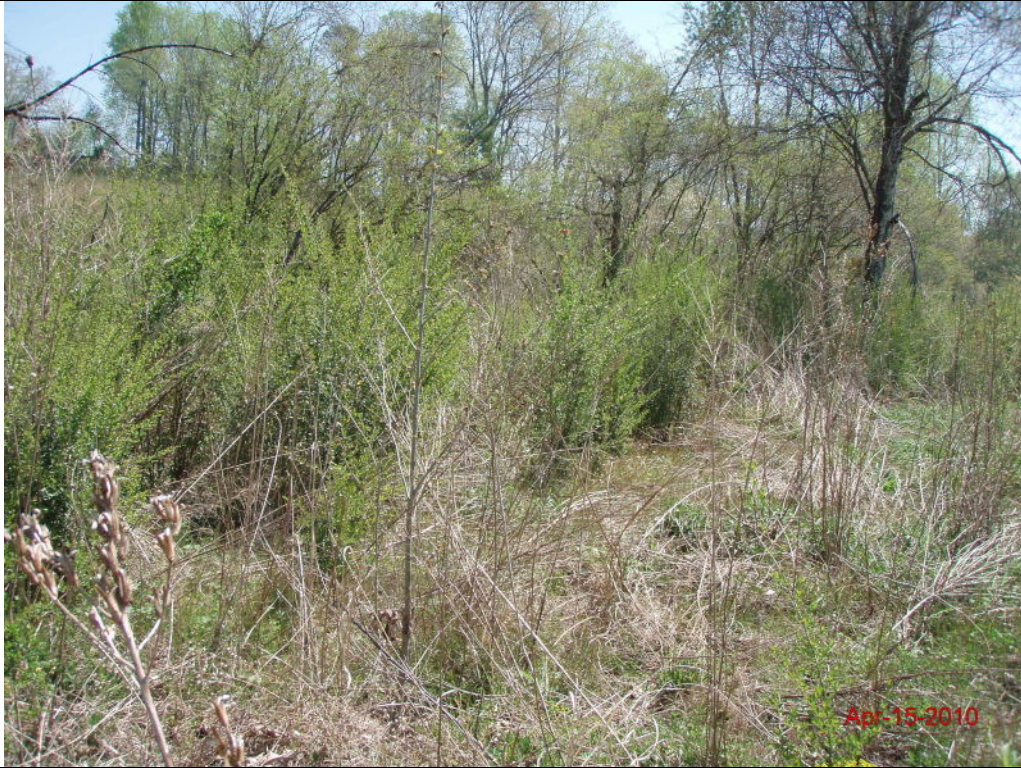
UT1 – Isolated Area of privet (*Ligustrum sp.*)

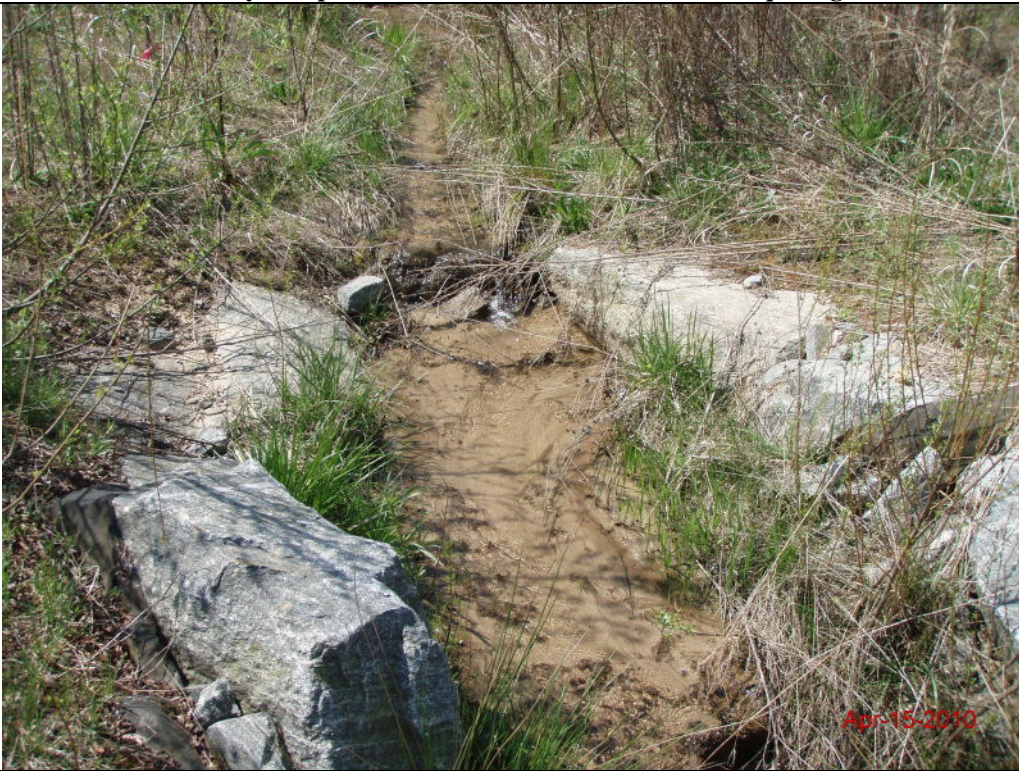
SPA5 UT2 Sta. 3000+50 – Pool Aggradation

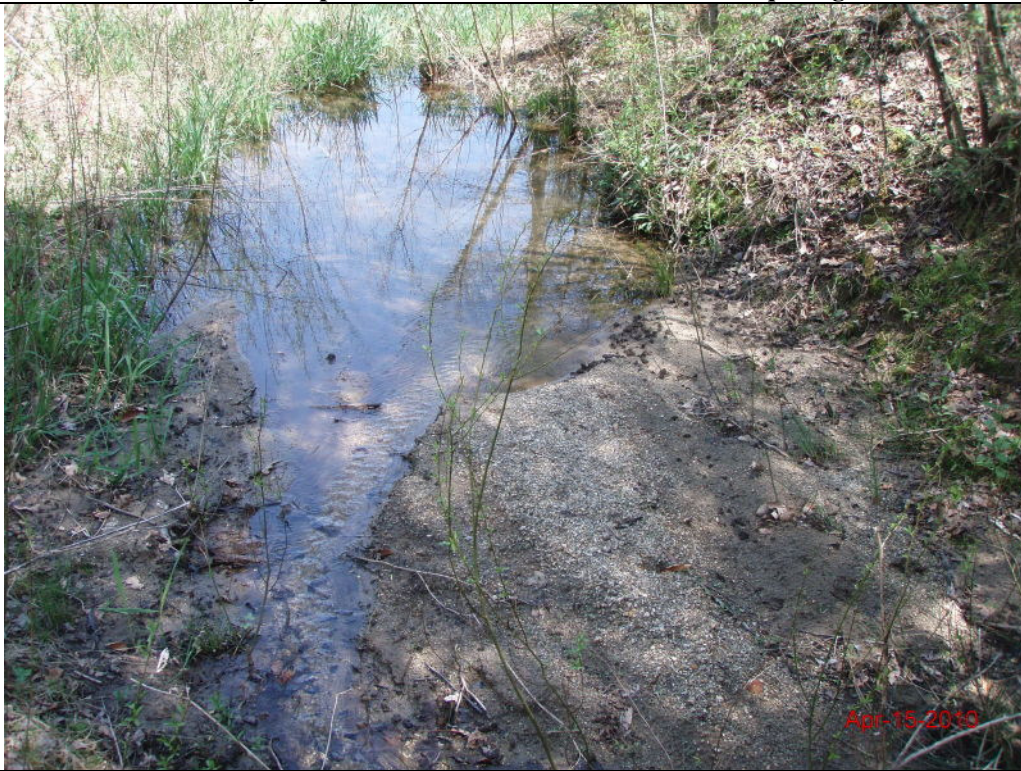
SPA11 UT3 Sta. 4000+10 – Pool Aggradation

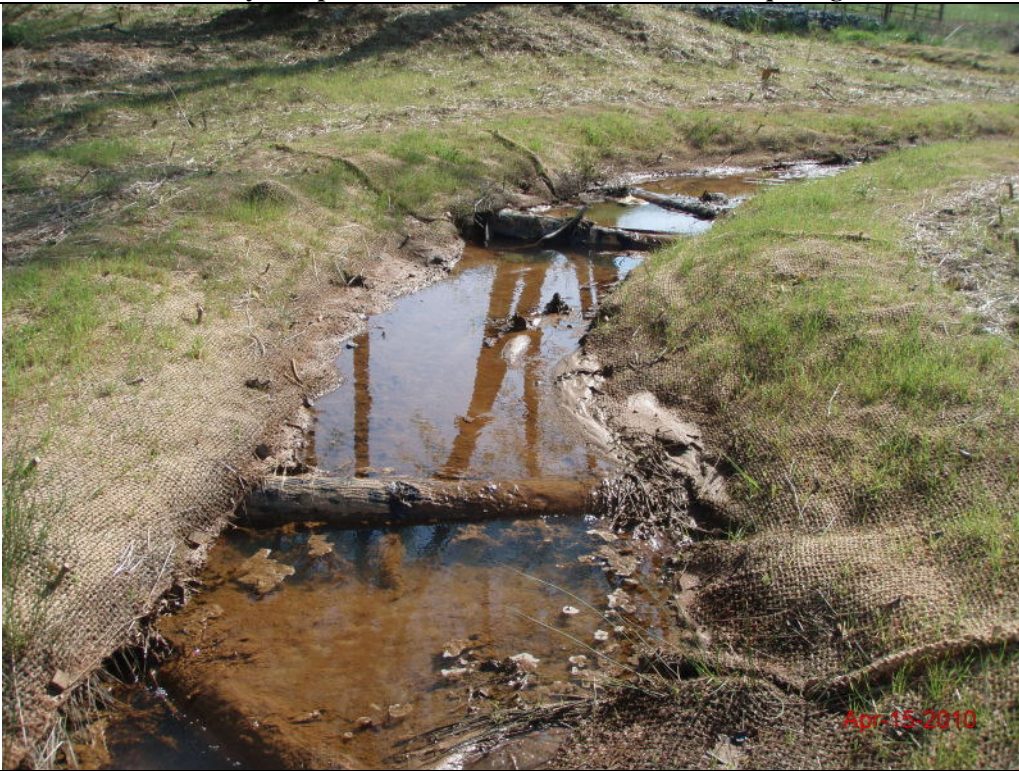
SPA14 UT4 Sta. 5001+50 – Pool Aggradation

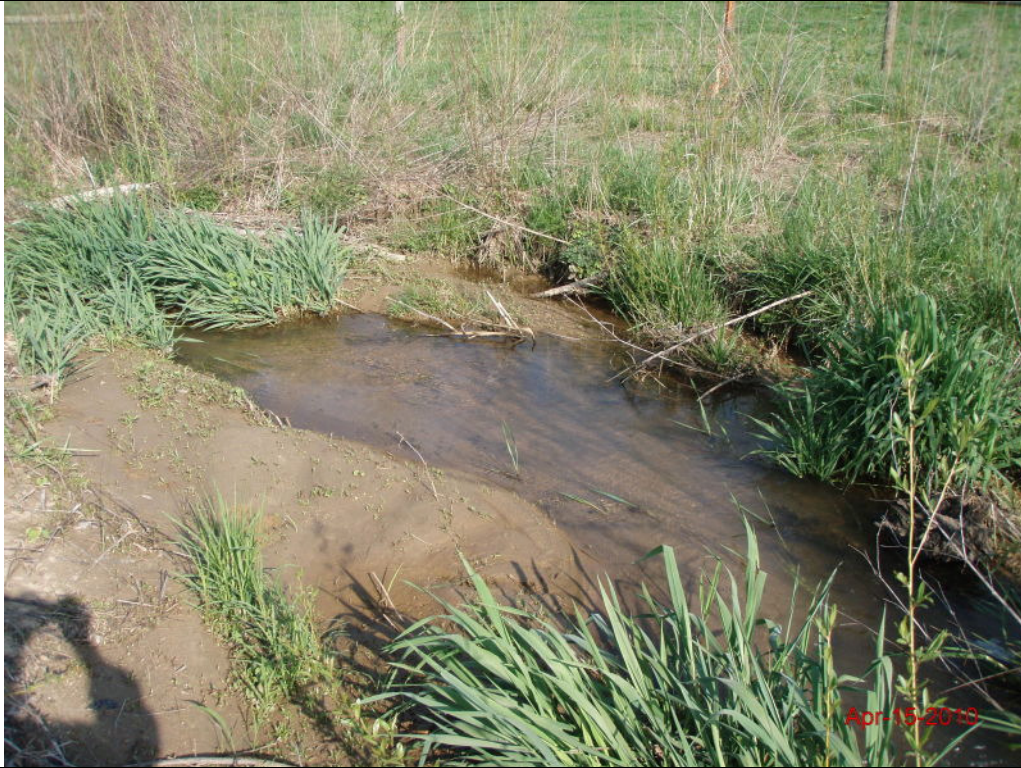
SPA17 UT6 Sta. 7003+00 – Pool Aggradation
