Morgan Creek Stream Restoration Site

Year 5 Final Monitoring Report

Project ID Number: 16-D06027

Equinox Environmental Consultation and Design, Inc.

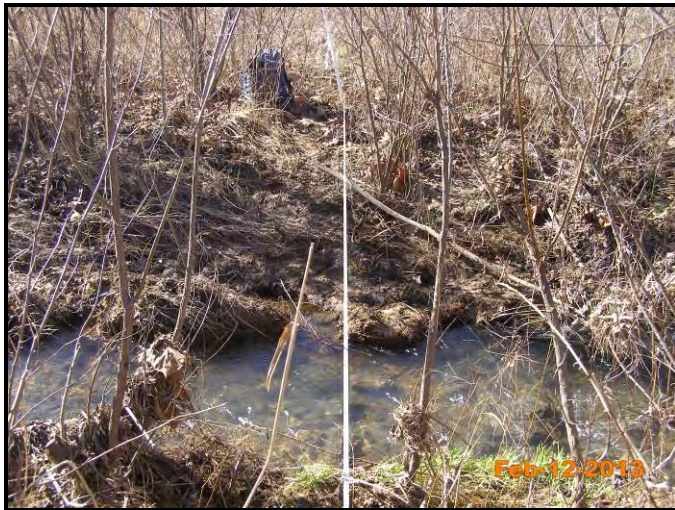
Morgan Creek Upper – Riffle 1 Cross-Section 1

Looking at Left Bank

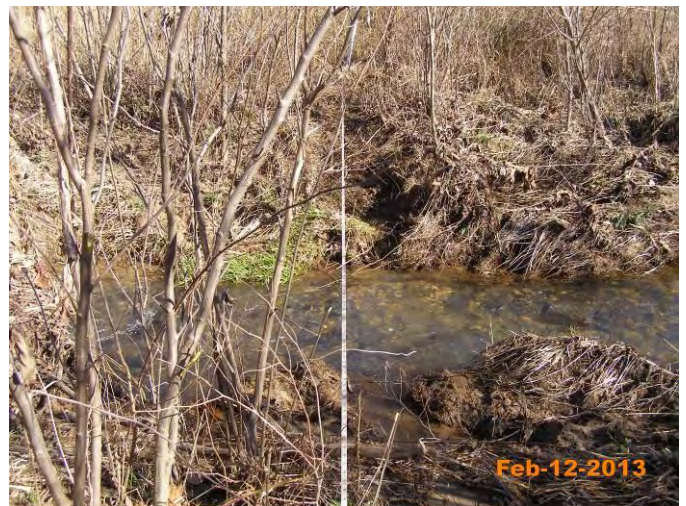
Looking at Right Bank

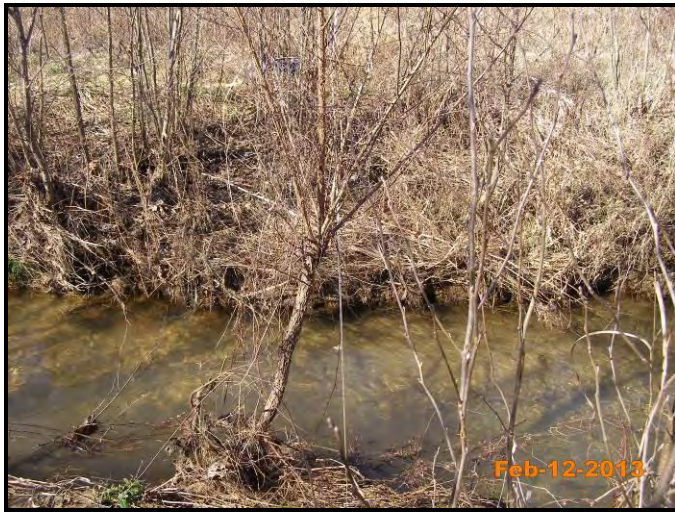
Morgan Creek Upper – Riffle 2 Cross-Section 2

Looking at Left Bank

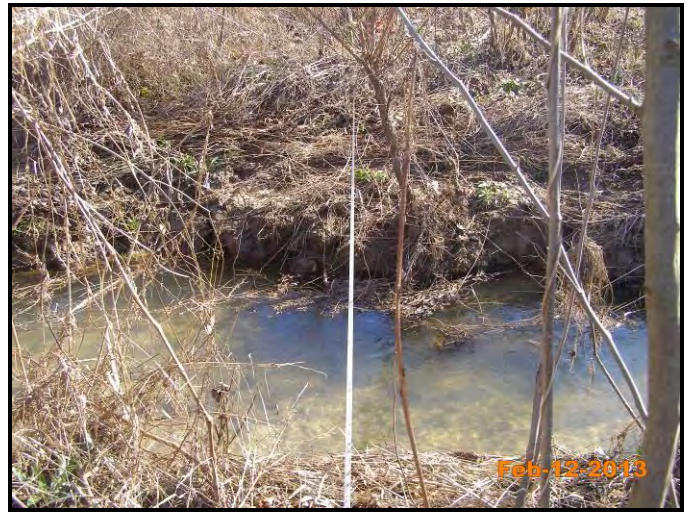
Looking at Right Bank

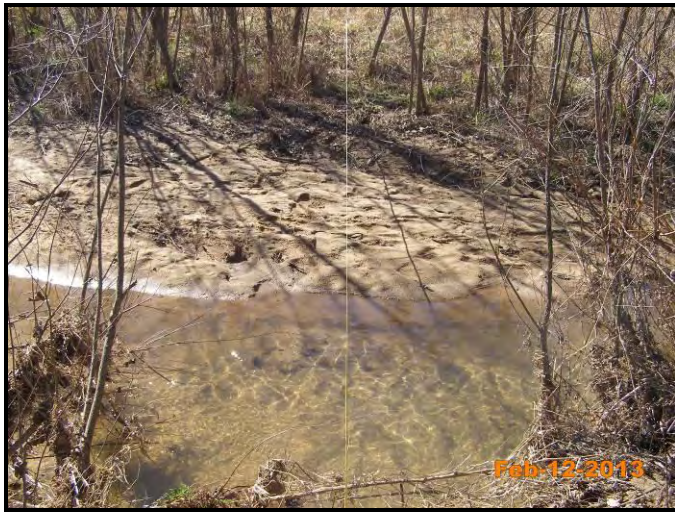
Morgan Creek Upper – Pool 1 Cross-Section 3

Looking at Left Bank

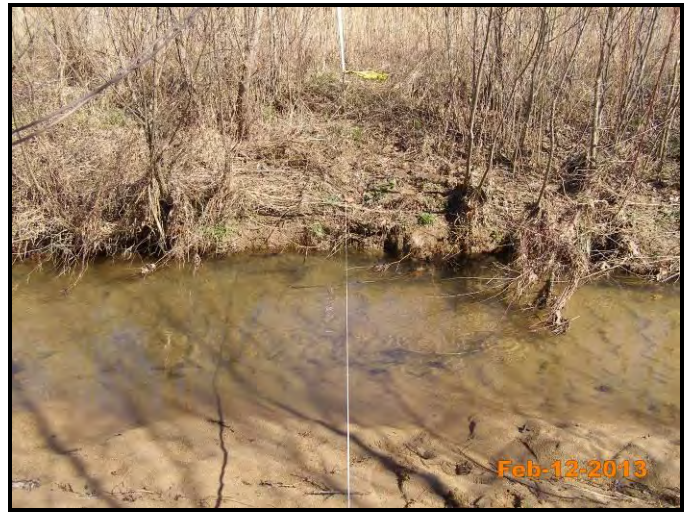
Looking at Right Bank

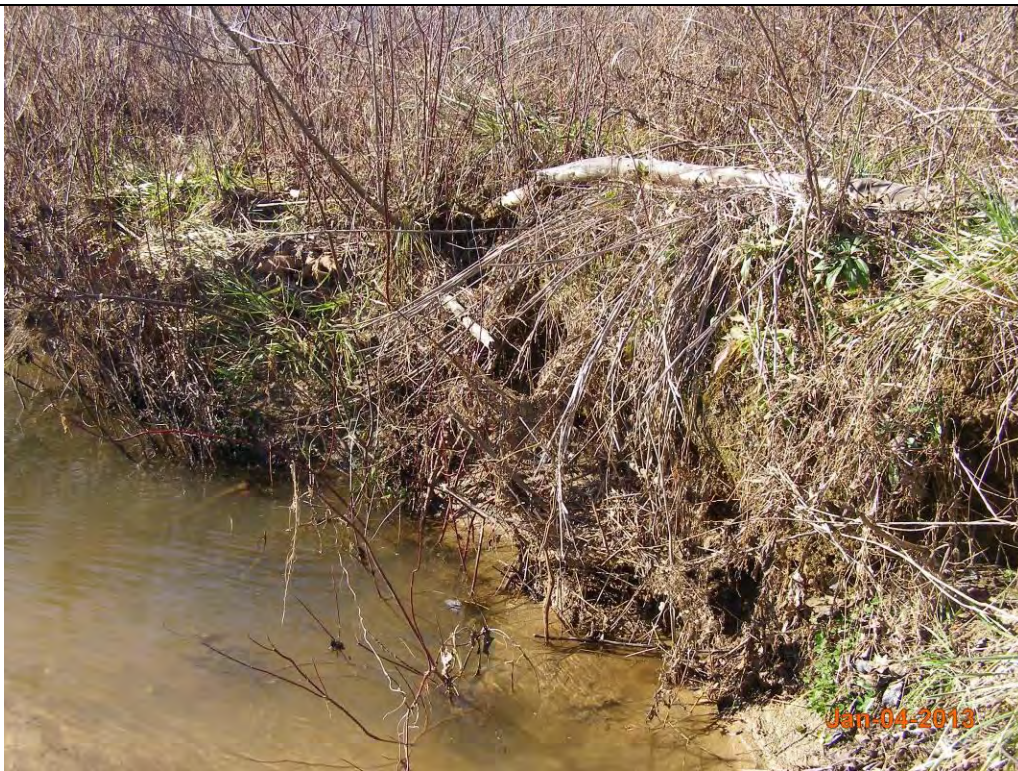
SPA 21 Morgan Creek Sta. 1029+40 – Bank erosion due to thalweg not centering

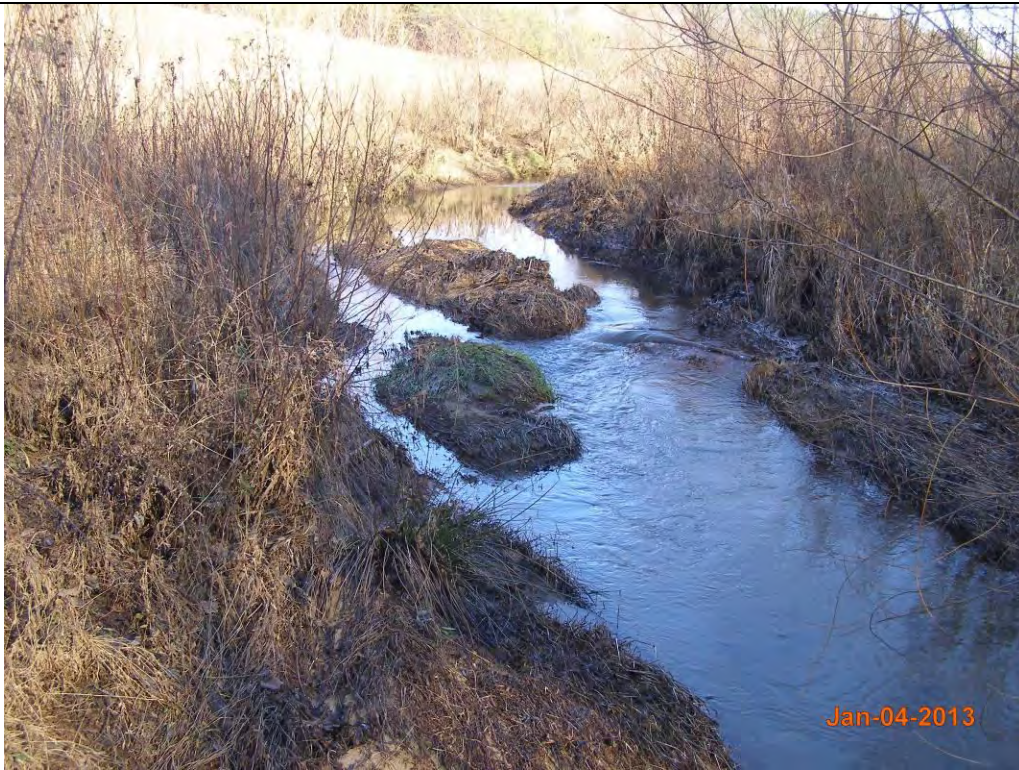
SPA 23 Morgan Creek Sta. 1038+50 – Riffle aggradation due to mid-channel bar formation

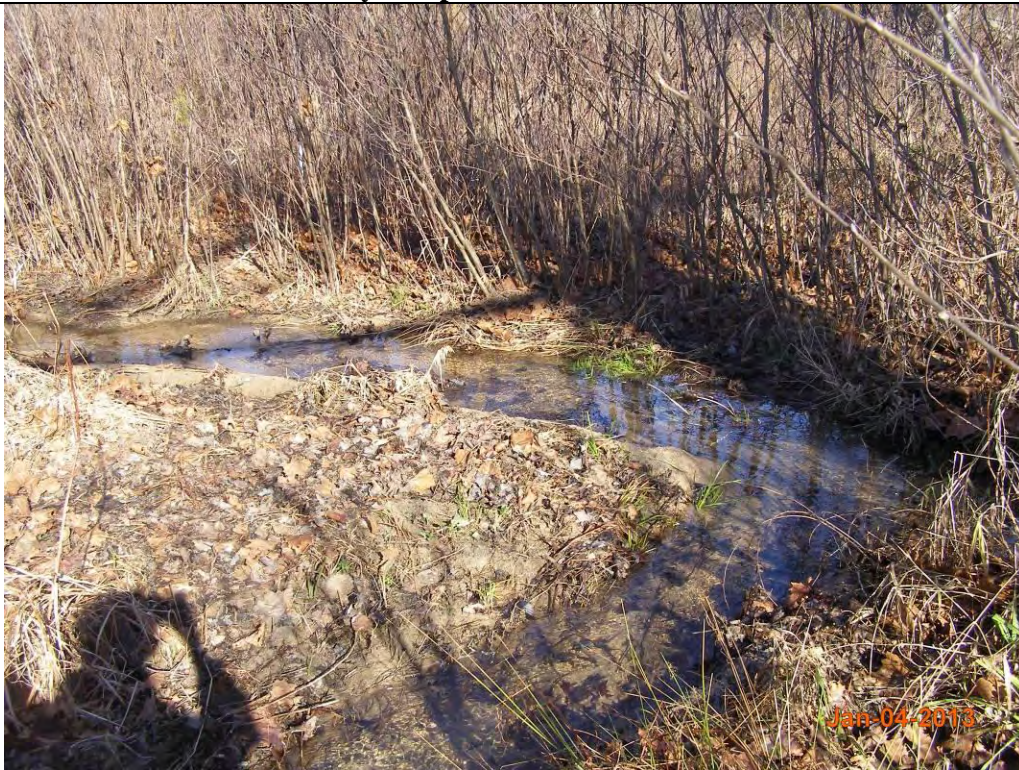
SPA 2 UT1 Sta. 2001+75 – Reduced pool depth due to aggradation

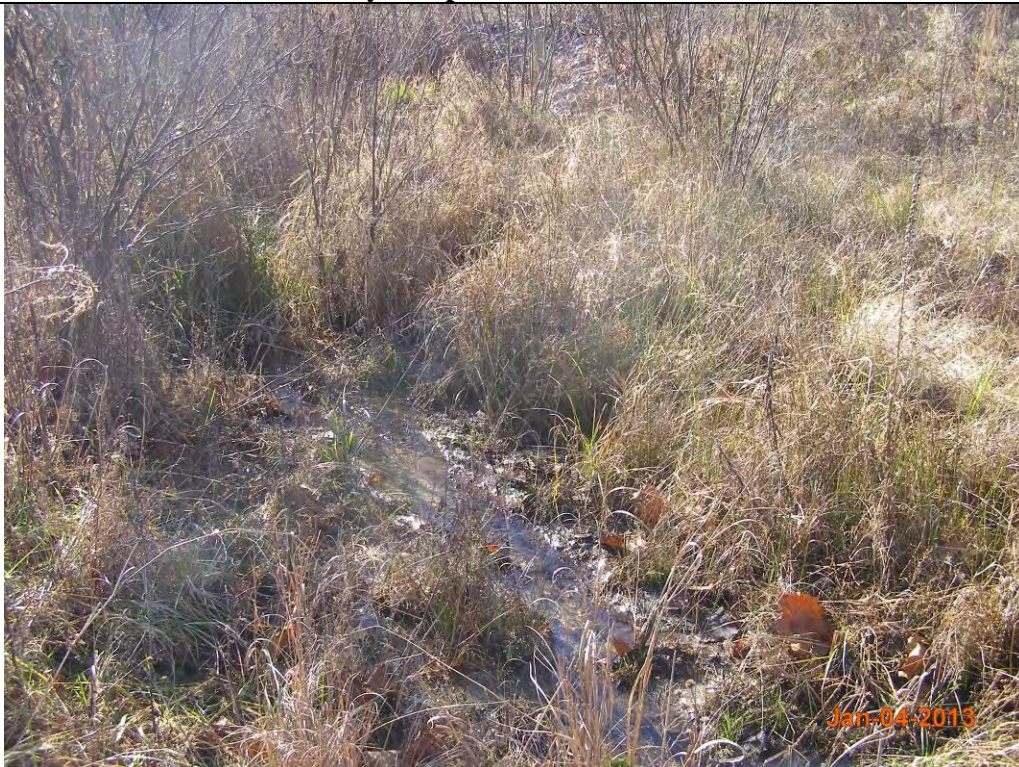
SPA 5 UT2 Sta. 3000+50 – Reduced pool depth and riffle fining due to aggradation
