South Muddy Creek Stream Restoration Project Year 2 Monitoring Report

NCEEP Project Number – 737

Site Assessment Report – Monitoring Year 2

South Muddy Creek (Randolph/Duncan Properties) Stream Restoration
Project
McDowell County, North Carolina
May 2013

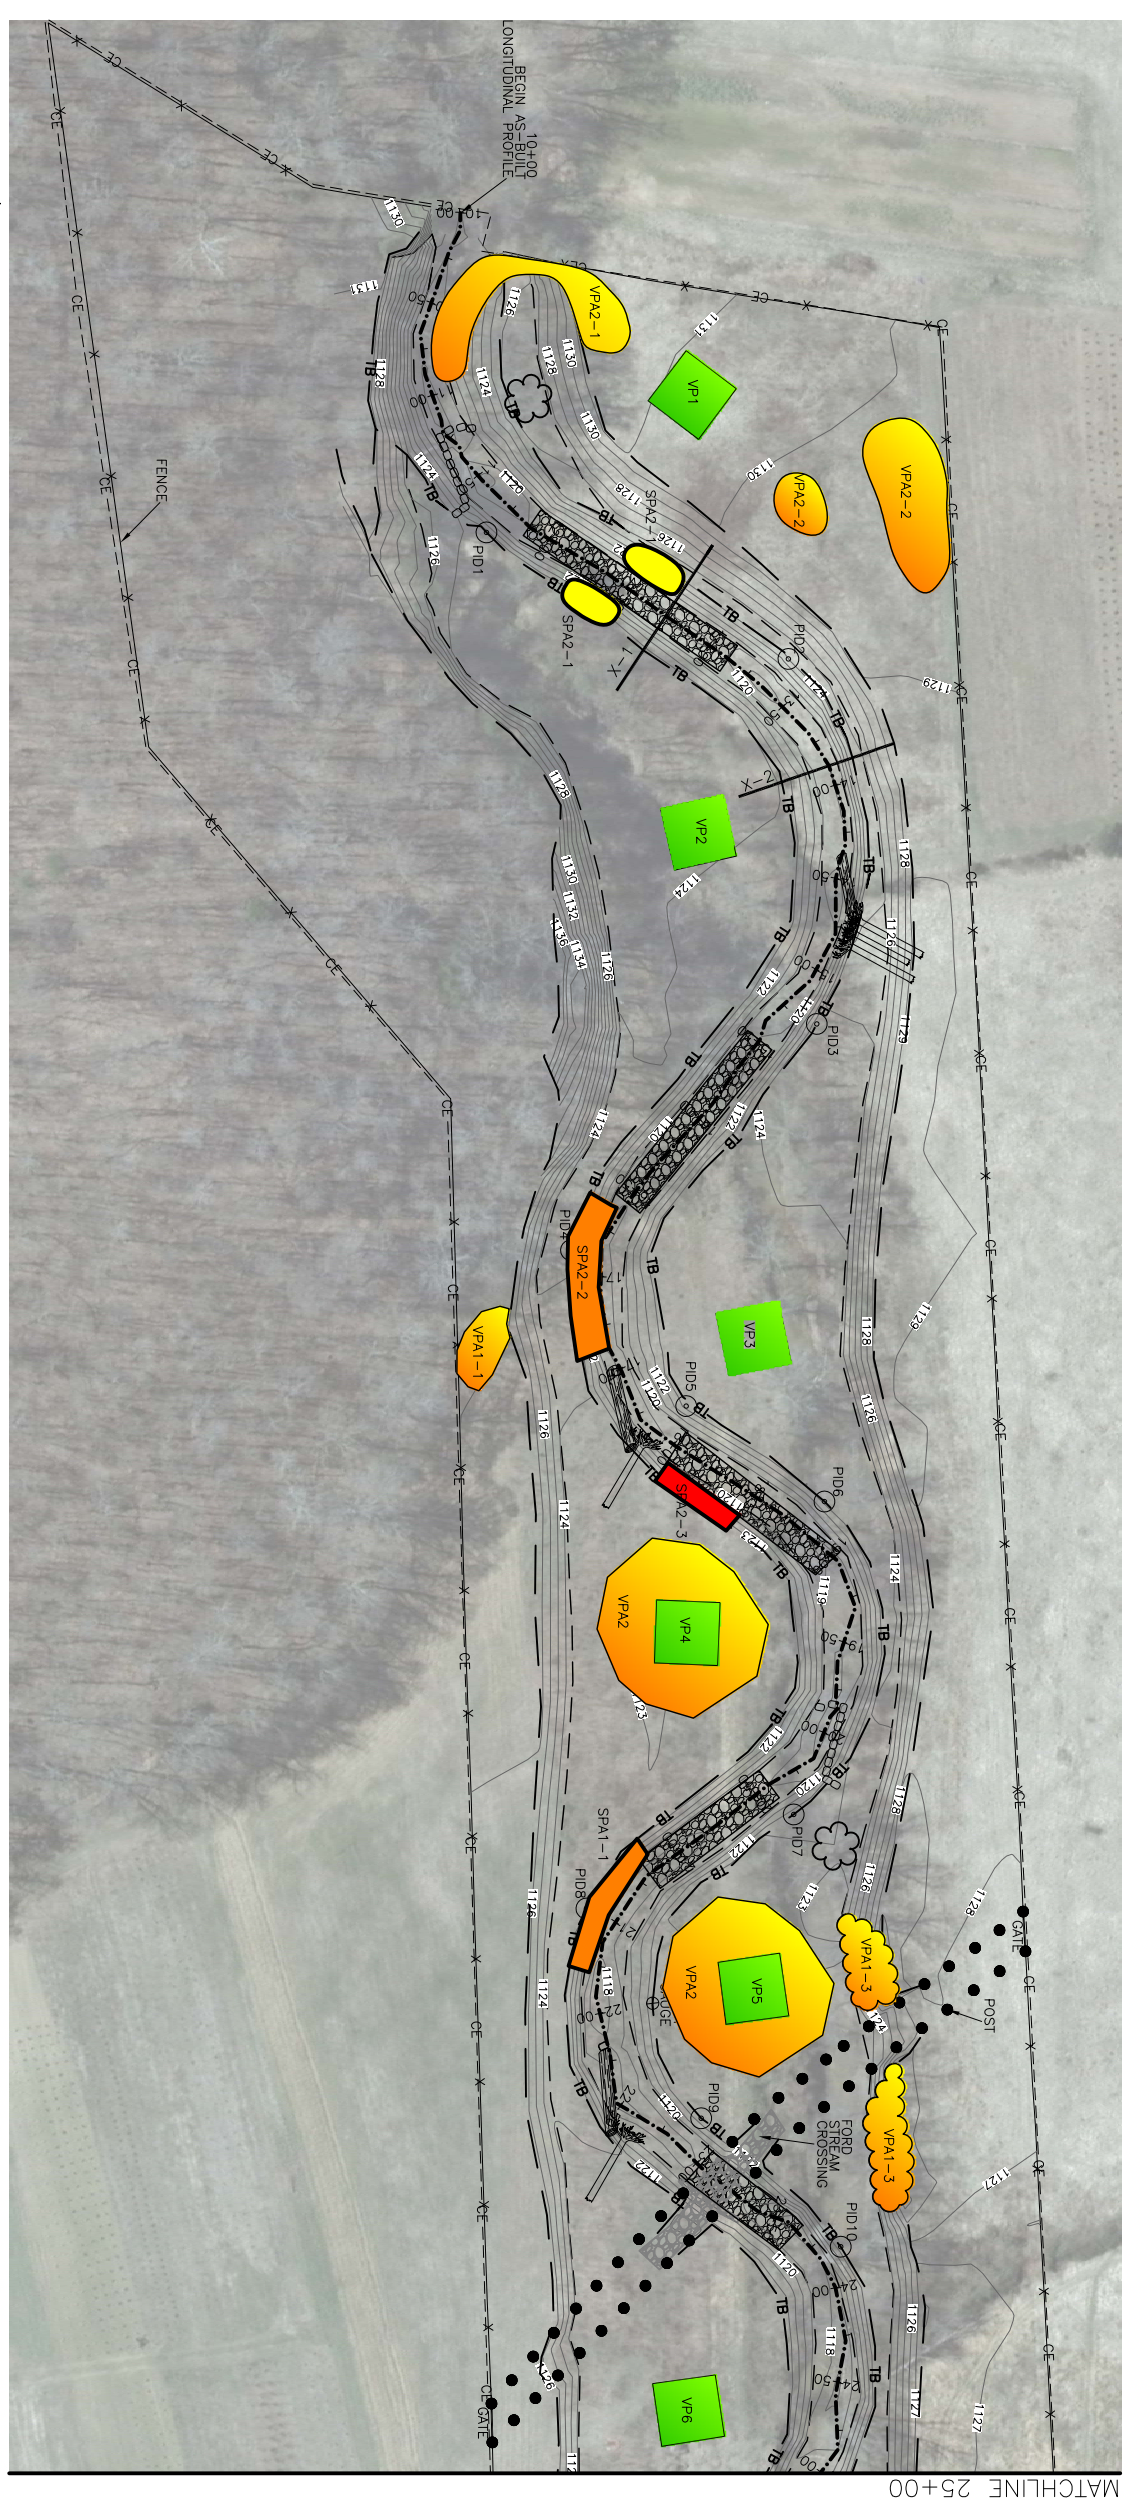
SOUTH MUDDY CREEK
CURRENT CONDITION PLAN VIEW
YEAR 2 MONITORING
STA. 10+00-25+00

Invasive areas of concern were observed and documented accordingly in Table 6a and as vegetation problem areas (VPAs) in Figure 2 and Table 6b (Appendix B). Eighteen discrete areas of invasive species were documented throughout the site and totaled approximately 1.26 acres, or 7.4 percent of the total easement acreage. A more detailed summary of the results for the vegetation condition assessment can be found in Appendix B which includes a technical memorandum, current condition plan view (CCPV) figures, supporting data tables, and photo logs; the contents of Appendix B was submitted to NCEEP in May 2013 and served as the interim visual site assessment report.

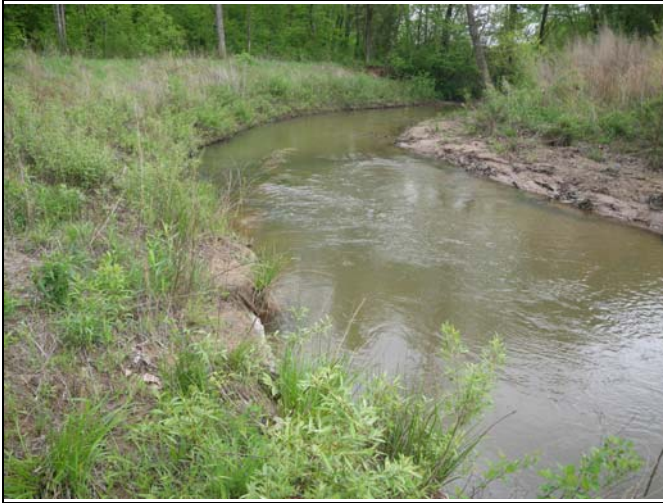
South Muddy Creek PID 1 – J-Hook near upstream end of project

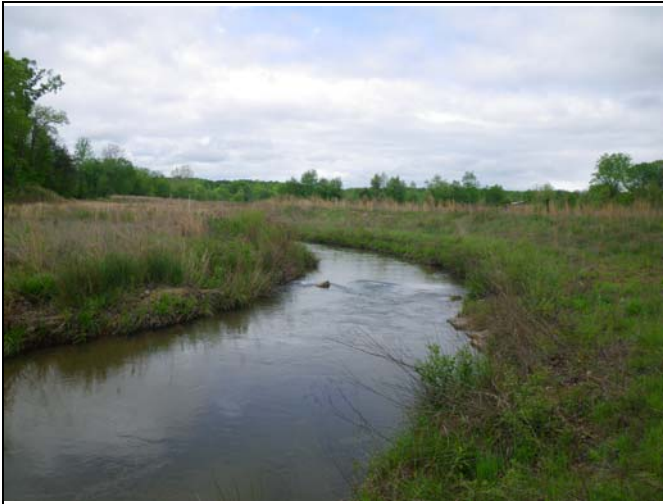
South Muddy Creek PID 7 – J-Hook in Meander

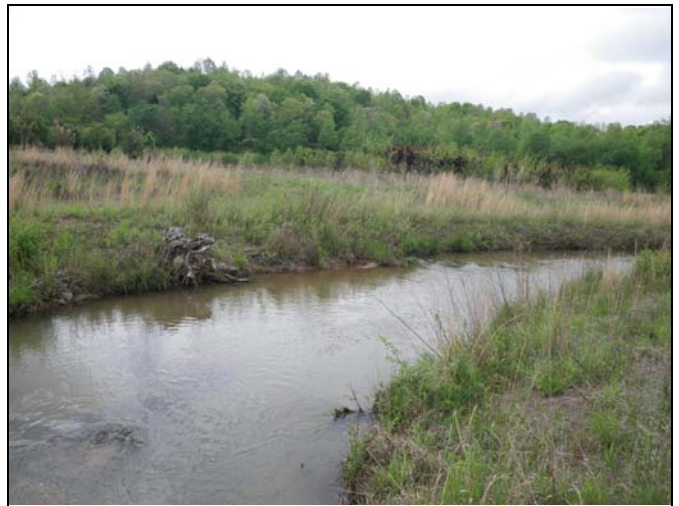
South Muddy Creek PID 12 – Log Vane and Root Wad in Meander

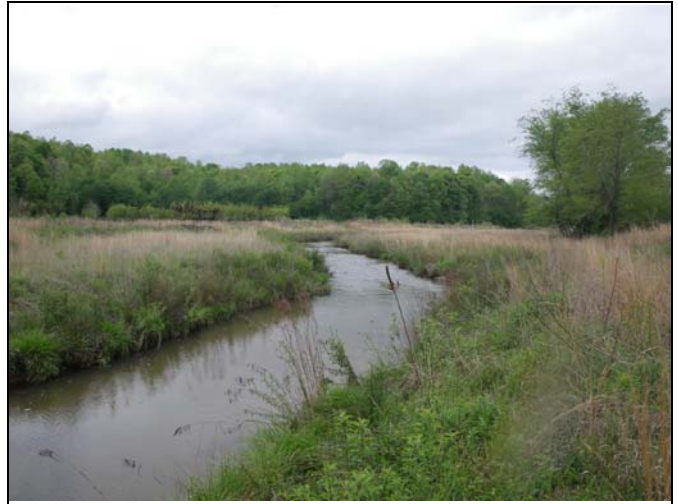
South Muddy Creek PID 14 – Immediately upstream of Sain Road crossing

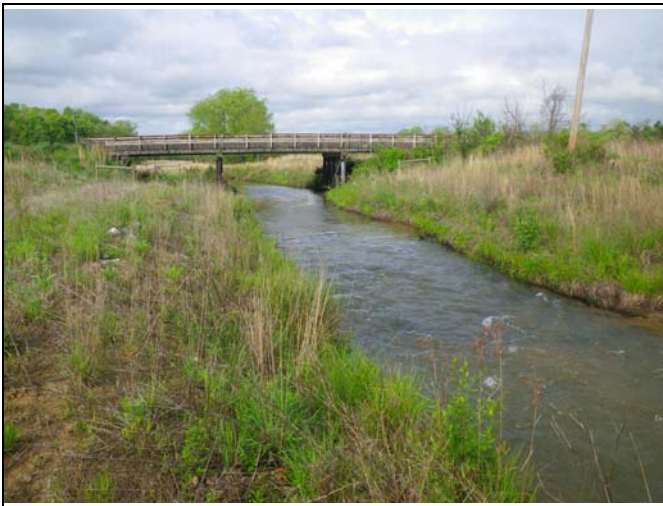
South Muddy Creek PID 15 – Constructed Riffle downstream of Sain Road crossing

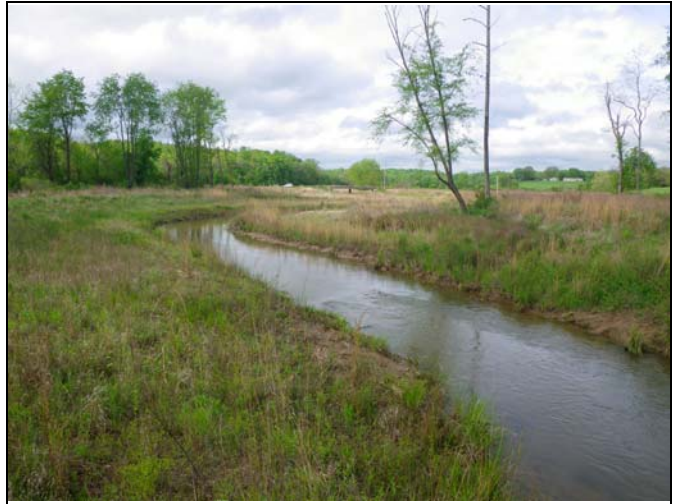
South Muddy Creek PID 20 – J-Hook near downstream
end of project
