# South Muddy Creek Stream Restoration Project Year 3 Monitoring Report

**McDowell County, North Carolina**

**NCEEP Project Number – 737**

Project Info:           Monitoring Year: 3 of 5  
                              Year of Data Collection: 2014  
                              Year of Completed Construction: 2011  
                              NCEEP Project Manager: Mathew Reid  
                              Submission Date: November 28, 2014

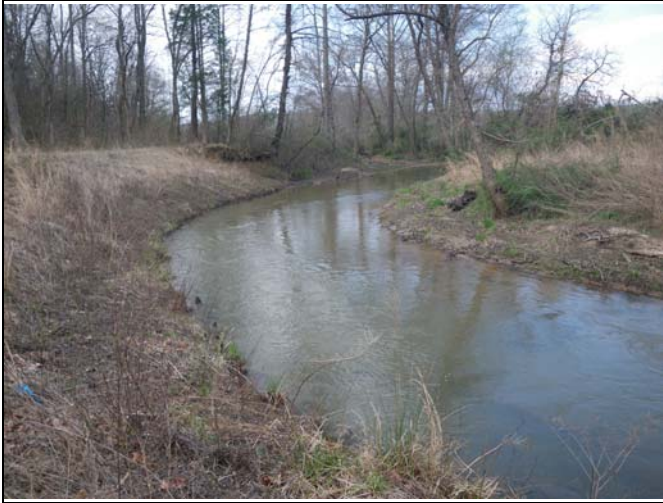
South Muddy Creek PID 1 – J-Hook near upstream end of project

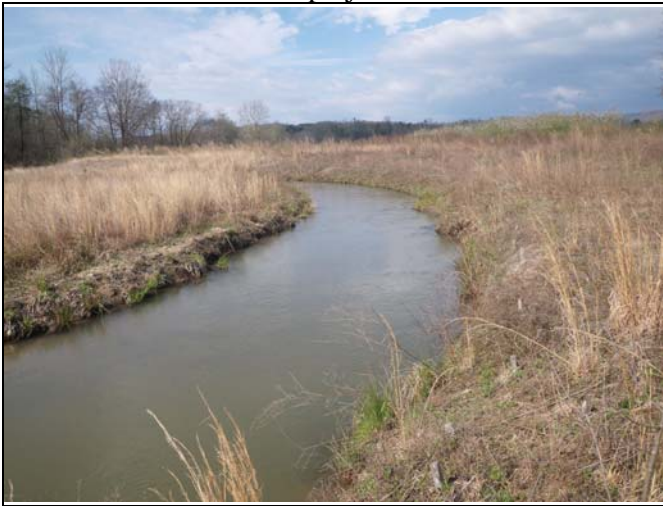
South Muddy Creek PID 3 – Log Vane in Meander

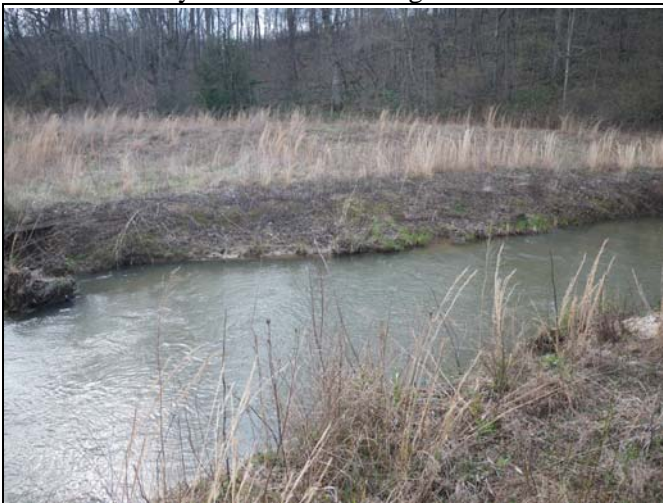
South Muddy Creek PID 5 – Log Vane in Meander

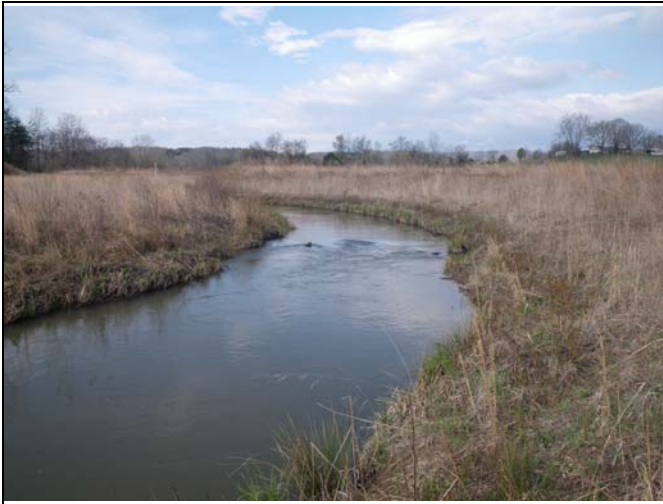
South Muddy Creek PID 7 – J-Hook in Meander

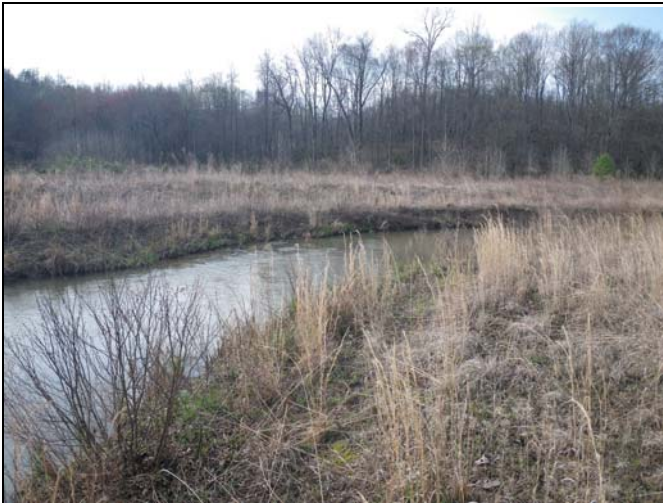
South Muddy Creek PID 9 – Log Vane in Meander

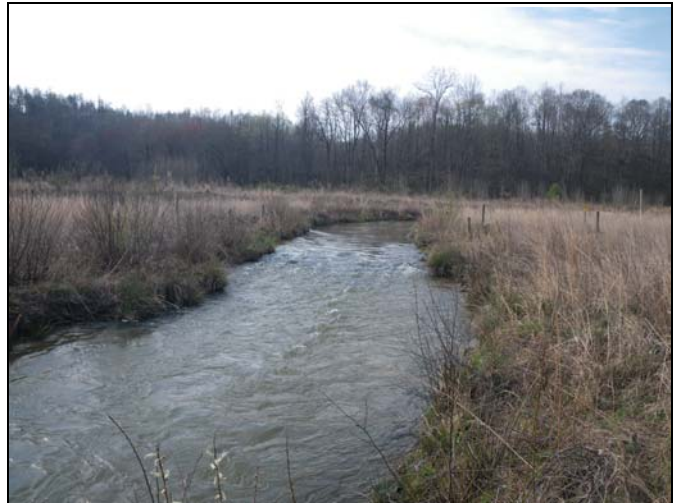
South Muddy Creek PID 10 – Stream Crossing

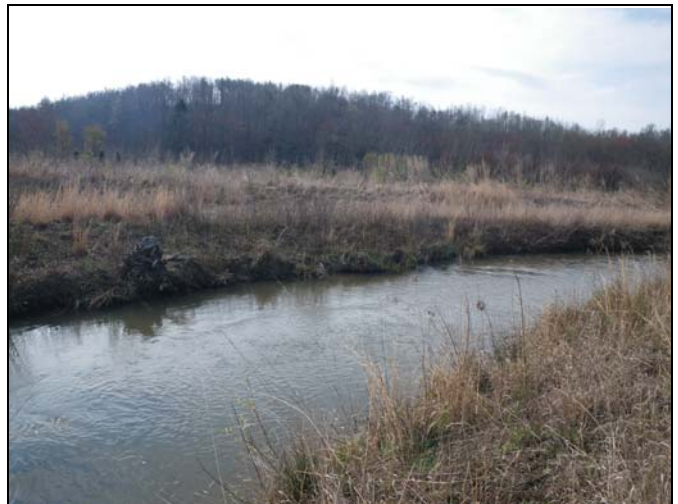
South Muddy Creek PID 12 – Log Vane and Root Wad in Meander

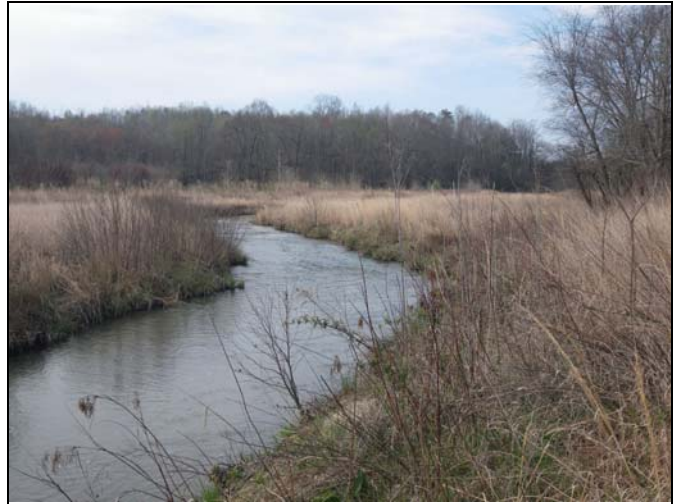
South Muddy Creek PID 14 – Immediately upstream of Sain Road crossing

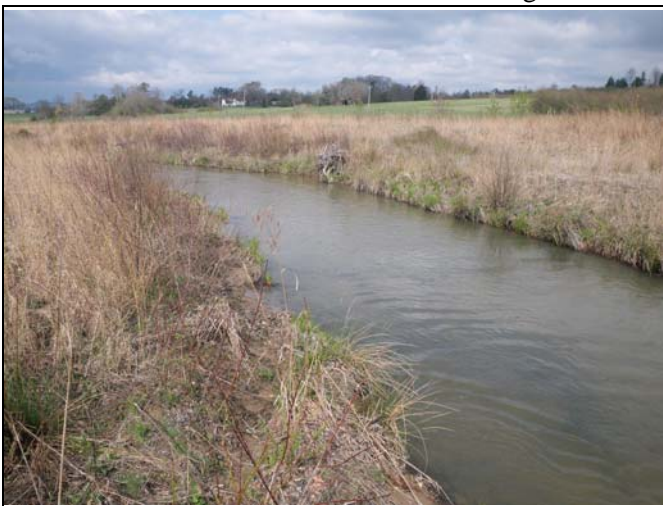
South Muddy Creek PID 17 – Log Vane in Meander

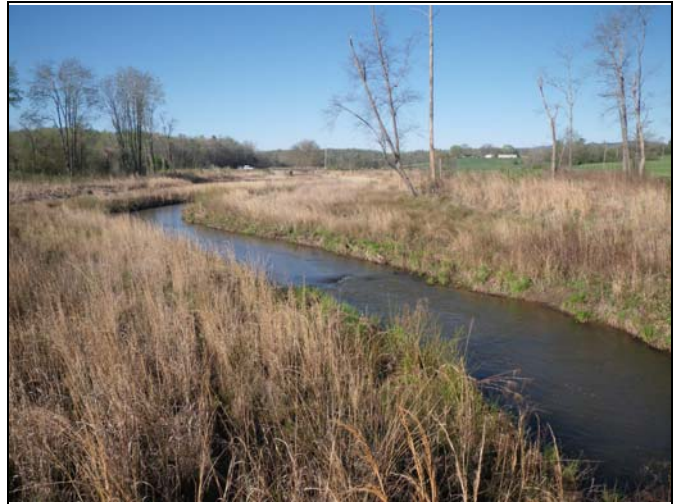
South Muddy Creek PID 20 – J-Hook near downstream  
end of project

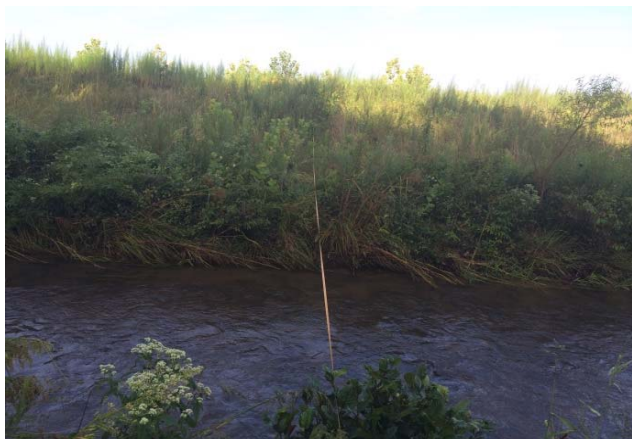
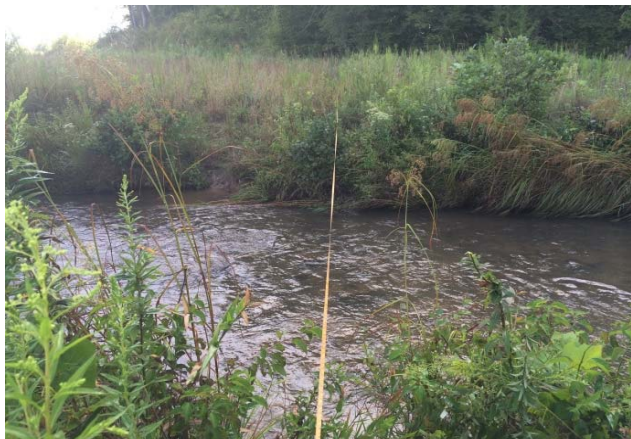
## Permanent Cross Section X1

Feature	Stream Type	BKF Area	BKF Width	BKF Depth	Max BKF Depth	W/D	BH Ratio	ER	BKF Elev	TOB Elev
Riffle	C	100	41.73	2.4	4.19	17.41	1.1	2.2	1124.2	1124.41

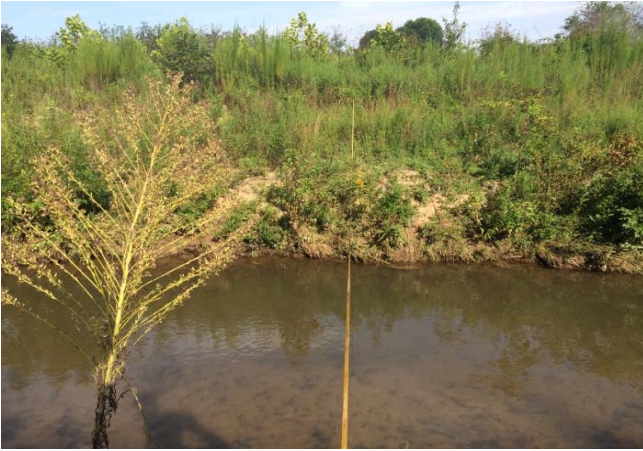
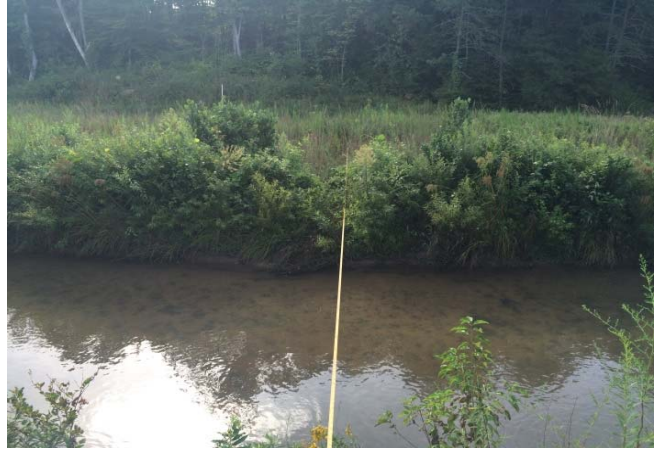
## Permanent Cross Section X2

Feature	Stream Type	BKF Area	BKF Width	BKF Depth	Max BKF Depth	W/D	BH Ratio	ER	BKF Elev	TOB Elev
Pool		116.9	42.27	2.77	5.73	15.28	1	2	1124.12	1124.05

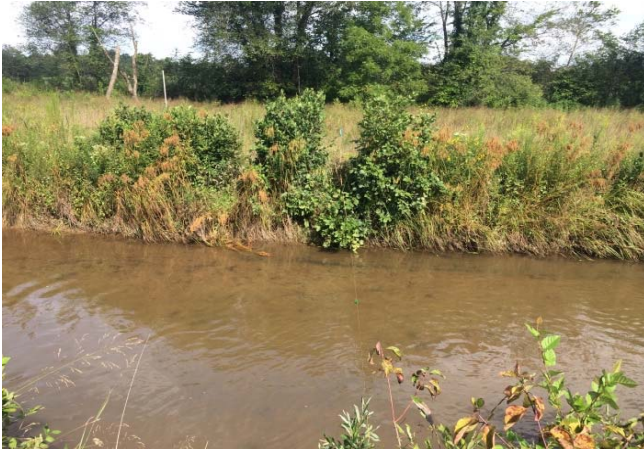
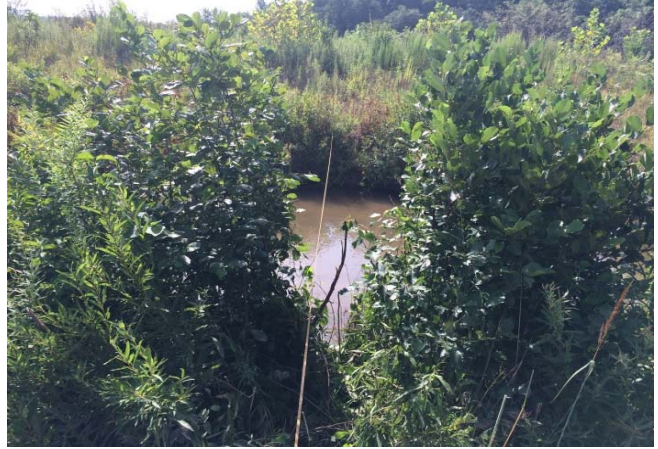
## Permanent Cross Section X3

Feature	Stream Type	BKF Area	BKF Width	BKF Depth	Max BKF Depth	W/D	BH Ratio	ER	BKF Elev	TOB Elev
Pool		137.8	43.18	3.19	4.94	13.53	1	2.2	1122.2	1122.36

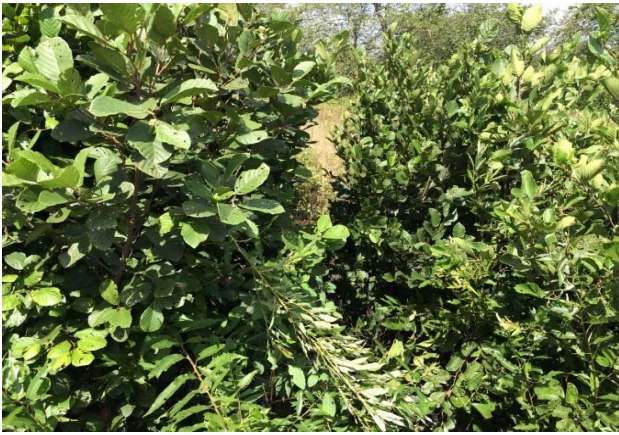
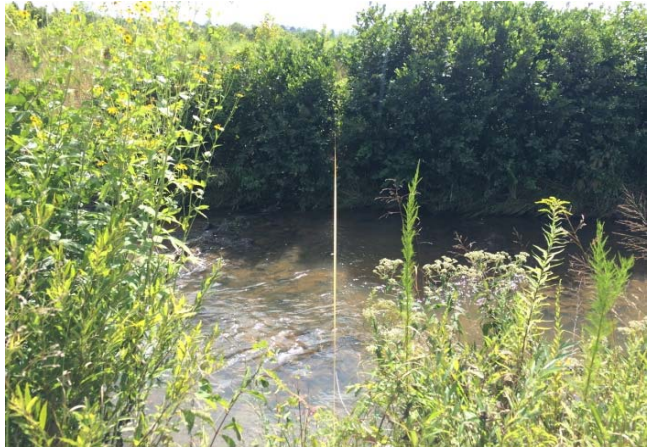
## Permanent Cross Section X4

Feature	Stream Type	BKF Area	BKF Width	BKF Depth	Max BKF Depth	W/D	BH Ratio	ER	BKF Elev	TOB Elev
Riffle	C	111.5	40.31	2.77	4.44	14.57	1	2.3	1122	1122.11
