# South Muddy Creek Stream Restoration Project Year 4 Monitoring Report

**McDowell County, North Carolina**

**NCDMS Project Number – 737**

# **Site Assessment Report – Monitoring Year 4**

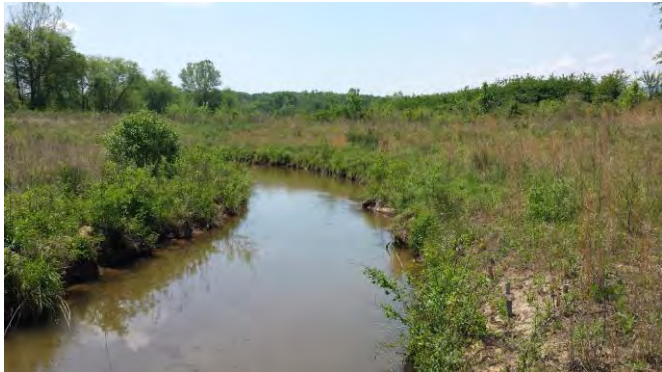
South Muddy Creek PID 3 – Log Vane in Meander

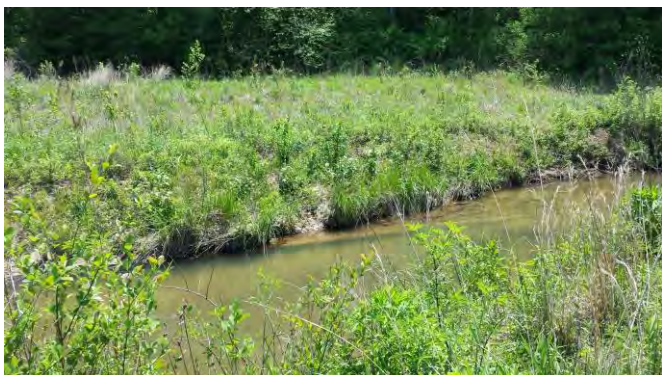
South Muddy Creek PID 5 – Log Vane in Meander

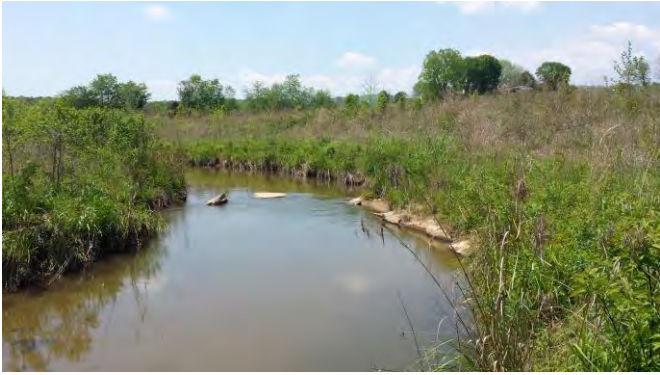
South Muddy Creek PID 7 – J-Hook in Meander

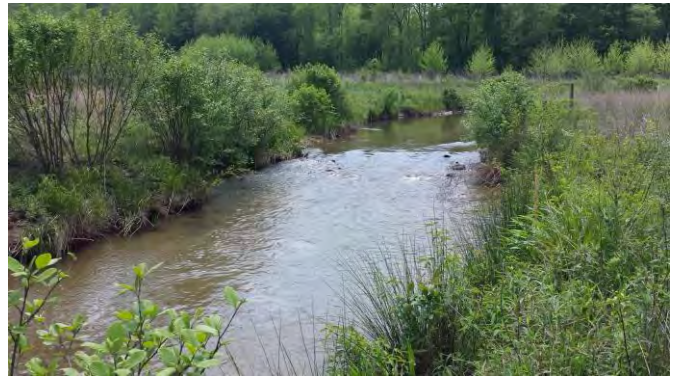
South Muddy Creek PID 10 – Stream Crossing

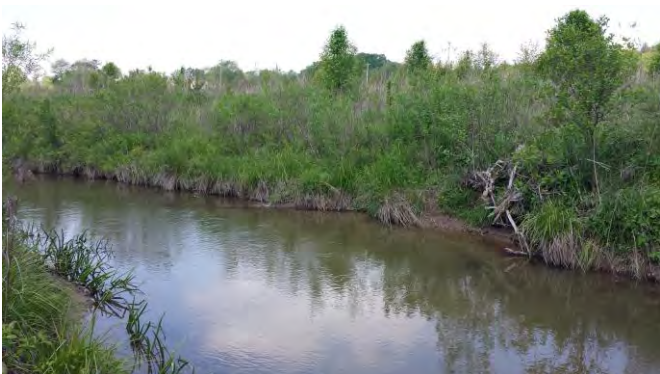
South Muddy Creek PID 17 – Log Vane in Meander

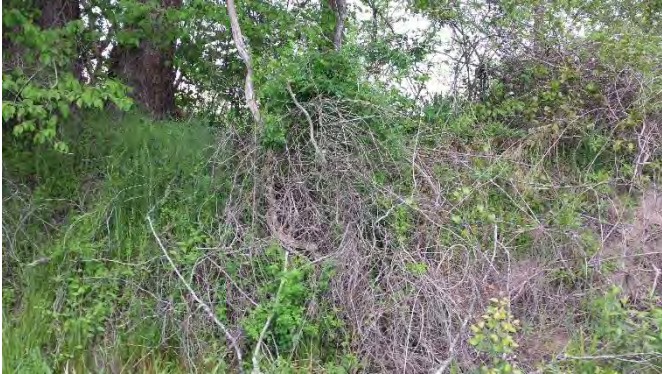
VPA1-4 – Multiflora Rose, Chinese Privet, Japanese Honeysuckle

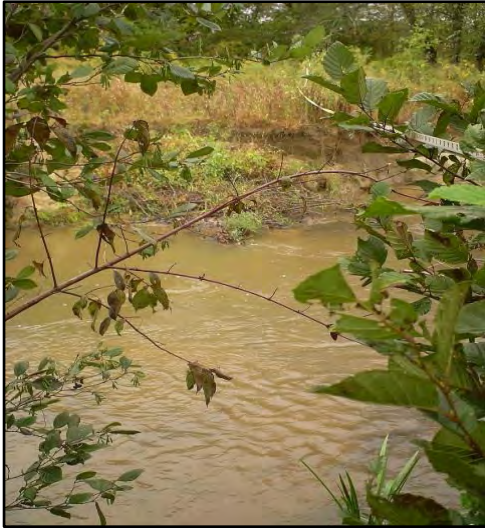
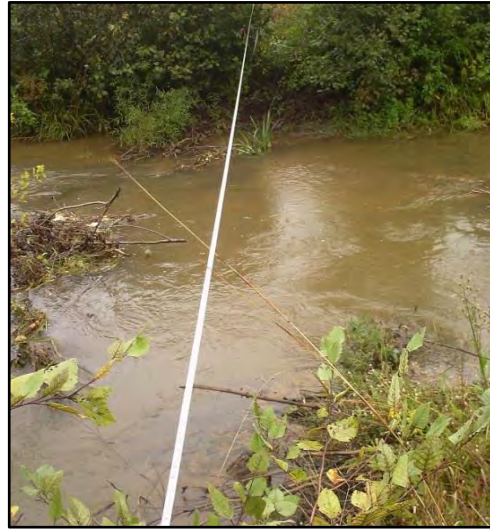
## Permanent Cross Section X4

\* MY4 Cross-section X4 is located where the damage from the beaver dam was located, and was surveyed prior to the completion of the repair that was completed in November 2015.
