# South Muddy Creek Stream Restoration Project Year 5 Monitoring Report

**McDowell County, North Carolina**

**NCDMS Project Number – 737**

# **Site Assessment Report – Monitoring Year 5**

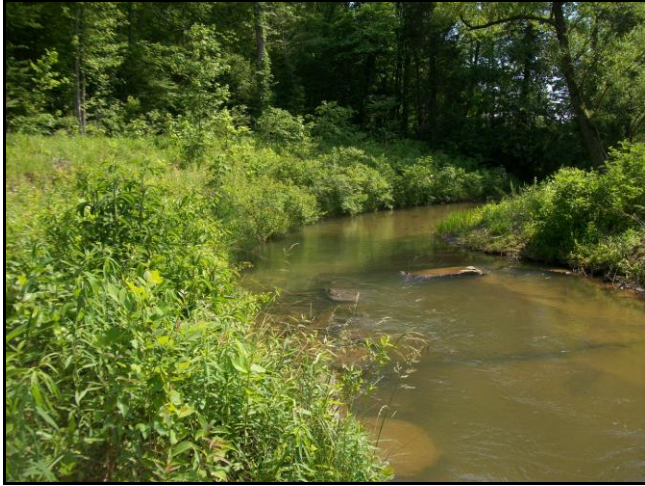
South Muddy Creek PID 1 – J-Hook near upstream end of project

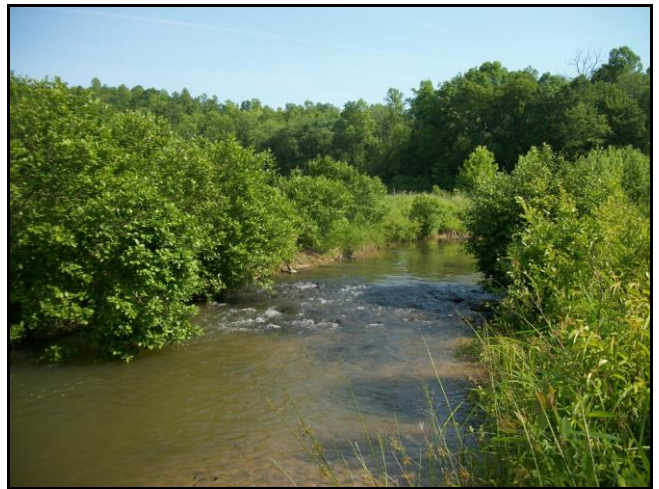
South Muddy Creek PID 10 – Stream Crossing

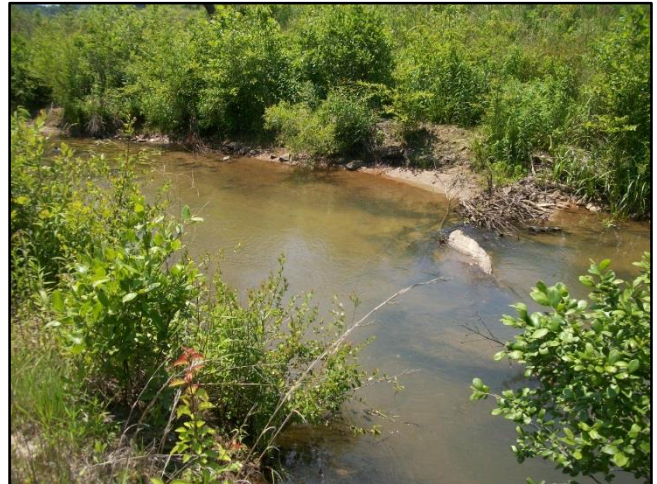
SPA 5-7 – Scour on right bank just downstream of SPA 4-5, a remnant beaver dam (5-25-16)
