MUDDY RUN STREAM RESTORATION PROJECT

MONITORING REPORT

MONITORING YEAR 2

DUPLIN COUNTY, NORTH CAROLINA, PROJECT # 95018

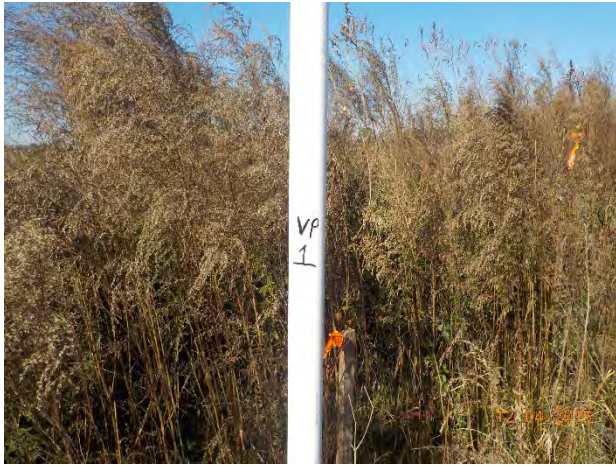
Vegetation Plot 1 (12/4/2015)

Table 8. Vegetation Problem Areas			
Muddy Run Stream Restoration Project - Project # 95018			
Feature Category	Station Numbers	Suspected Cause	Photo Number
Invasive/Exotic Populations	Reach 1B- See Plan View	Ligustrum: encroachment from outside easement. Recommend invasive treatment and removal.	VP1

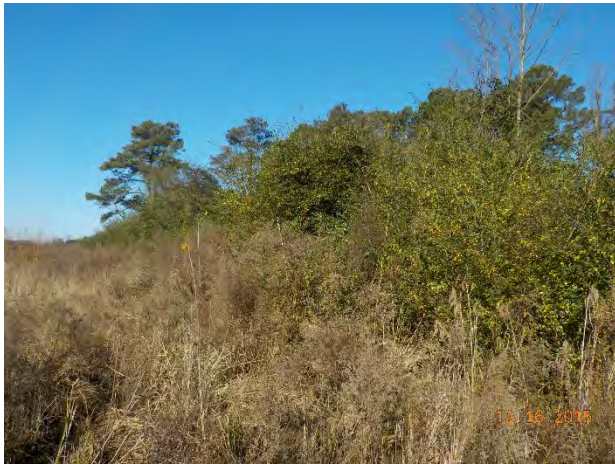
VP1- Invasive population: *Ligustrum* along Reach
1B

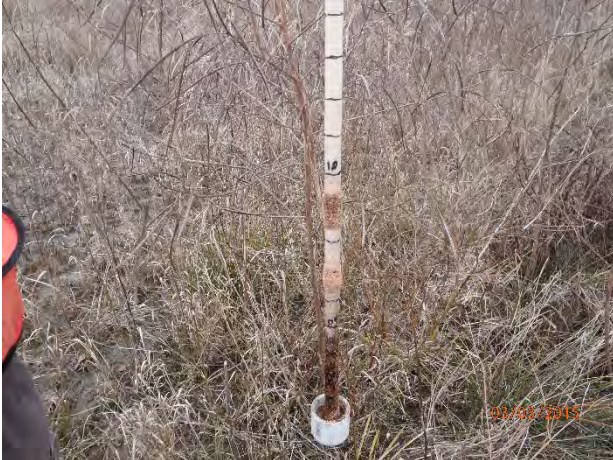
Crest Gauge 1 Reading 0.95' (3/3/2015)

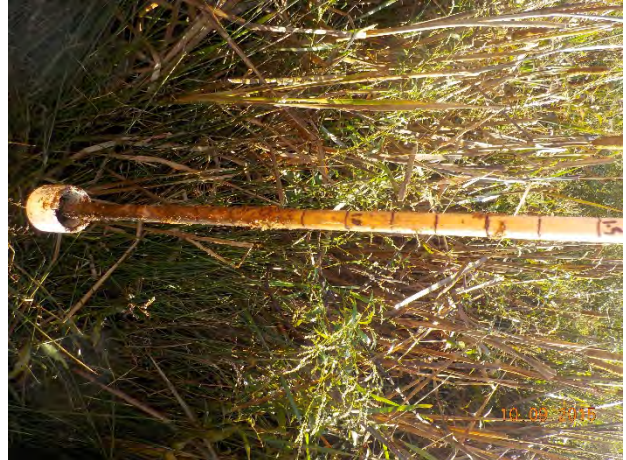
Crest Gauge 1 Reading 0.90' (10/9/2015)

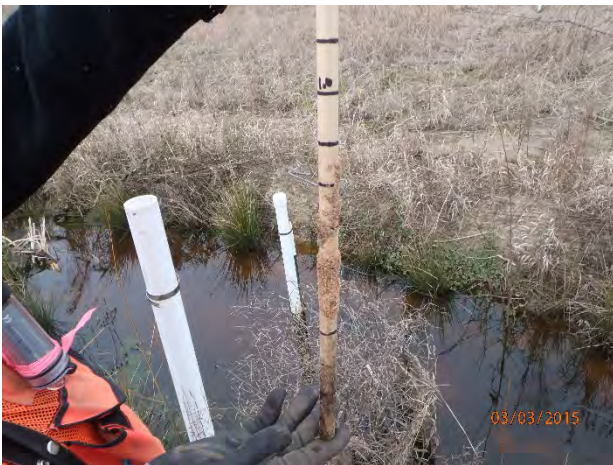
Crest Gauge 2 Reading 0.85' (3/3/2015)

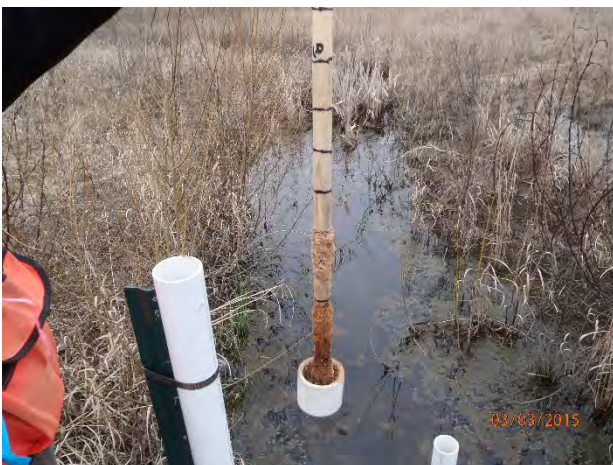
Crest Gauge 3 Reading 0.60' (3/3/2015)

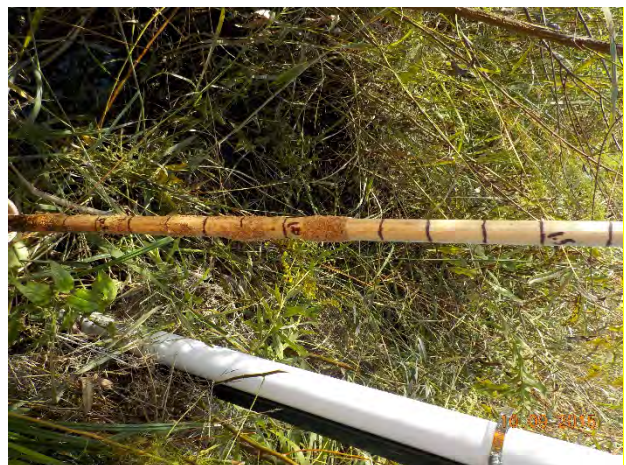
Crest Gauge 3 Reading 1.10' (10/9/2015)

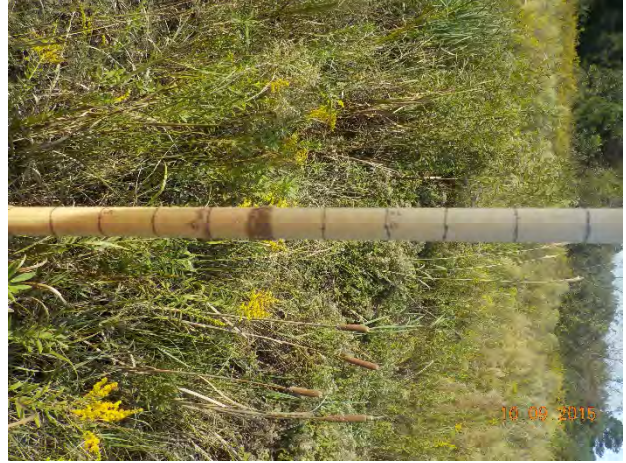
Crest Gauge 4 Reading 1.8' (10/9/2015)
