**MUDDY RUN STREAM RESTORATION PROJECT
MONITORING REPORT
MONITORING YEAR 3**

DUPLIN COUNTY, NORTH CAROLINA, PROJECT # 95018

December 2016

**Muddy Run
Duplin County, North Carolina
DMS Project ID 95018**

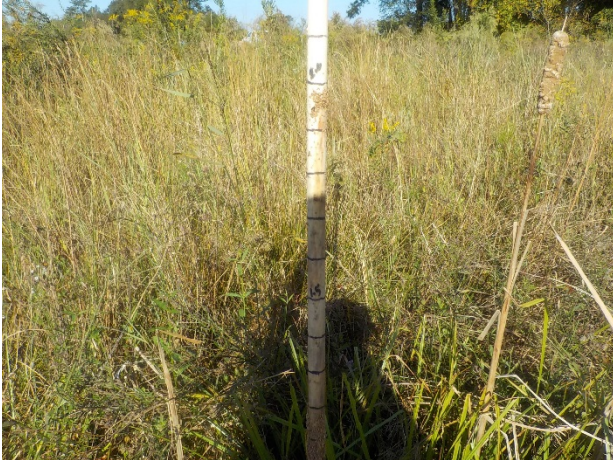
Crest Gauge 1 Reading 2.3' (10/8/2016)

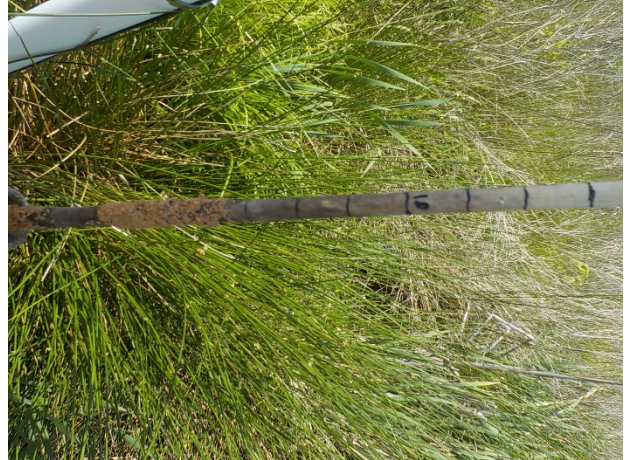
Crest Gauge 1 Reading 0.70' (4/26/2016)

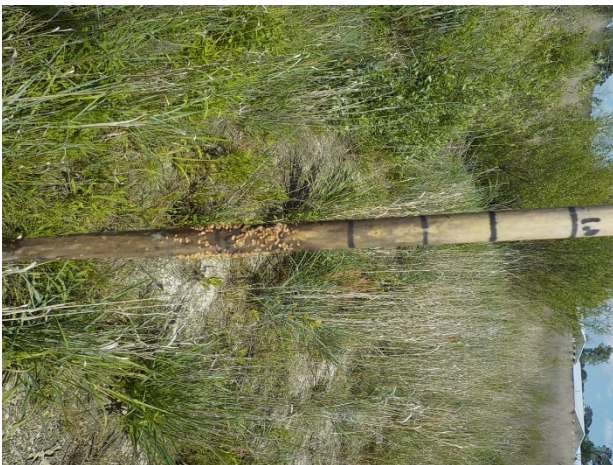
Crest Gauge 2 Reading 0.40' (4/26/2016)

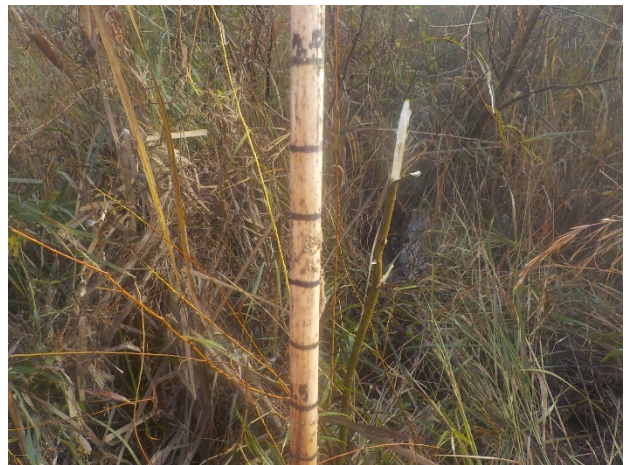
Crest Gauge 2 Reading 2.30' (10/8/2016)

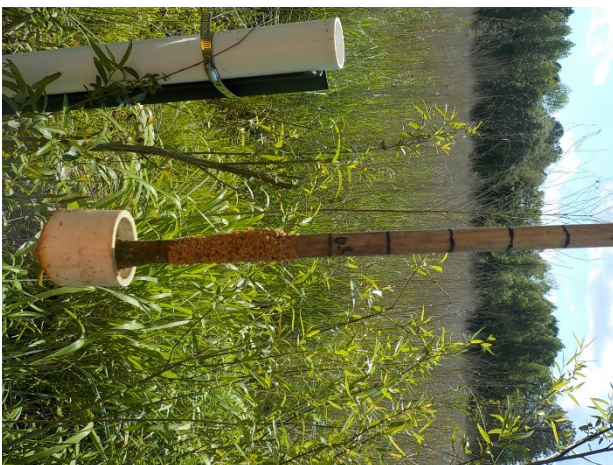
Crest Gauge 3 Reading 0.40' (4/26/2016)

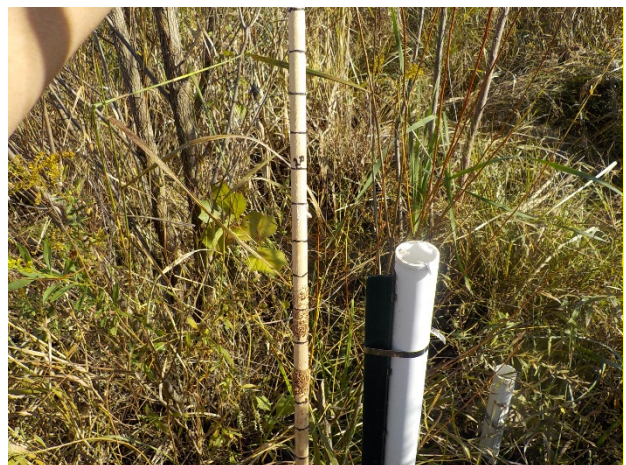
Crest Gauge 3 Reading 1.70' (10/8/2016)

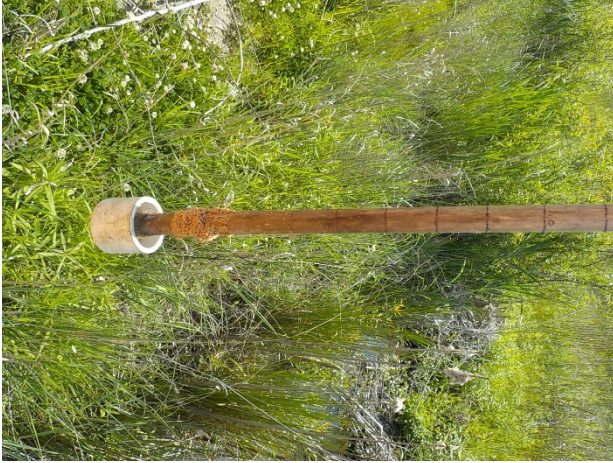
Crest Gauge 4 Reading 0.40' (4/26/2016)

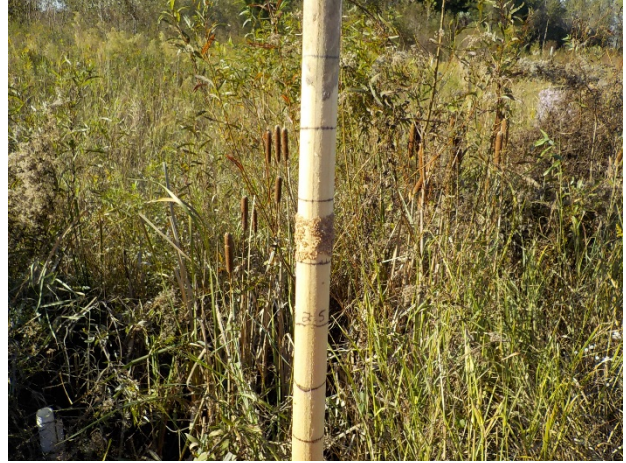
Crest Gauge 4 Reading 2.70' (10/8/2016)
