**MUDDY RUN II STREAM AND WETLAND RESTORATION
PROJECT
FINAL-MONITORING REPORT
MONITORING YEAR 1**

DUPLIN COUNTY, NORTH CAROLINA, PROJECT # 95354

January 2015

**Muddy Run II
Duplin County, North Carolina
EEP Project ID 95354**

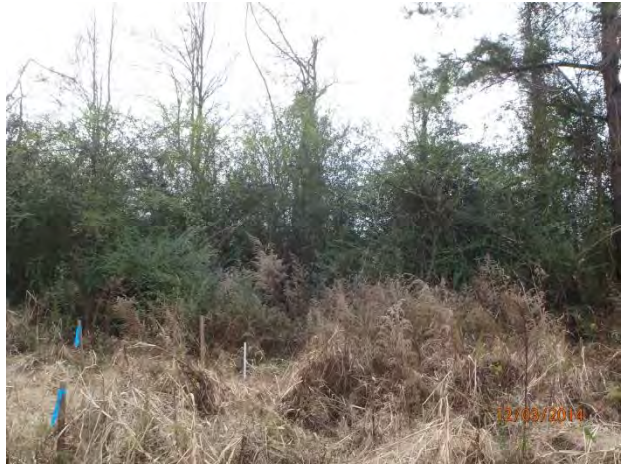
VPA1- Invasive population: *Ligustrum* along Reach 2 @ Sta 0+50 – Sta 3+00.

Table 8. Vegetation Problem Areas			
Muddy Run II Stream and Wetland Restoration Project - Project # 95354			
Feature Category	Station Numbers	Suspected Cause; Repair	Photo Number
Invasive/Exotic Populations	Reach 2 @ Sta 0+50 - 3+00	Ligustrum: encroachment from outside easement; Continued clearing and stump treatment.	VPA1
Invasive/Exotic Populations	Reach 3A @ Sta 11+00 - 16+00	Ligustrum: encroachment from outside easement; Continued clearing and stump treatment.	VPA2
Invasive/Exotic Populations	Reach 3A- localized areas- see plan view	Ligustrum; Continued clearing and stump treatment.	VPA3
Sparse vegetation/ Easement encroachment	Reach 3A @ Sta 19+00 - Sta 23+00	Vehicles driving in the easement; Plant approximately 80 trees in 2 rows and restrict vehicle access to the easement.	VPA4
Missing rows of trees	Reach 3A @ Sta 28+50 - 33+75	Trees were never planted; Plant approximately 400 trees.	VPA5

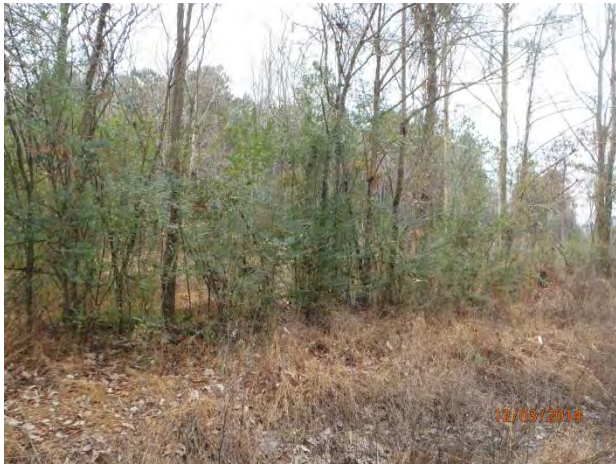
VPA2- Invasive population: *Ligustrum* along Reach 3a @ Sta 11+00 – Sta 16+00.

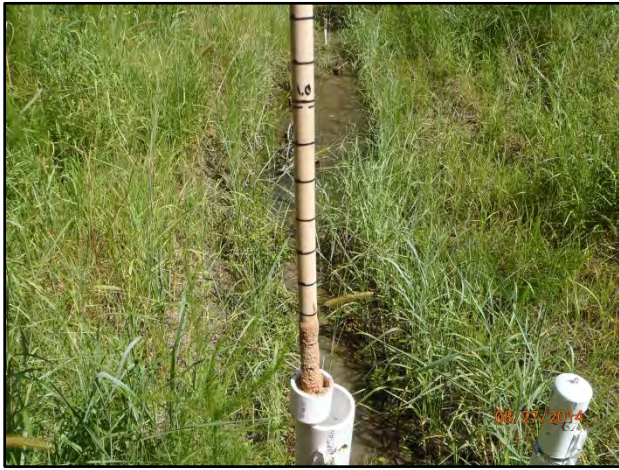
Photo 1. Crest Gauge 1 (Reach 2 - 0.4 ft. – 8/1/2014)

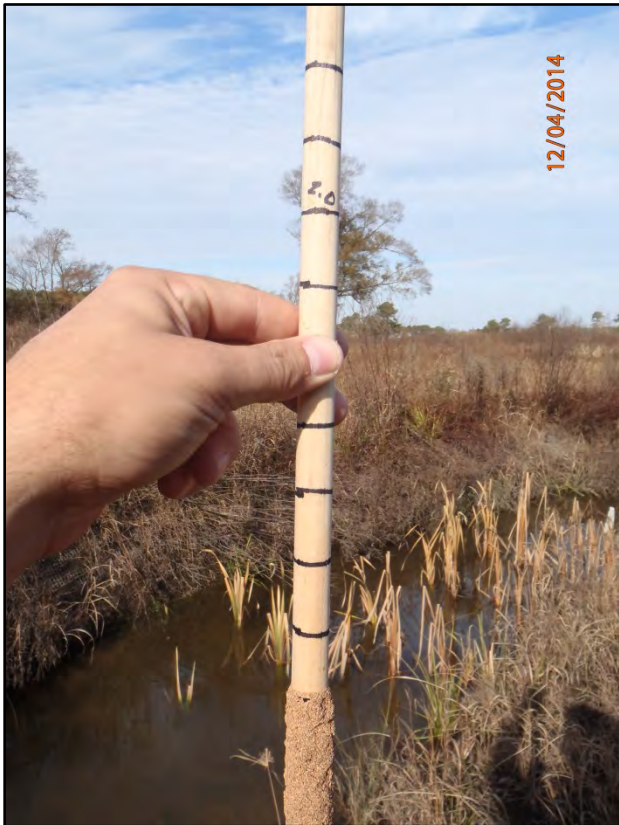
Photo 2b. Crest Gauge 2 (Reach 3A - 1.3 ft. – 11/26/2014)

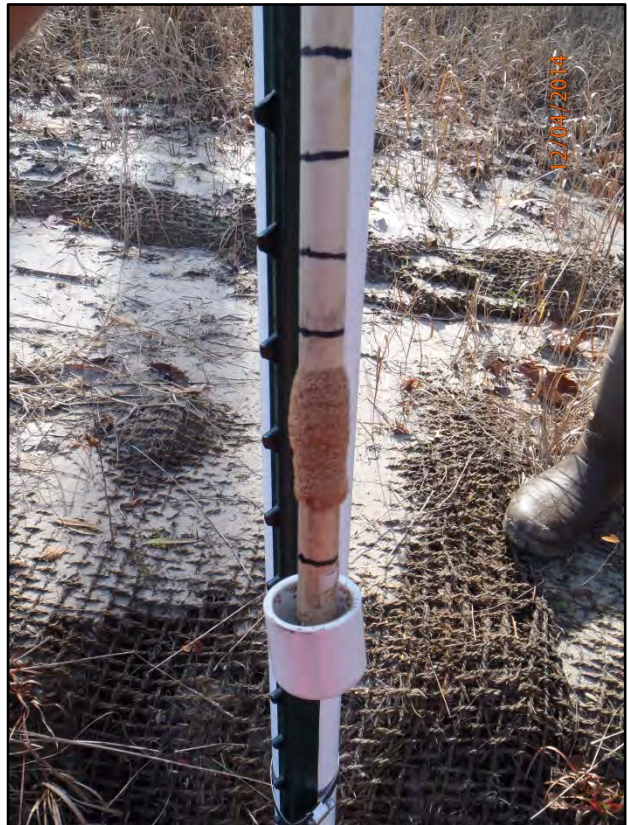
Photo 3. Crest Gauge 4 (Reach 5A - 0.45 ft. – 9/12/2014)
