**MUDDY RUN II STREAM AND WETLAND RESTORATION  
PROJECT  
MONITORING REPORT  
MONITORING YEAR 2**

DUPLIN COUNTY, NORTH CAROLINA  
CONTRACT NO. 004632 - PROJECT # 95354

**Muddy Run II  
Duplin County, North Carolina  
DMS Project ID 95354**

**Resource Environmental Solutions  
302 Jefferson Street, Suite 110  
Raleigh, NC 27605  
919-829-9909**

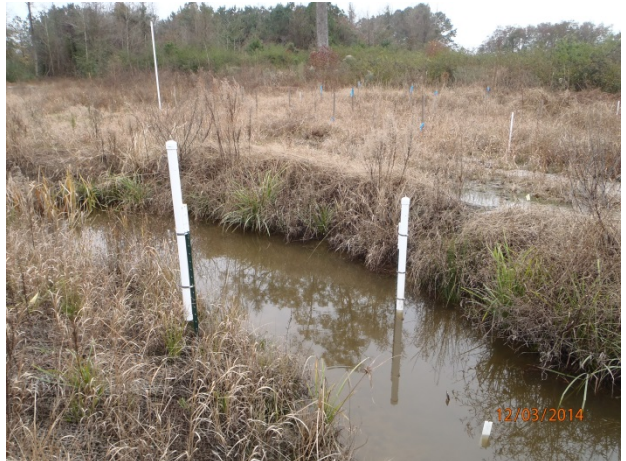
Crest Gauge 2- Reach 3A (12/03/2014)

**Photo 2.** Crest Gauge 2 (Reach 3A – 2.0 ft. – 2/10/16)

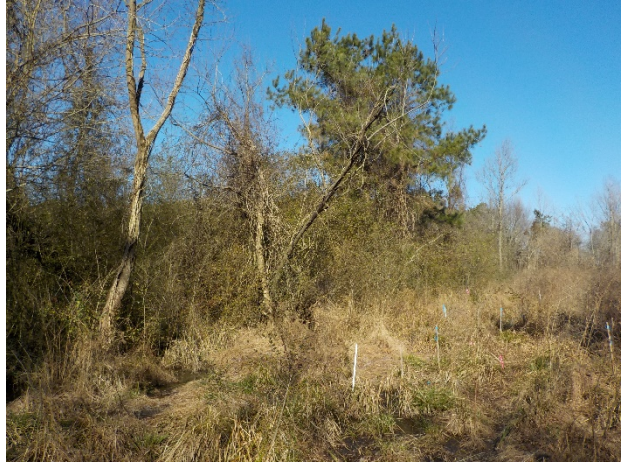
VPA2- Invasive population: *Ligustrum* along Reach 3a @ Sta 11+00 – Sta 16+00.

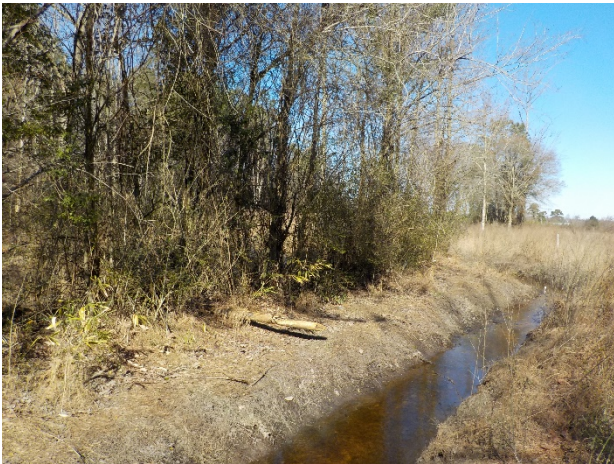
VPA3- Localized invasive populations: *Ligustrum* along Reach 3a

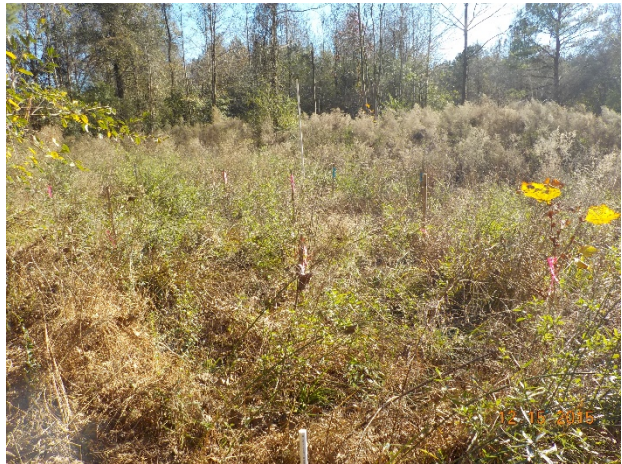
VPA4- Low stem density: Reach 4 @ Sta 1+00 – Sta 2+00

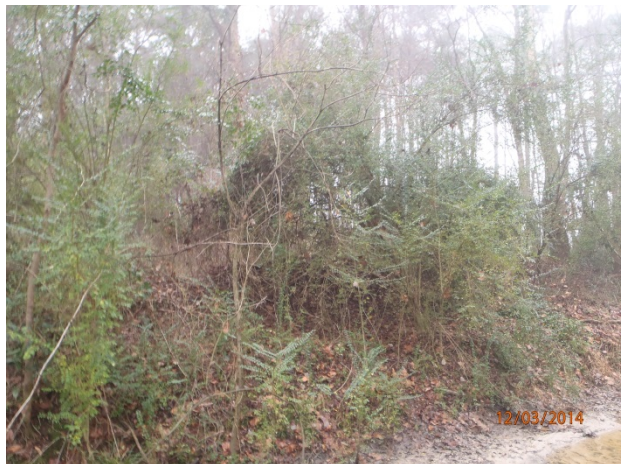
VPA6 - Localized invasive populations: *Ligustrum* along Reach 3c

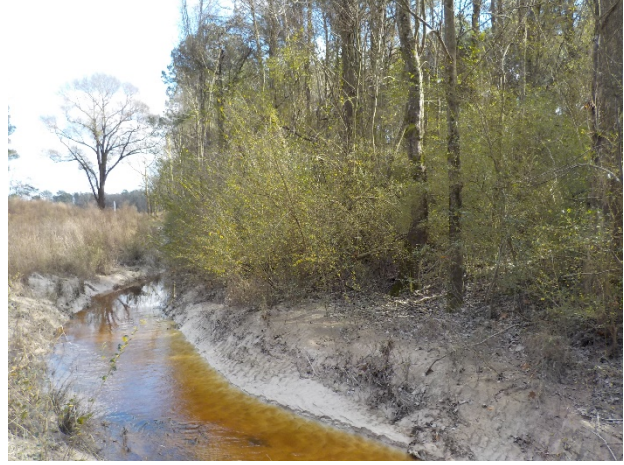
VPA 8 Invasive population: *Ligustrum* along Reach  
5b @ Sta 19+60 – Sta 23+68.

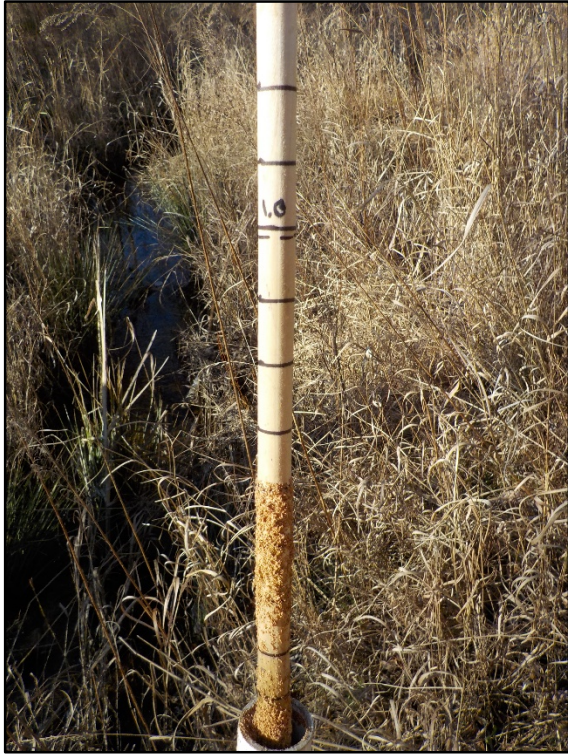
**Photo 1.** Crest Gauge 1 (Reach 2 - 0.6 ft. – 2/10/16)

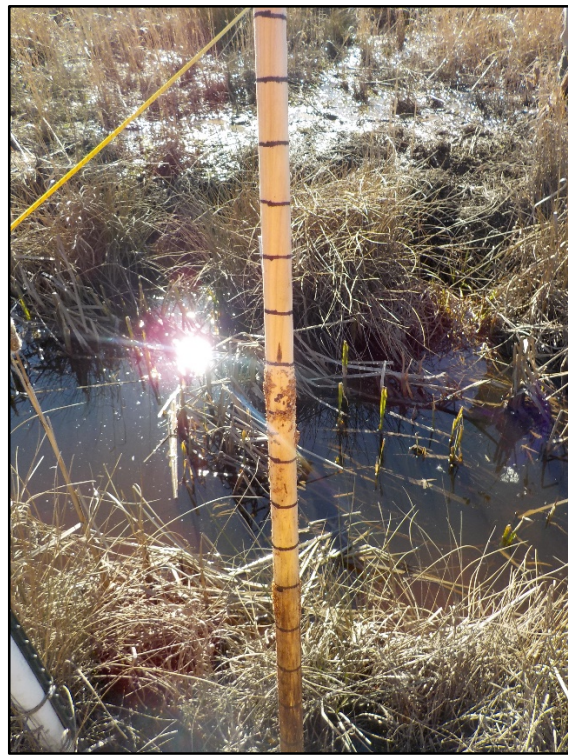
**Photo 4.** Crest Gauge 4 (Reach 5A - 0.08 ft. – 10/09/2015)
