**MUDDY RUN II STREAM AND WETLAND RESTORATION
PROJECT
MONITORING REPORT
MONITORING YEAR 5
FINAL**

DUPLIN COUNTY, NORTH CAROLINA
DMS CONTRACT No. 004631 – DMS PROJECT No. 95354
SAW-2011-02191
DWR 2013-0653

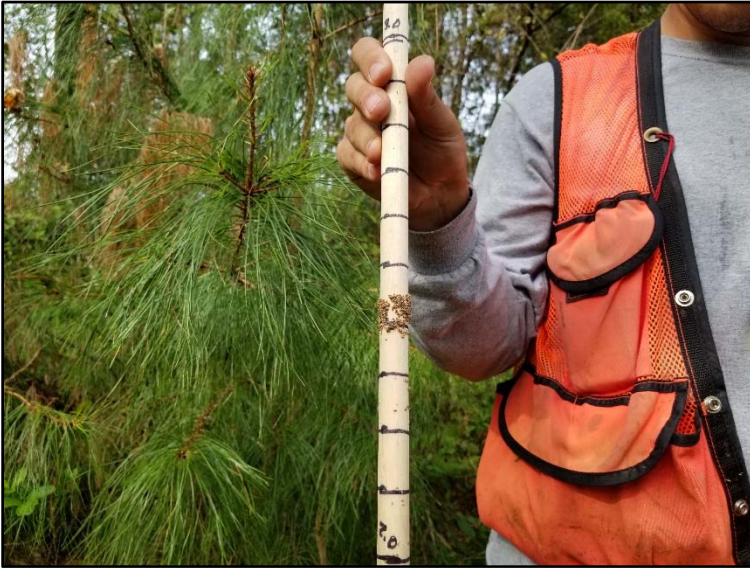
Photo 1. Crest Gauge 1 (Reach 2 – 2.45 ft. – 9/15/2018)

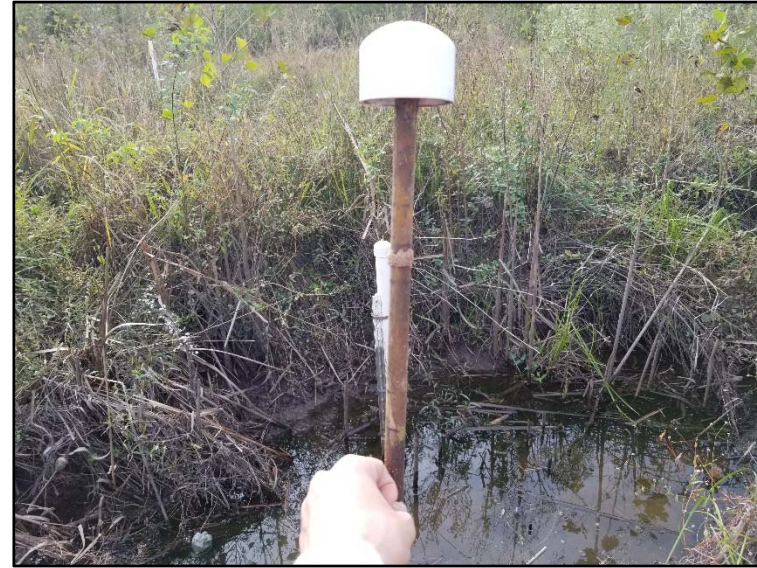
Photo 2. Crest Gauge 2 (Reach 3A – 3.5 ft. – 9/15/2018)

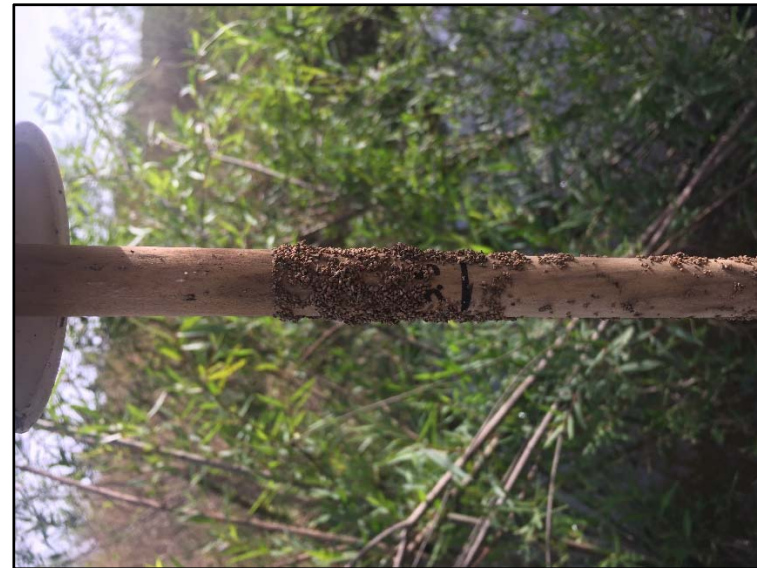
Photo 4. Crest Gauge 4 (Reach 5A – 3.75 ft. – 9/15/2018)
