**FINAL
MY1 MONITORING REPORT**

NESBIT SITE

Union County, North Carolina
Catawba River Basin
Cataloging Unit 03050103

DMS Project No. 100121
Full Delivery Contract No. 7868
DMS RFP No. 16-007704 (issued 9/6/2018)
USACE Action ID No. SAW-2019-00832
DWR Project No. 2019-0862

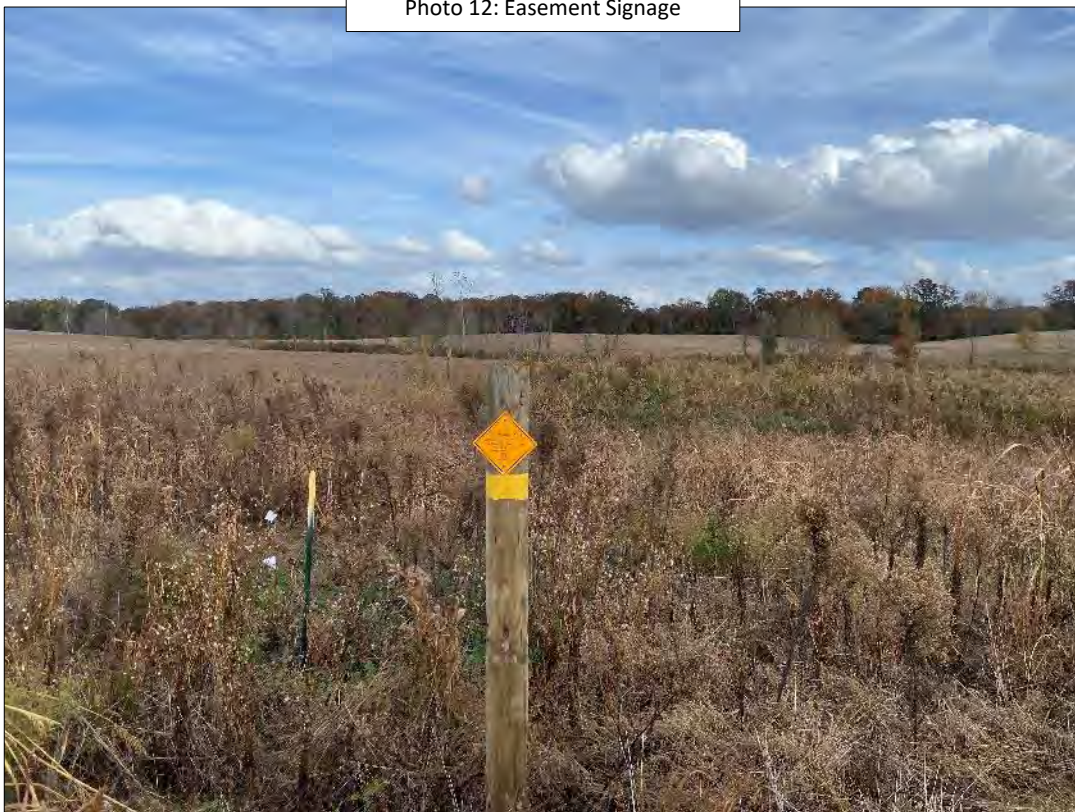
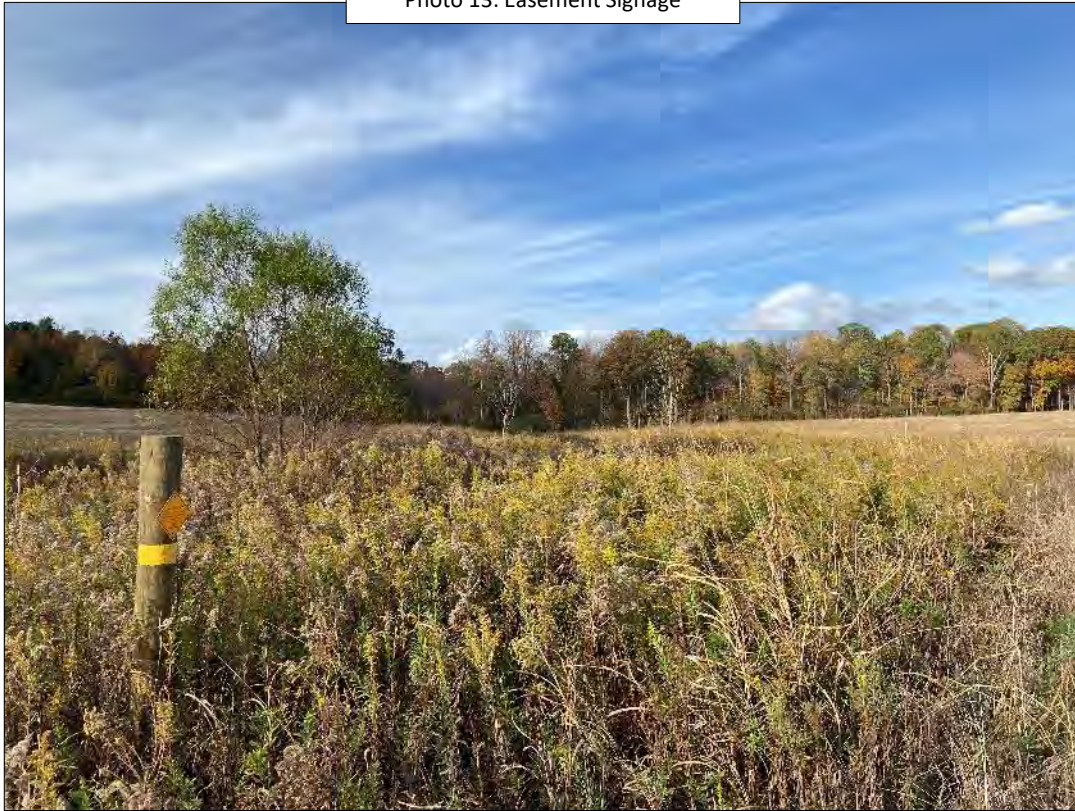
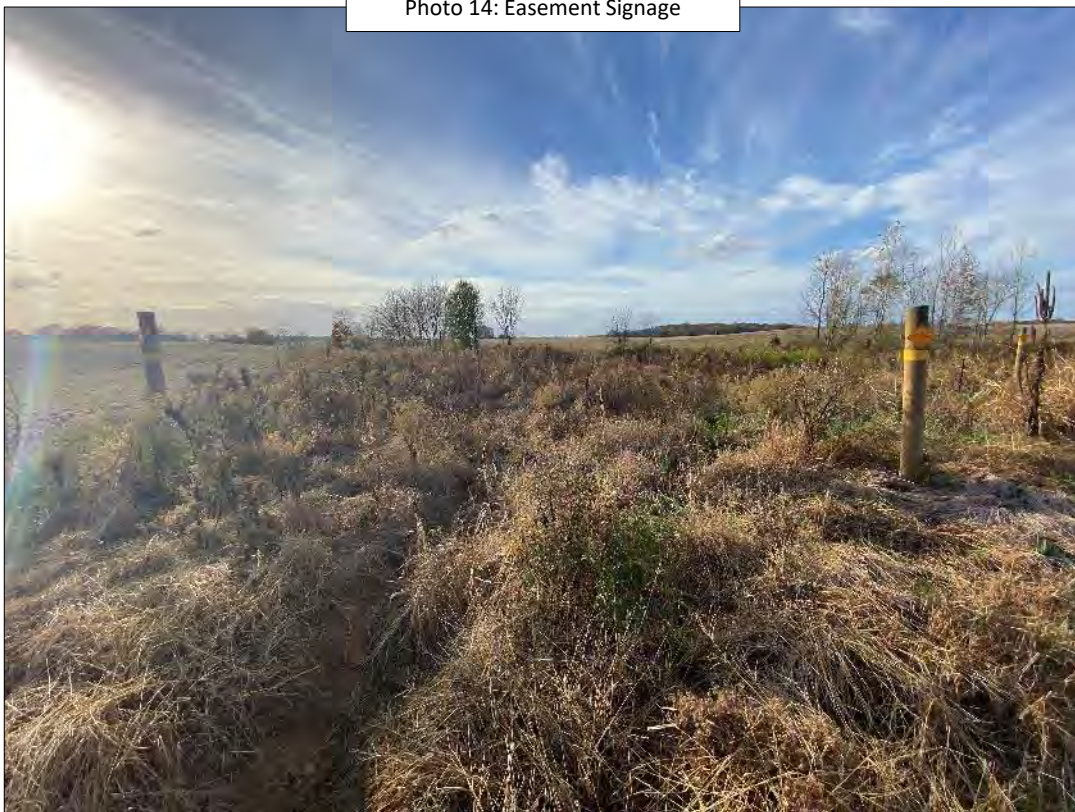
Photo 11: Easement Signage

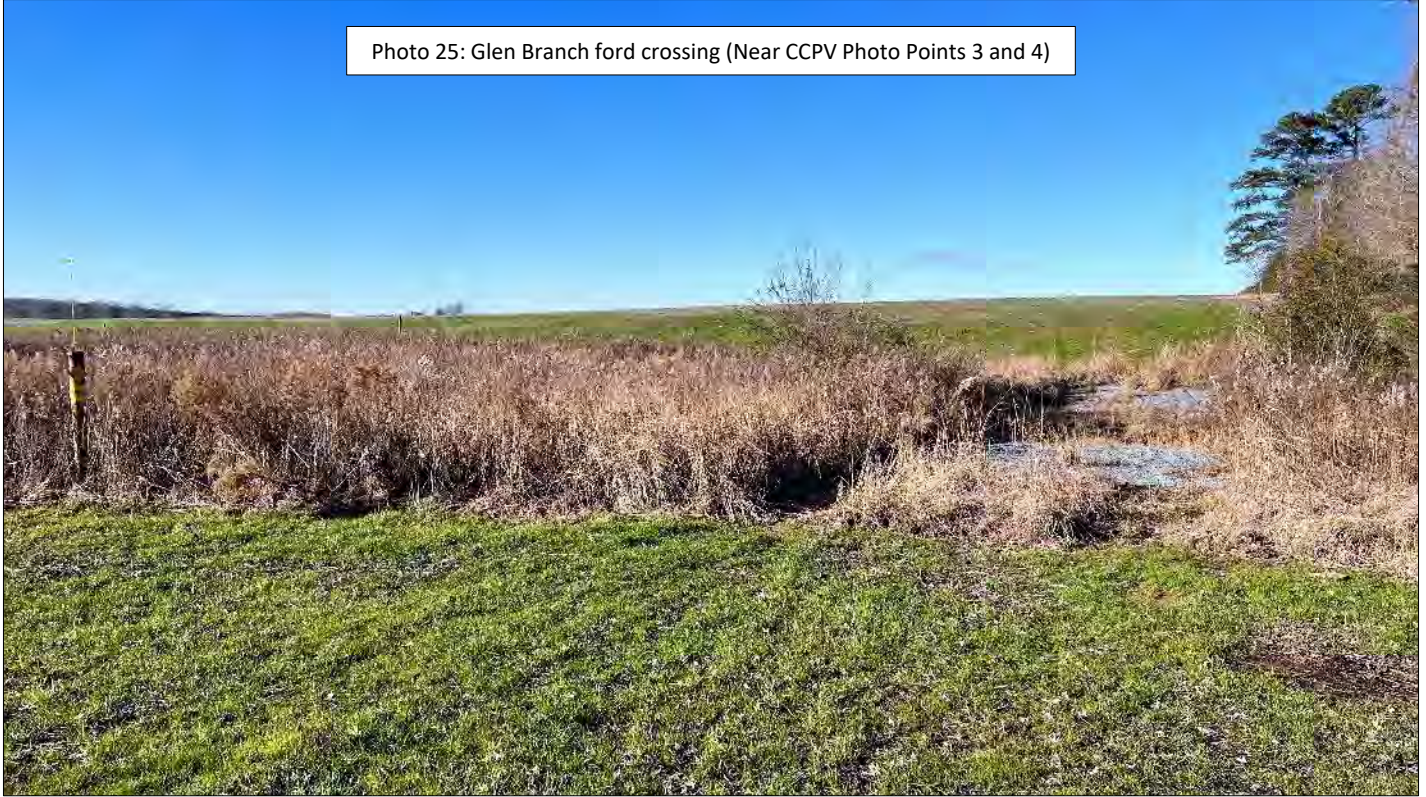
Photo 25: Glen Branch ford crossing (Near CCPV Photo Points 3 and 4)

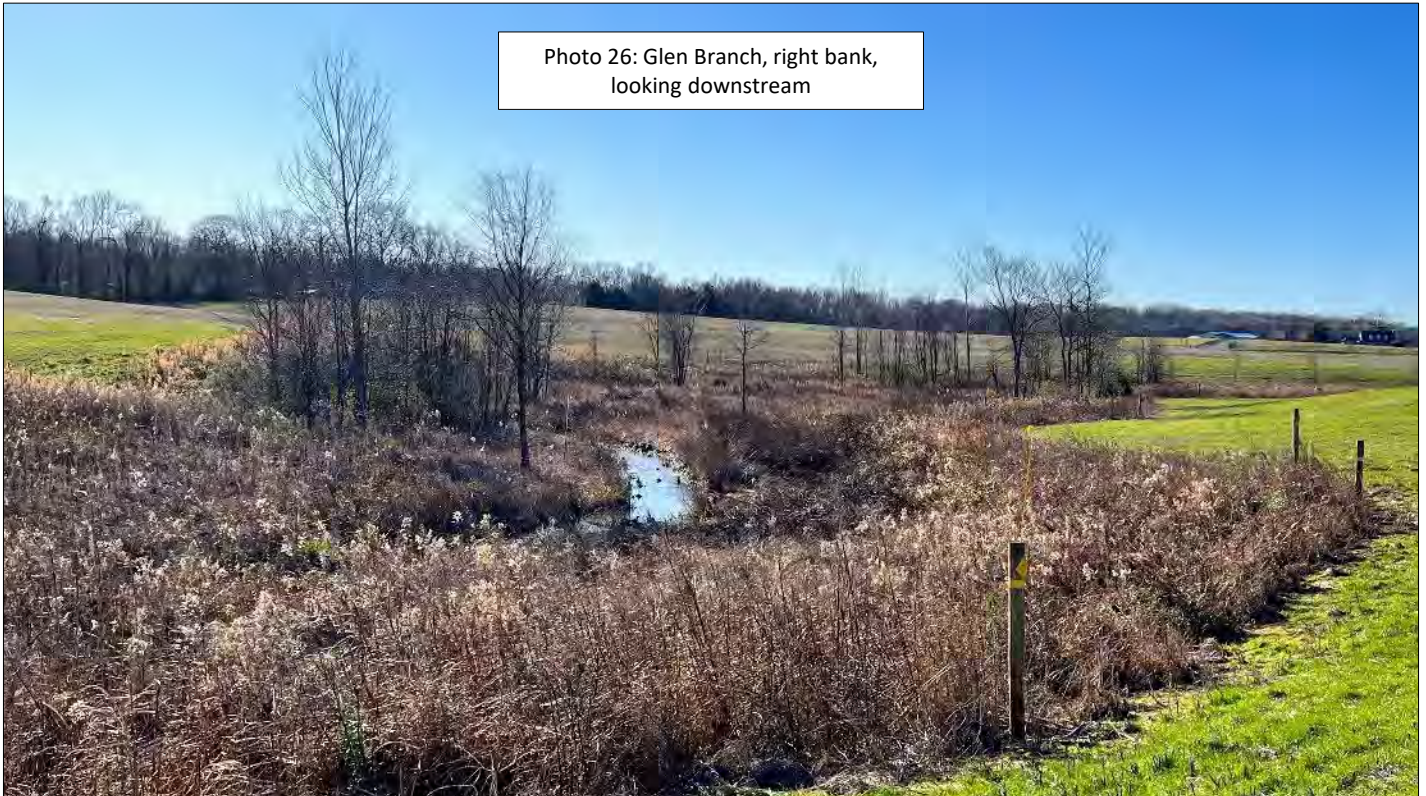
Photo 26: Glen Branch, right bank,
looking downstream

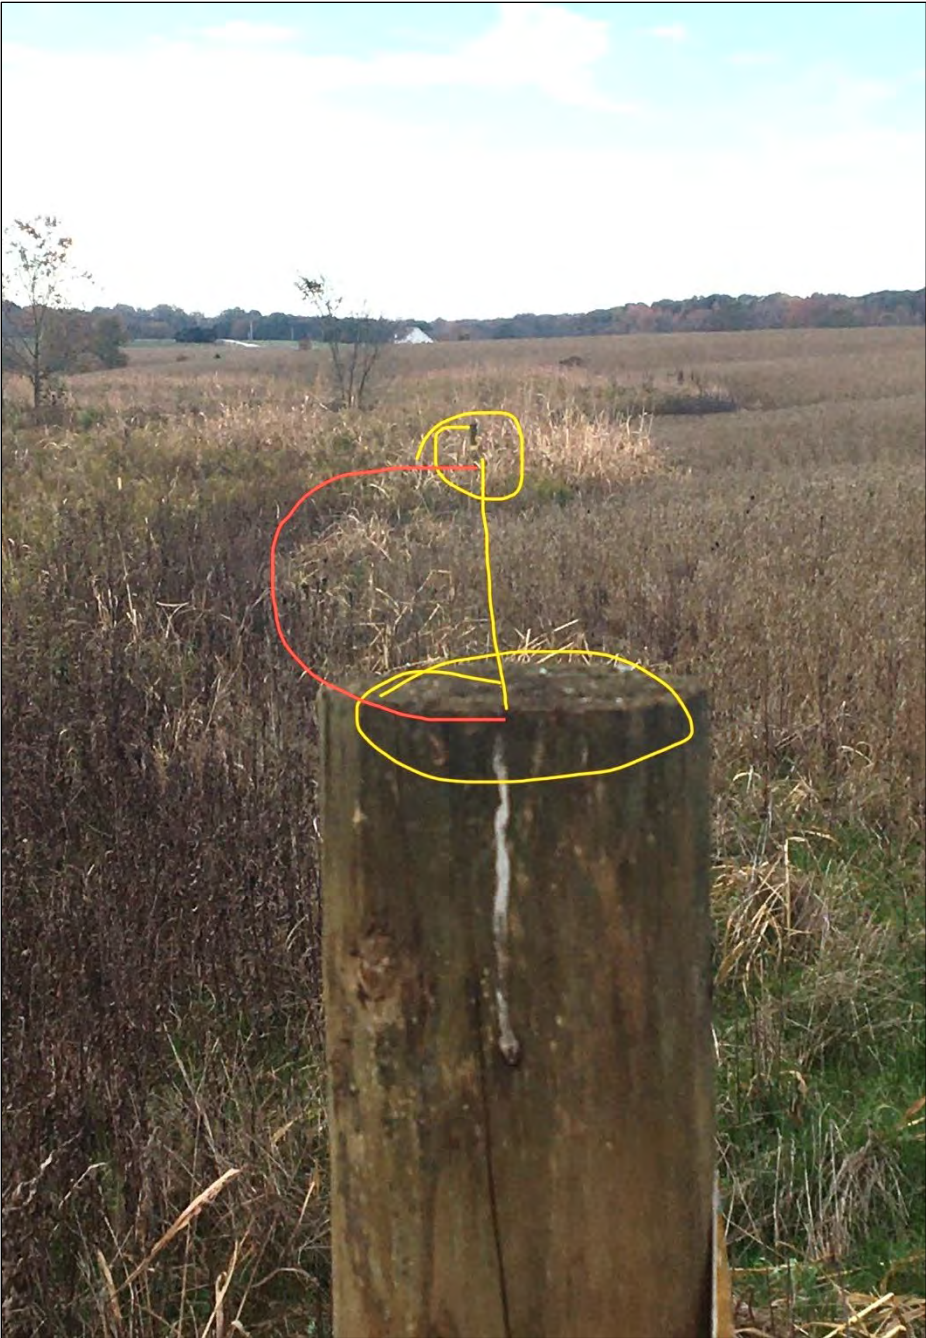
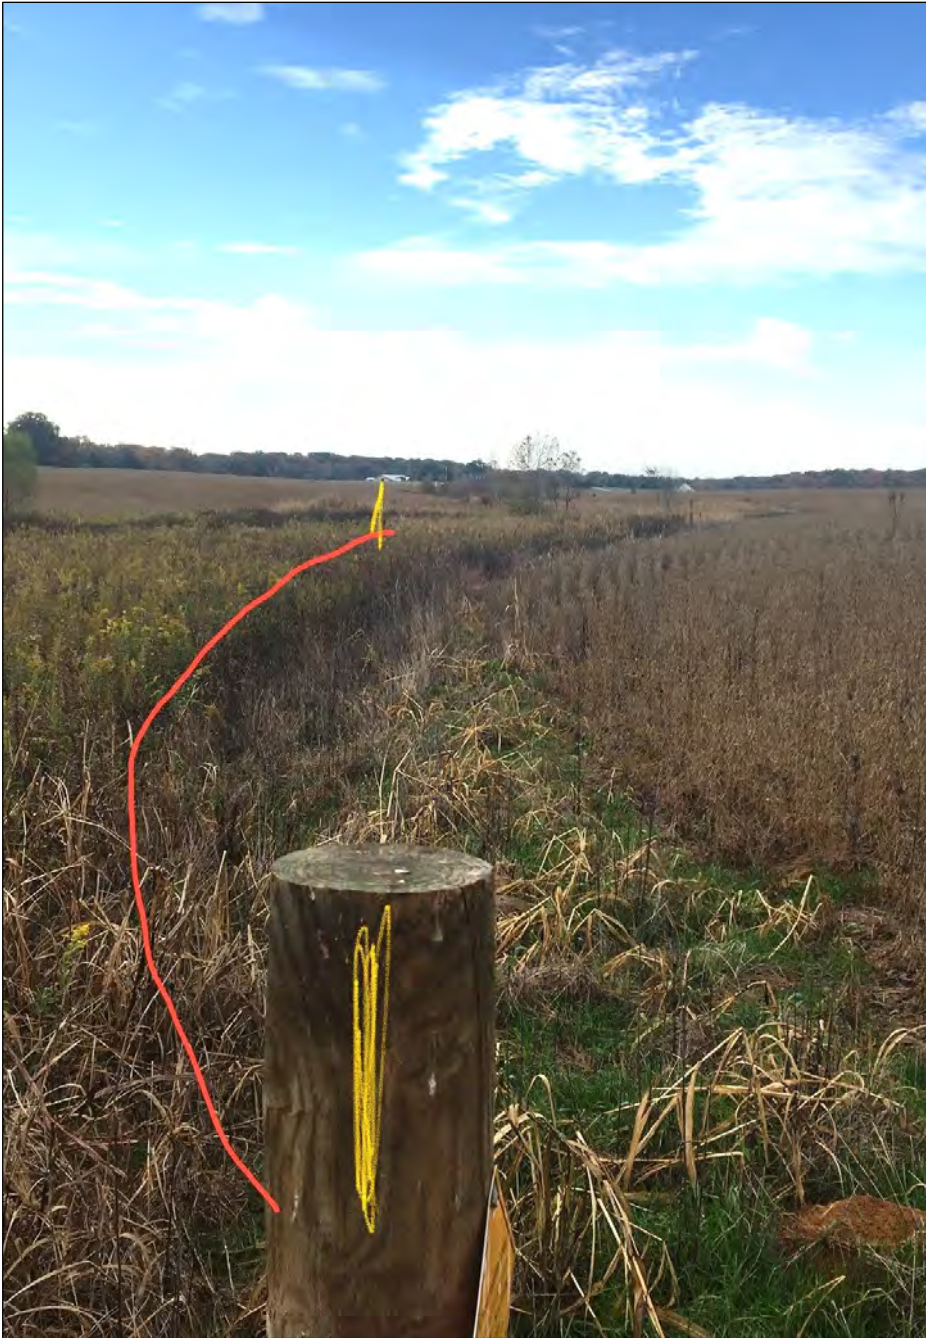
Photos sent to Alex Duchesneau, Farm Manager, on 11/03/2022
