**FINAL
MY2 MONITORING REPORT**

NESBIT SITE

Union County, North Carolina
Catawba River Basin
Cataloging Unit 03050103

DMS Project No. 100121
Full Delivery Contract No. 7868
DMS RFP No. 16-007704 (issued 9/6/2018)
USACE Action ID No. SAW-2019-00832
DWR Project No. 2019-0862

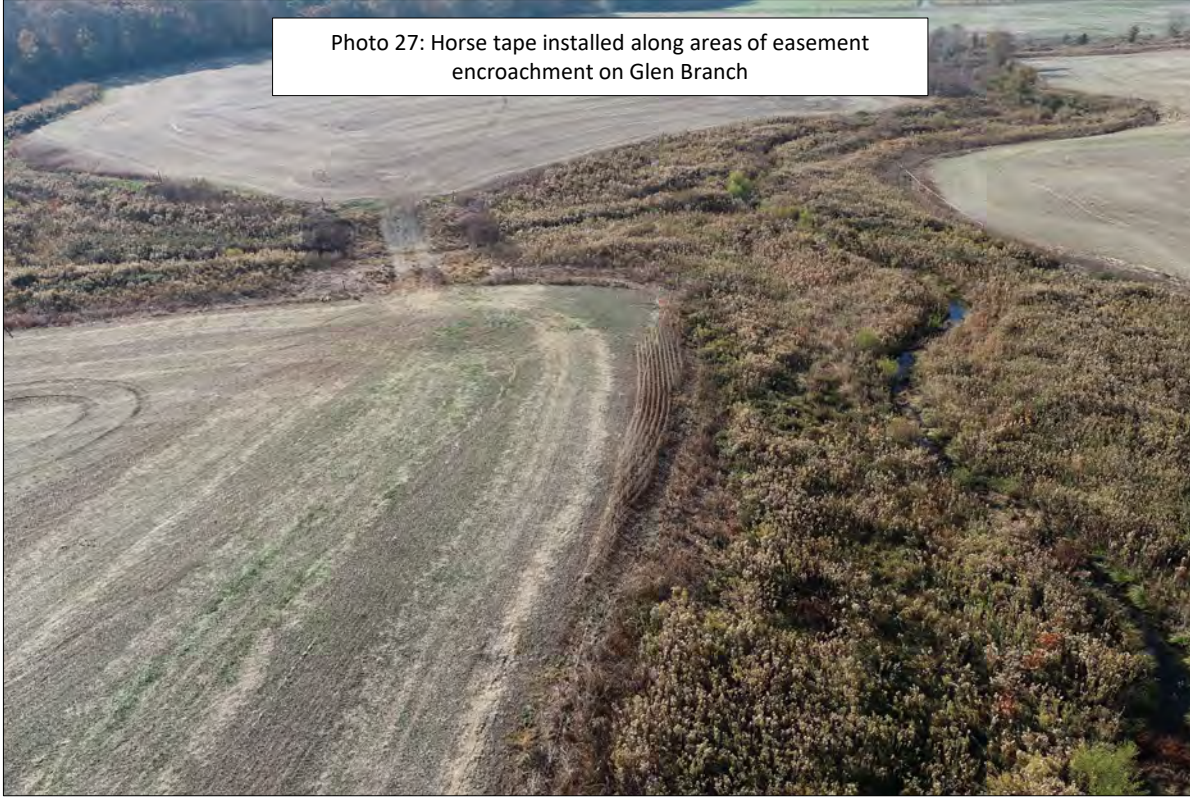
Photo 27: Horse tape installed along areas of easement encroachment on Glen Branch

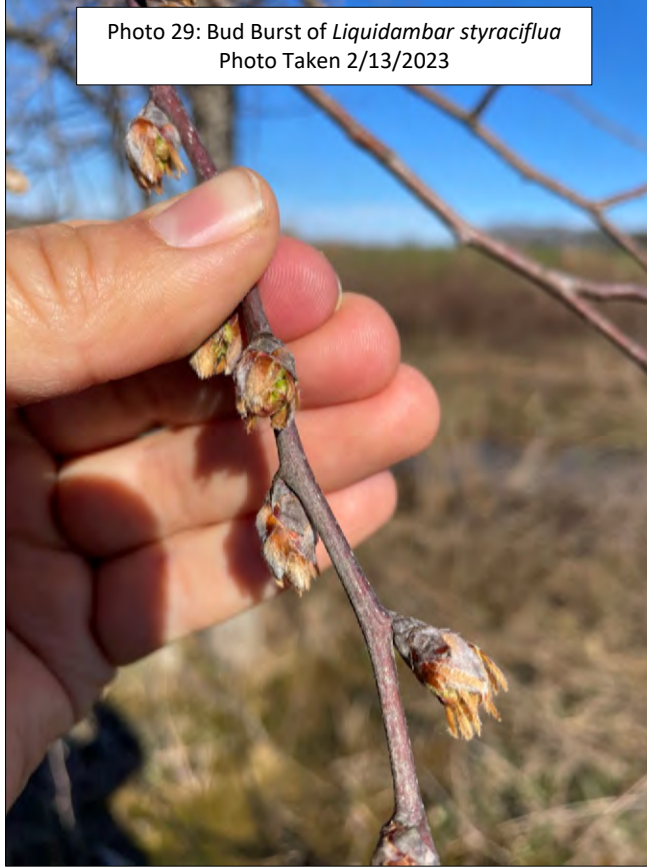
Photo 29: Bud Burst of *Liquidambar styraciflua*
Photo Taken 2/13/2023

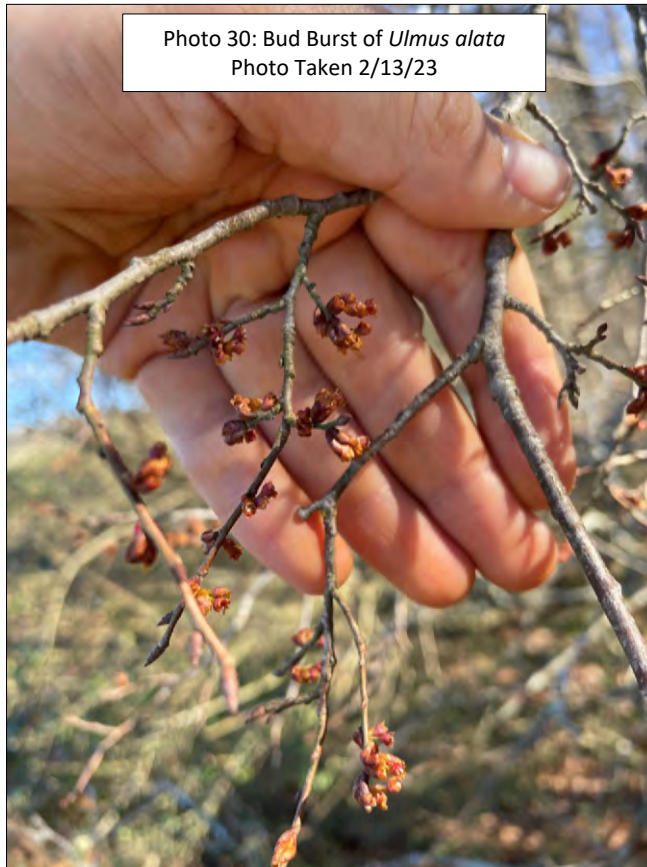
Photo 30: Bud Burst of *Ulmus alata*
Photo Taken 2/13/23
