**Newfound Creek Stream Restoration  
2013 Final Monitoring Report  
Monitoring Year Two**

**Ecosystem Enhancement Program Project Number 92497**

Submitted: December 2, 2013

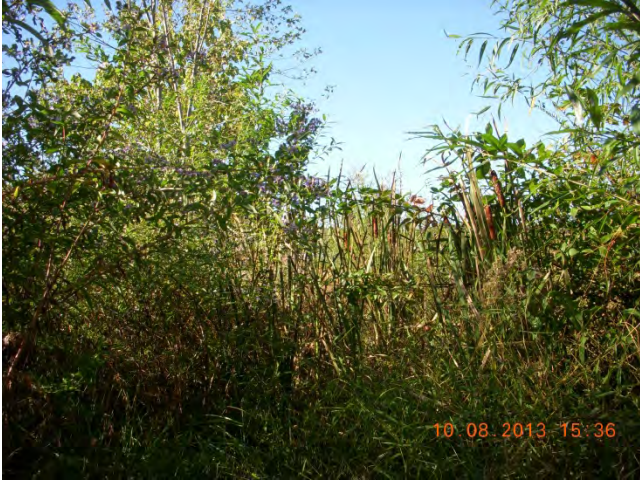
PS1, Tributary 8 facing downstream

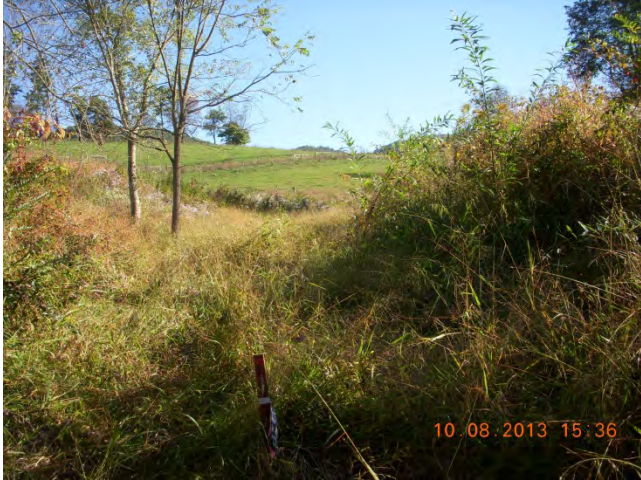
PS2, Tributary 8 facing upstream

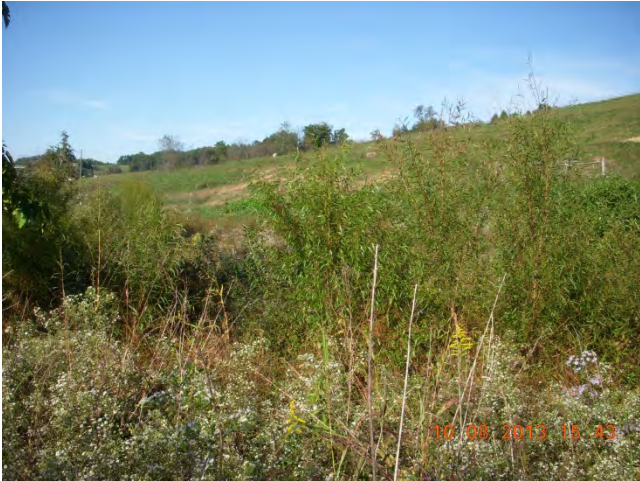
PS3, Tributary 8 facing downstream

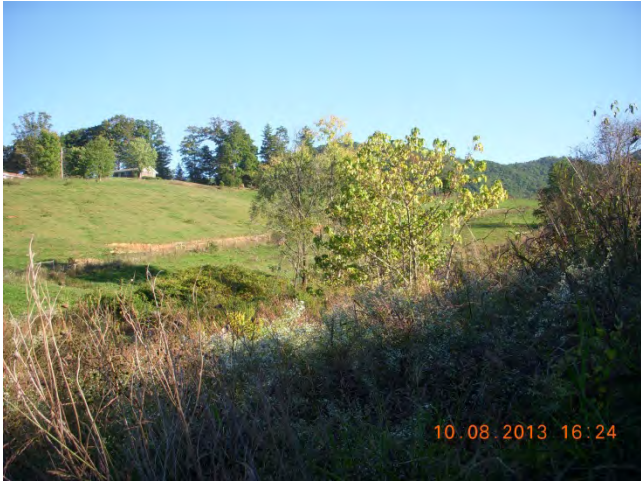
PS4, Tributary 8 facing upstream

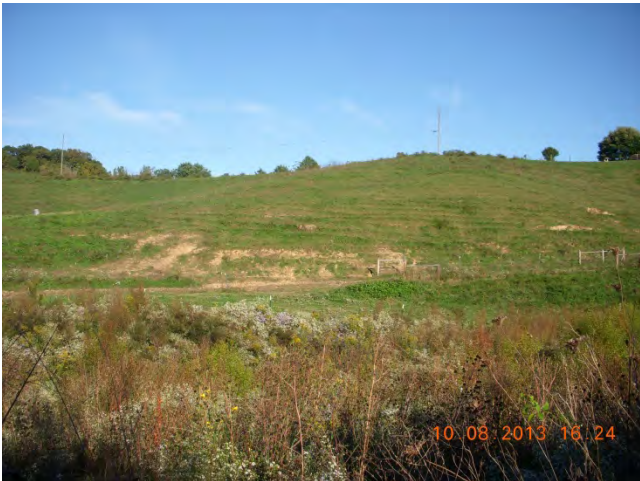
PS5, Tributary 8 facing east

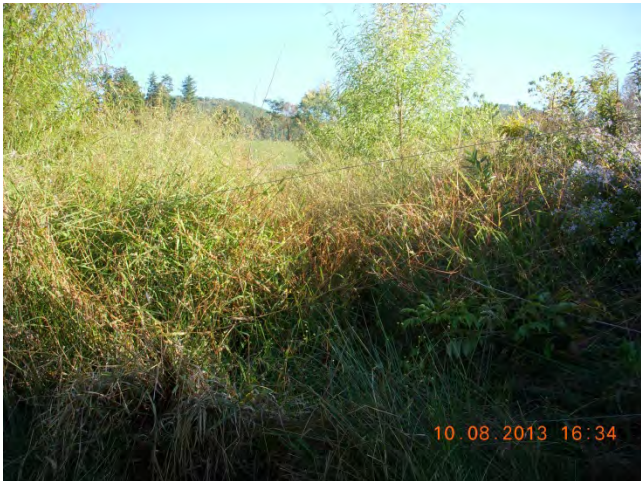
PS6, Tributary 8 facing upstream

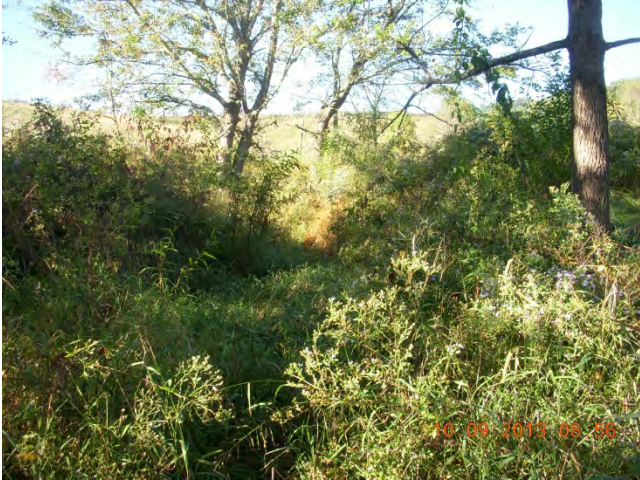
PS7, Tributary 7 facing upstream

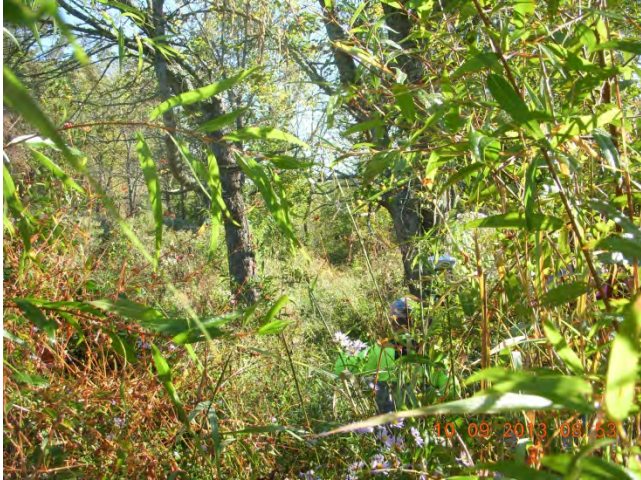
PS8, Tributary 7 facing downstream

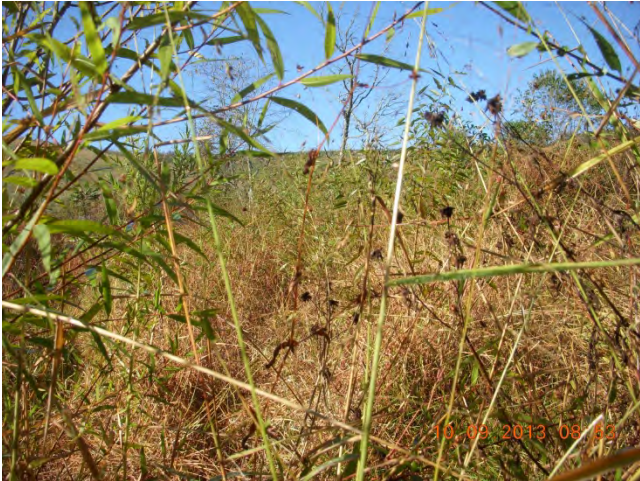
PS9, Tributary 7 facing upstream

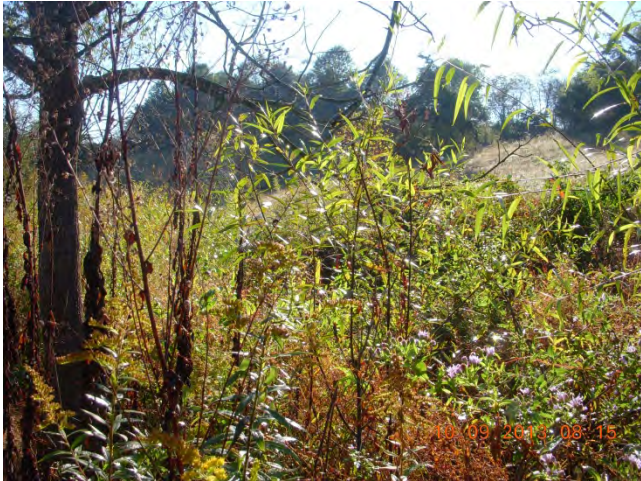
PS10, Tributary 7 facing downstream

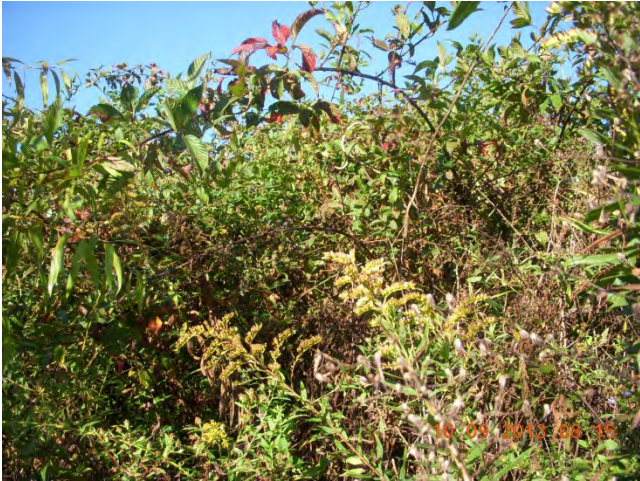
PS11, Tributary 7 facing upstream

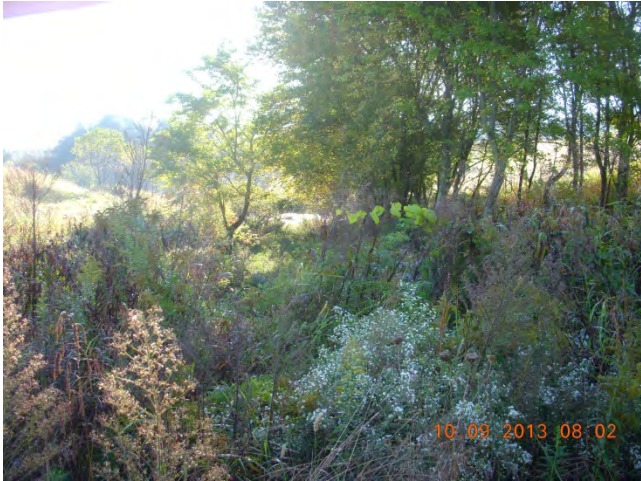
PS12, Tributary 7 facing downstream

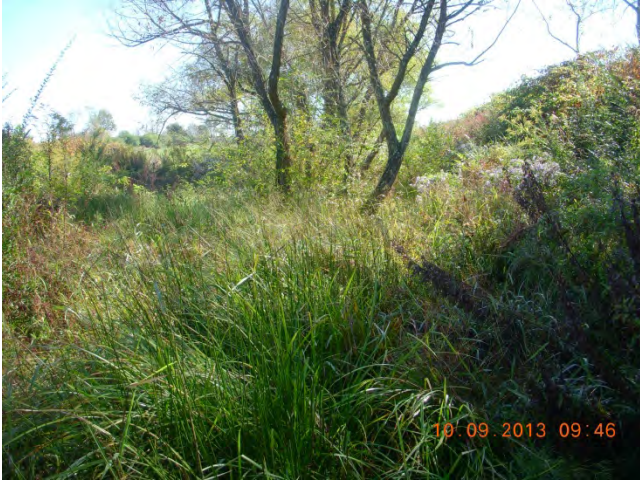
PS13, Tributary 4 facing downstream

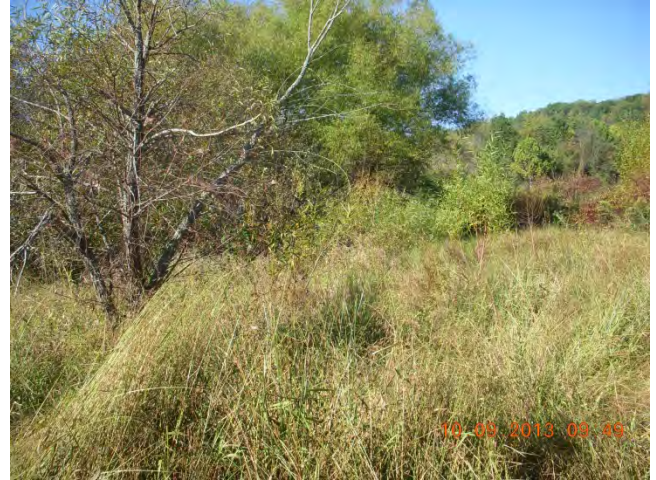
PS14, Tributary 4 facing upstream

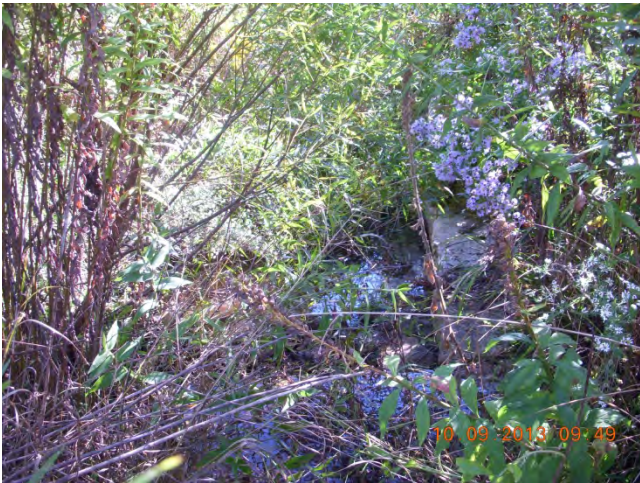
PS15, Tributary 4 facing downstream

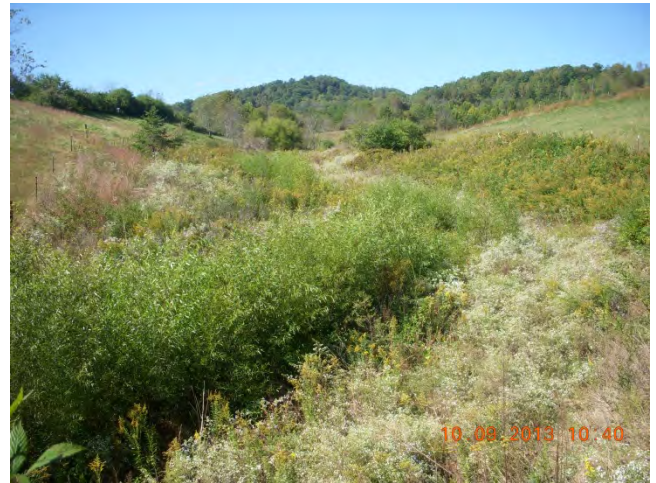
PS16, Tributary 4 facing upstream

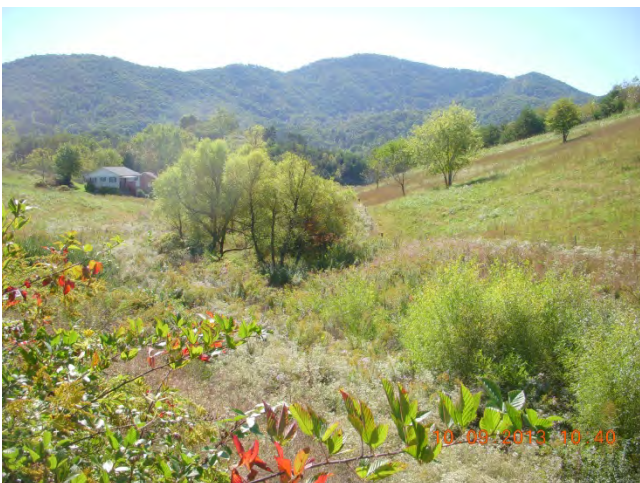
PS17, Tributary 4 facing downstream

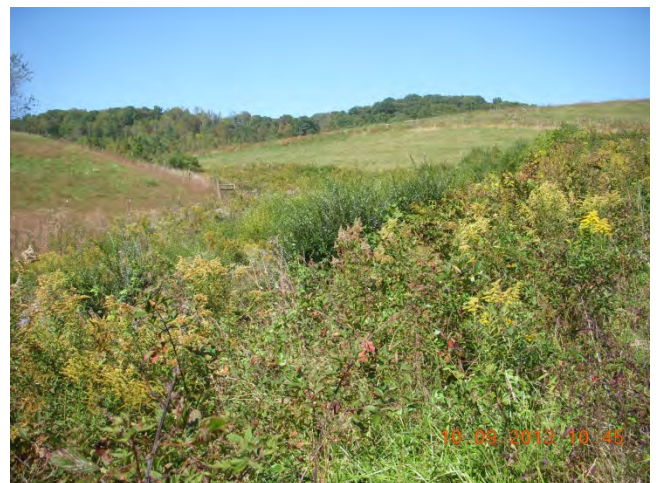
PS18, Tributary 4 facing upstream

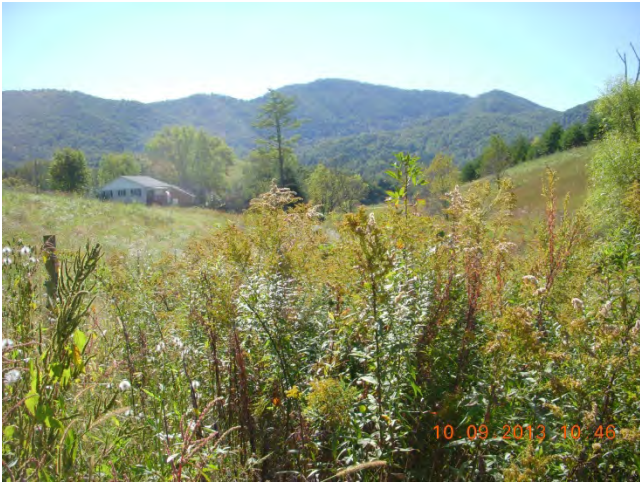
PS19, Tributary 4 facing downstream

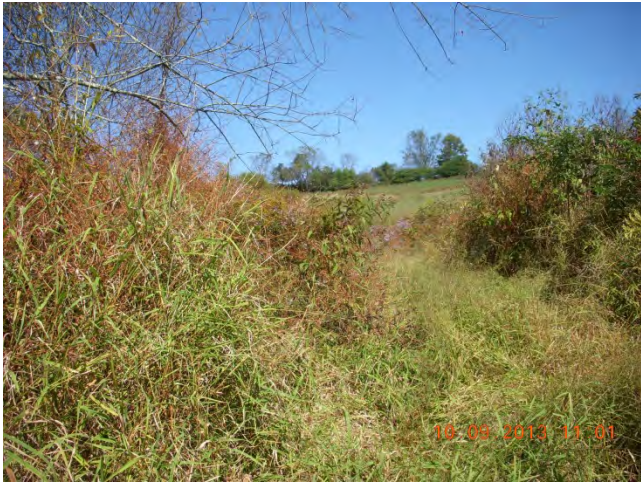
PS20, Tributary 4 facing upstream

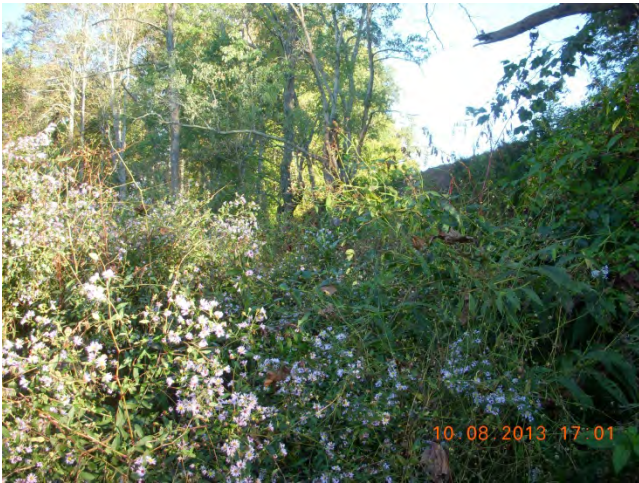
PS66, Tributary 6 facing downstream (photo from February 2013, new photo will be taken during site assessment in Spring of 2014)

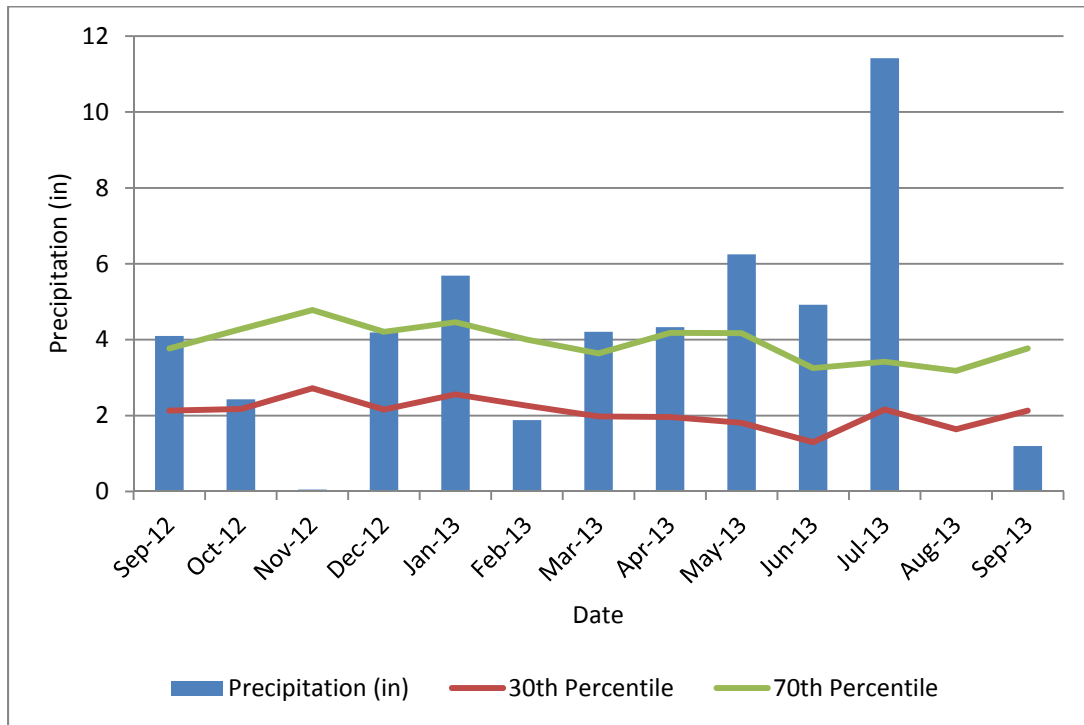
**Figure 25: Newfound Creek 30-70 Percentile Graph for Rainfall in 2012, Leicester, NC**

Rainfall data are presented in Figure 25. Rainfall data show that rainfall amounts near the site were at or above the 70<sup>th</sup> percentile for the majority of the past 12 months, with record rainfall amounts of 6.25 inches in May of 2013 and 11.42 inches in July of 2013.
