**Newfound Creek Stream Restoration
2014 Final Monitoring Report
Monitoring Year Three**

Ecosystem Enhancement Program Project Number 92497

Submitted: November 21, 2014

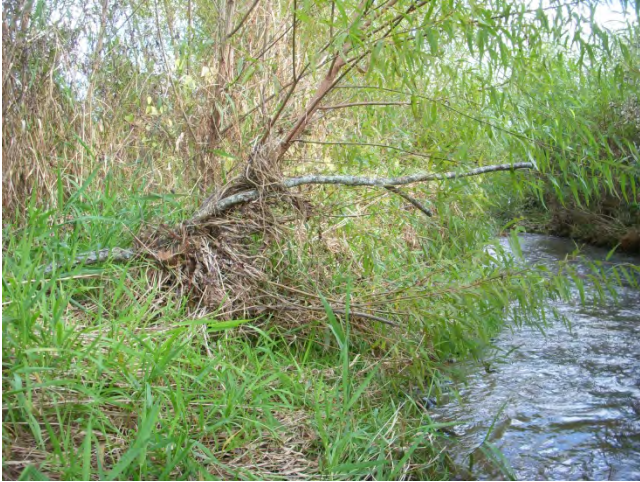
Photo 77. Wrack lines on upstream of mainstem

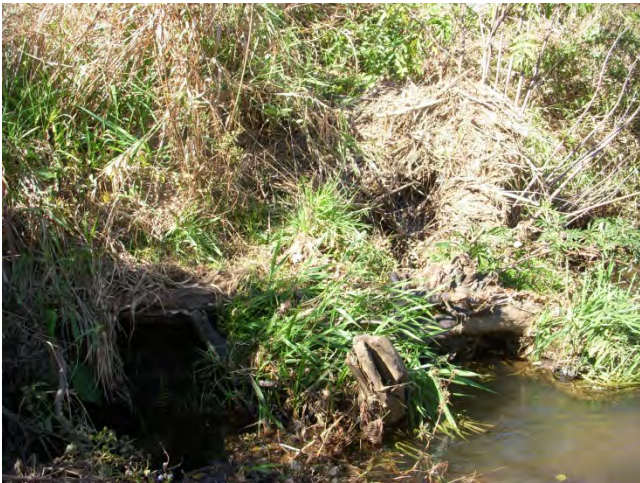
Photo 256. Wrack lines near bottom of mainstem

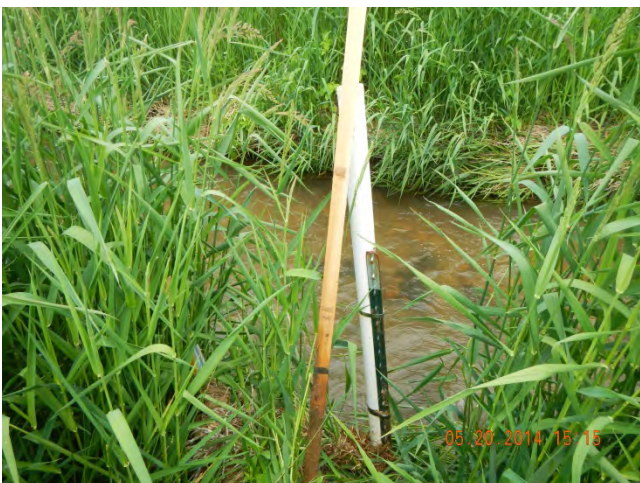
Photo 64. Crest Gauge 2, May 2014

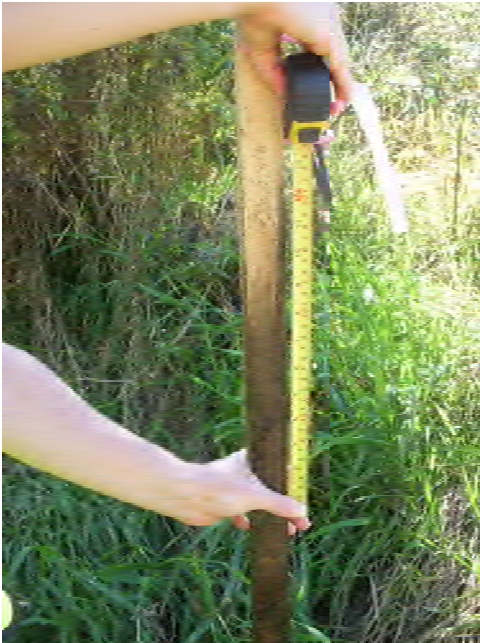
Photo 241. Crest gauge 1, November 2014

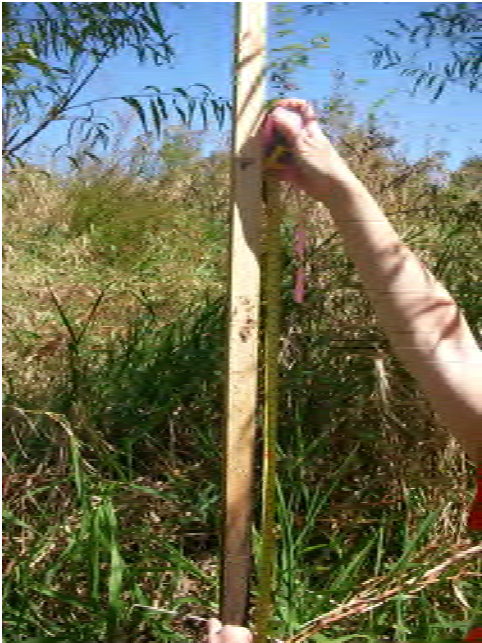
Photo 239. Crest gauge 2, November 2014
