**Newfound Creek Stream Restoration  
2015 Final Monitoring Report  
Monitoring Year Four**

**NC Division of Mitigation Services Project Number 92497**

Submitted: March 21, 2016

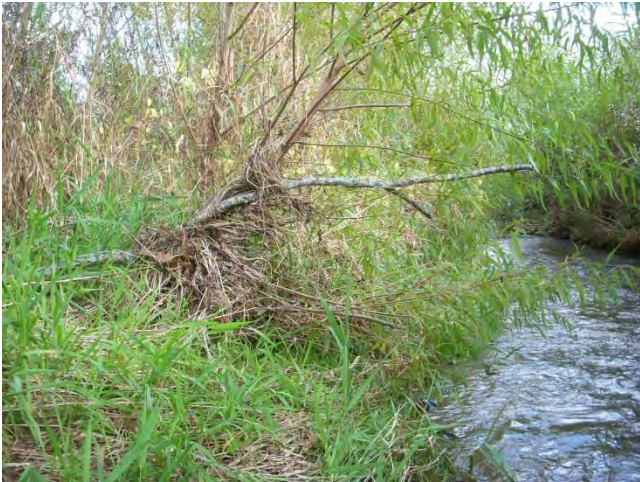
Photo 77. Wrack lines on upstream of mainstem

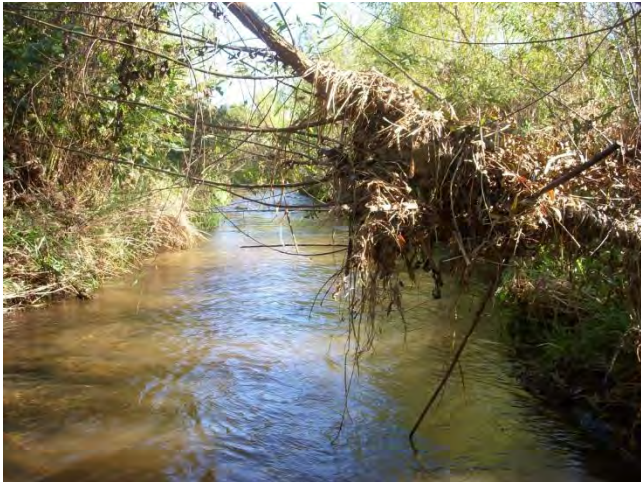
Photo 190. Wrack lines on downstream of mainstem

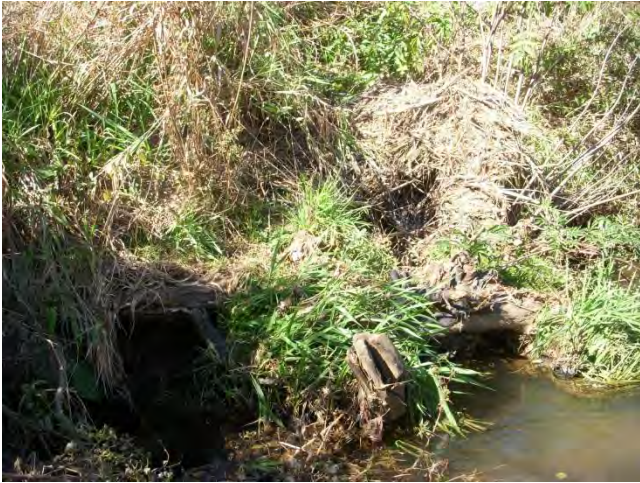
Photo 256. Wrack lines near bottom of mainstem

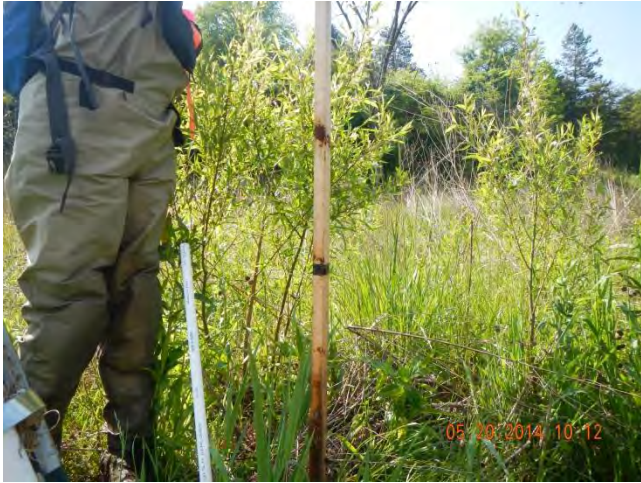
Photo 26. Crest Gauge 1, May 2014

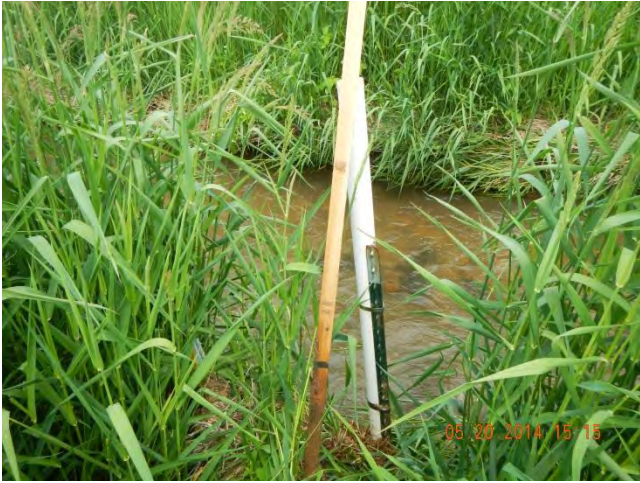
Photo 64. Crest Gauge 2, May 2014

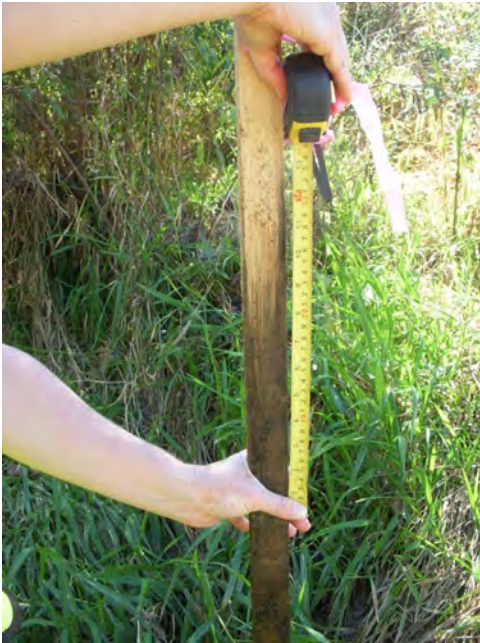
Photo 241. Crest gauge 1, November 2014

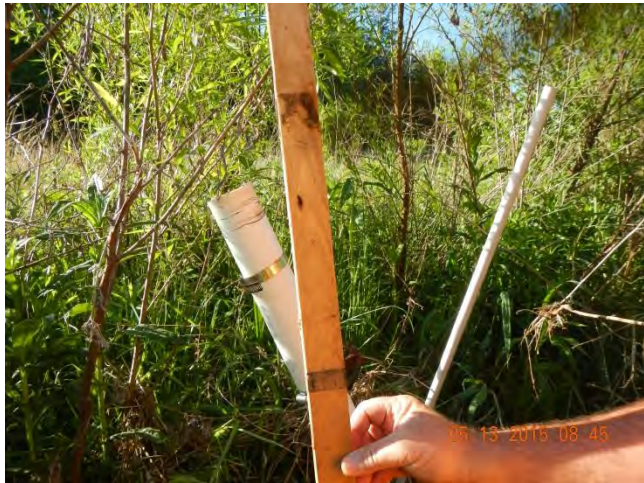
Crest gauge 1, May 2015

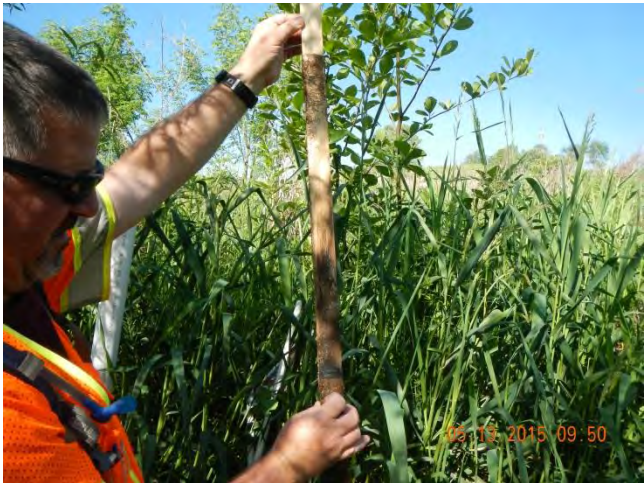
Crest gauge 2, May 2015

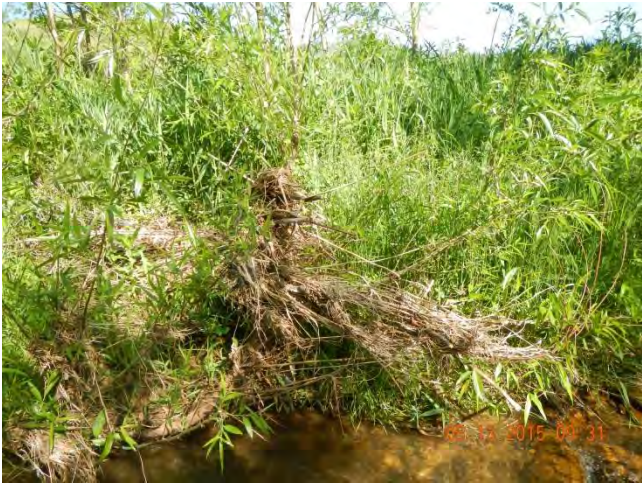
Wrack lines along mainstem, May 2015
