**Newfound Creek Stream Restoration  
2016 Monitoring Report  
Monitoring Year Five**

**NC Division of Mitigation Services Project Number 92497**

Submitted: January 5, 2017

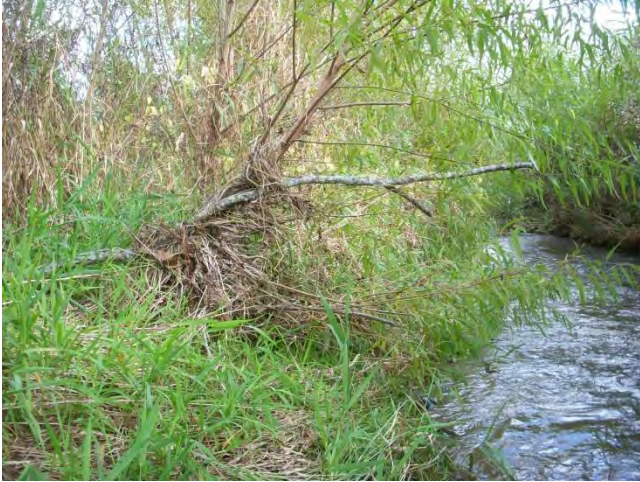
Photo 77. Wrack lines on upstream of mainstem

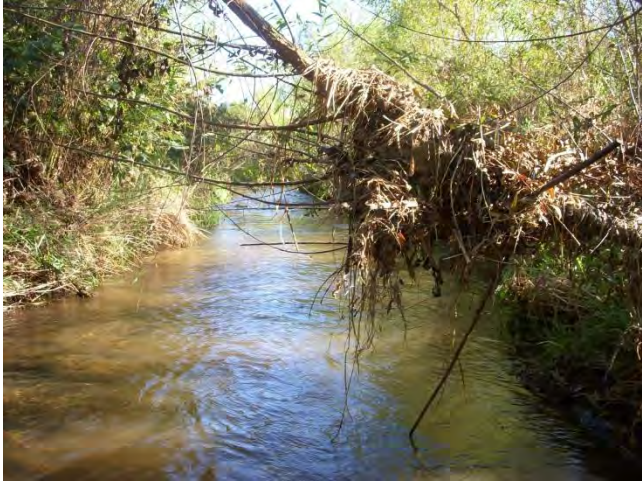
Photo 190. Wrack lines on downstream of mainstem
