**Newtown Stream and Wetland
Restoration Project
Union County, North Carolina
EEP Project #94150**

MY-01 Monitoring Report - Final

Data Collected: October 2011

Ward Consulting Engineers, P.C.
NCBELS Firm #C-2619
8368 Six Forks Road, Suite 104
Raleigh, NC 27615

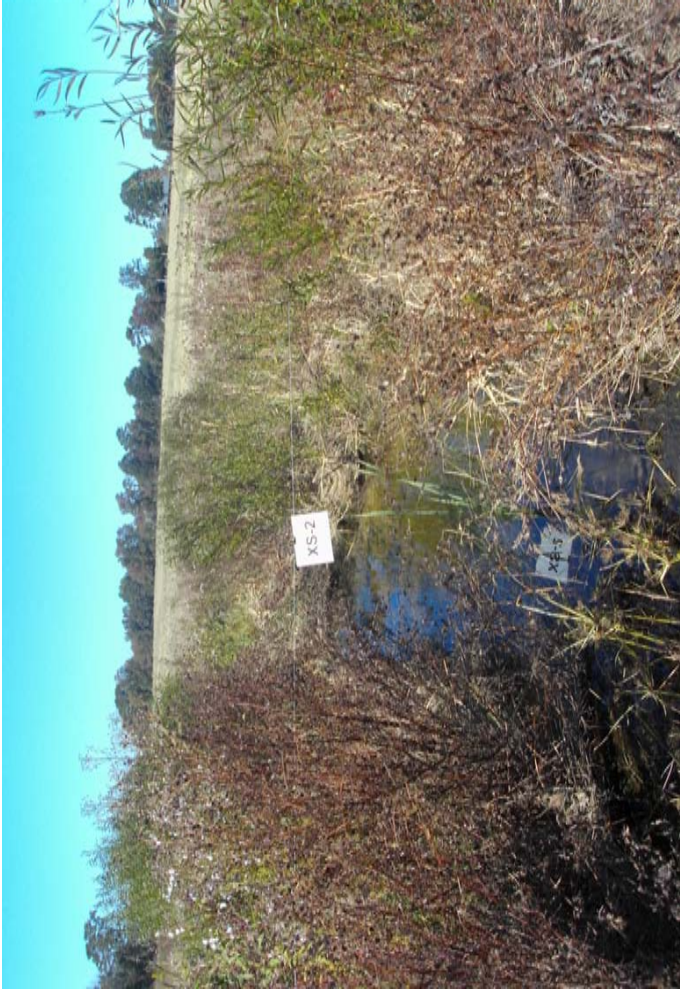
Cross Section 2

Photo of XS-2, looking in the downstream direction

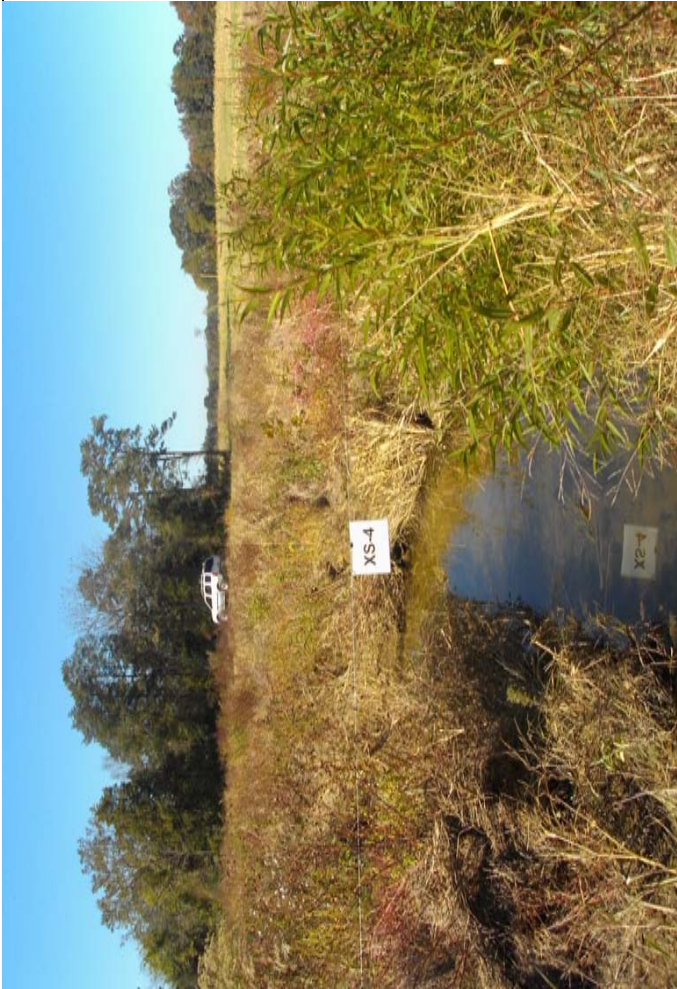
Cross Section 4

Photo of XS-4, looking in the downstream direction

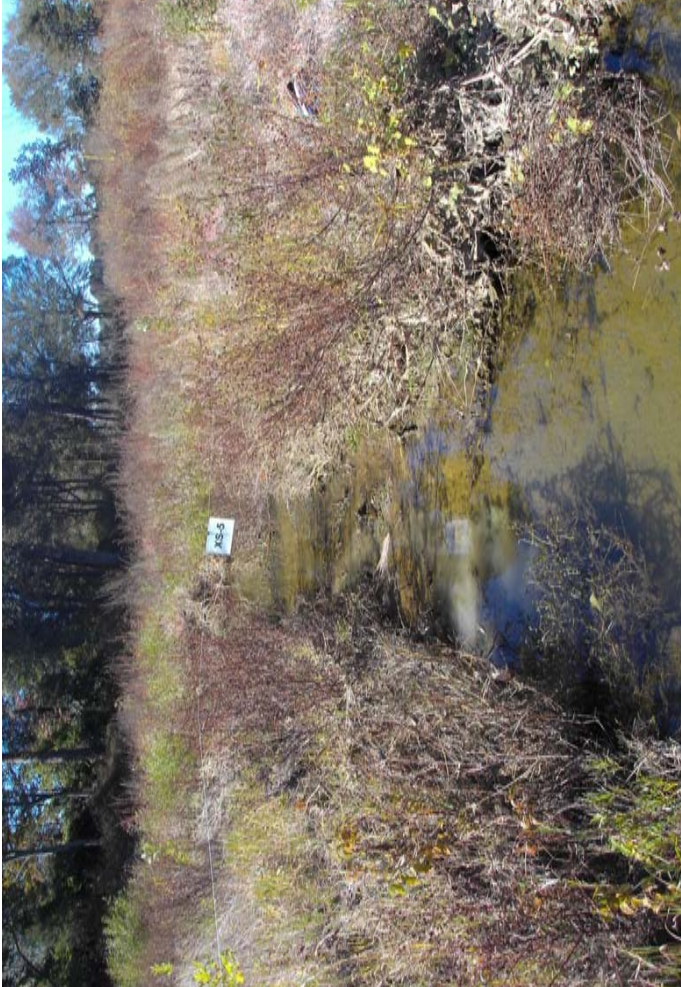
Cross Section 5

Photo of XS-5, looking in the downstream direction

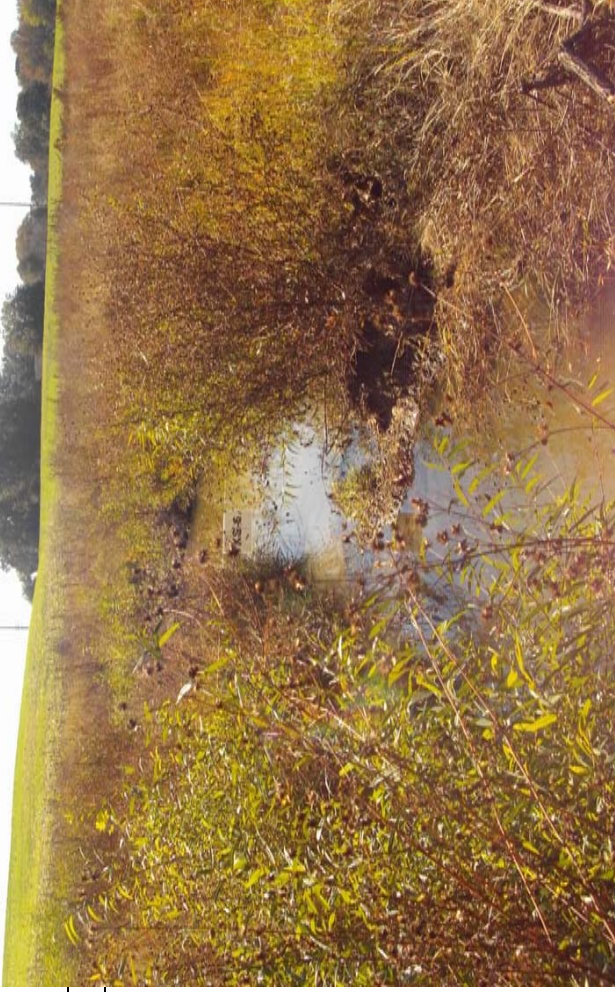
Cross Section 6

Photo of XS-6, looking in the downstream direction

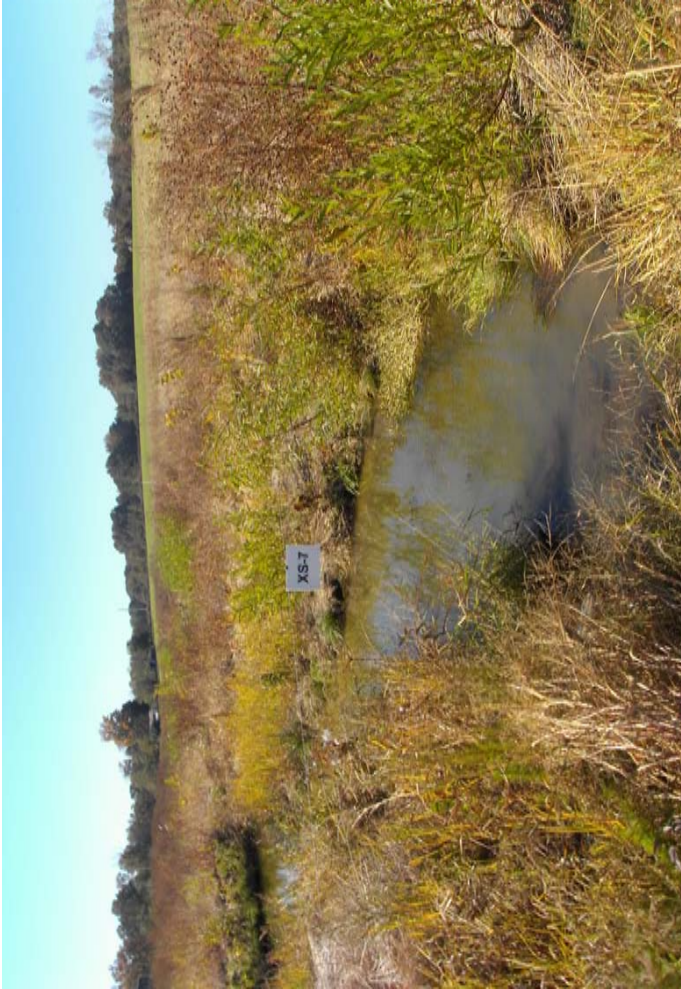
Cross Section 7

Photo of XS-7, looking in the downstream direction

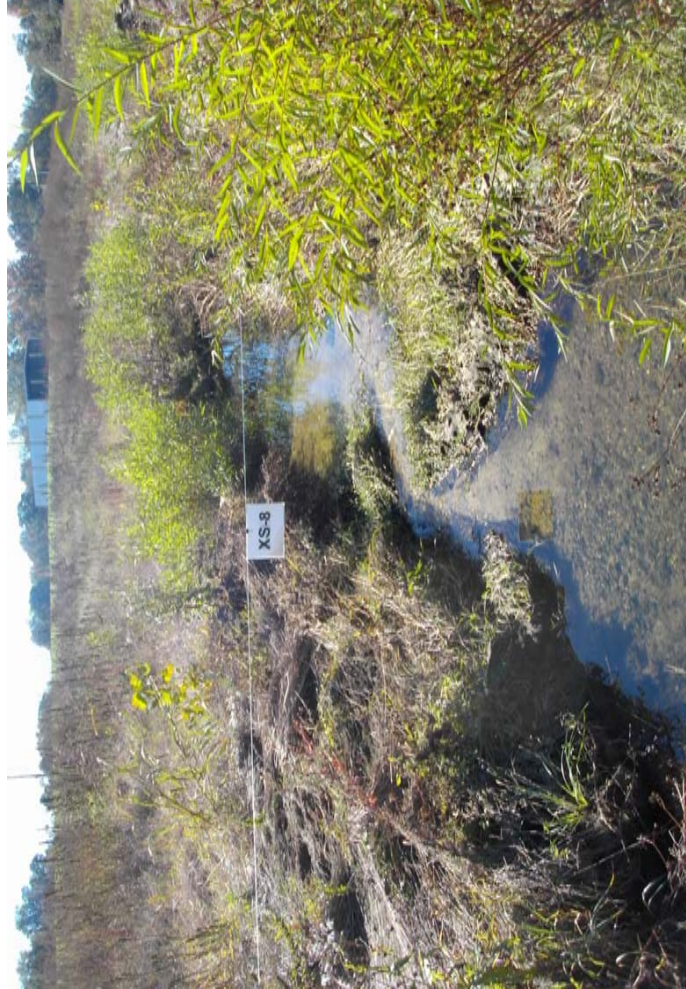
Cross Section 8

Photo of XS-8, looking in the downstream direction

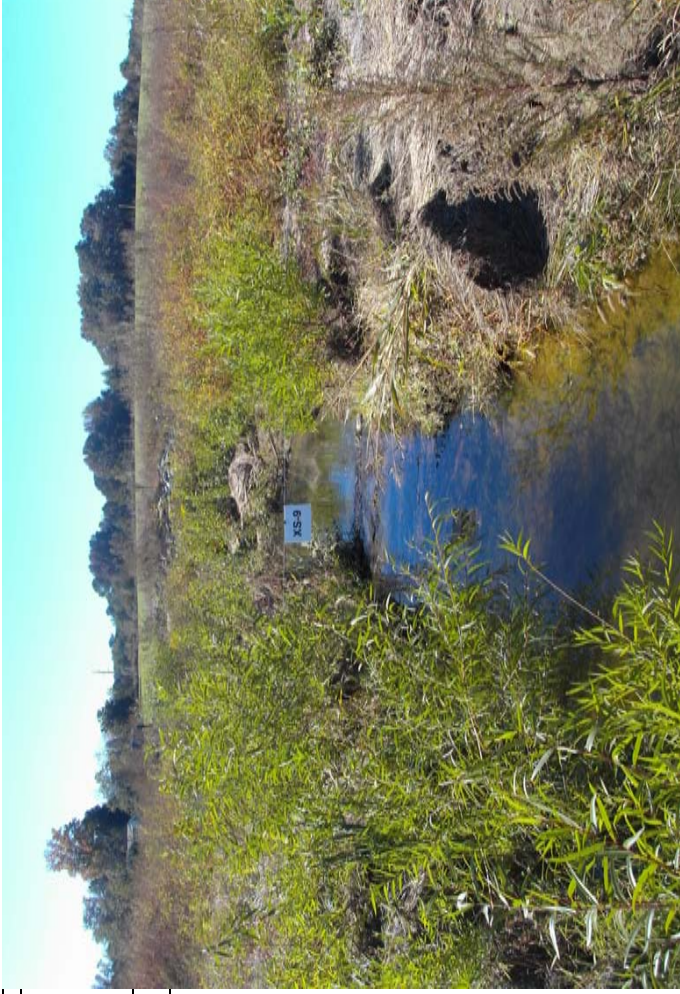
Cross Section 9

Photo of XS-9, looking in the downstream direction

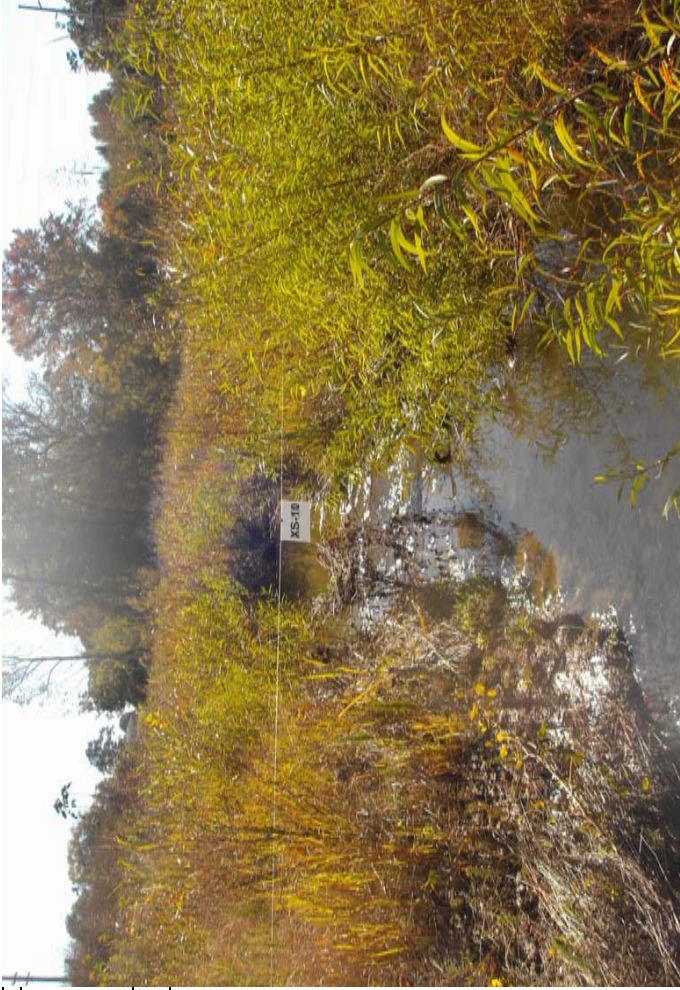
Cross Section 10

Photo of XS-10, looking in the downstream direction

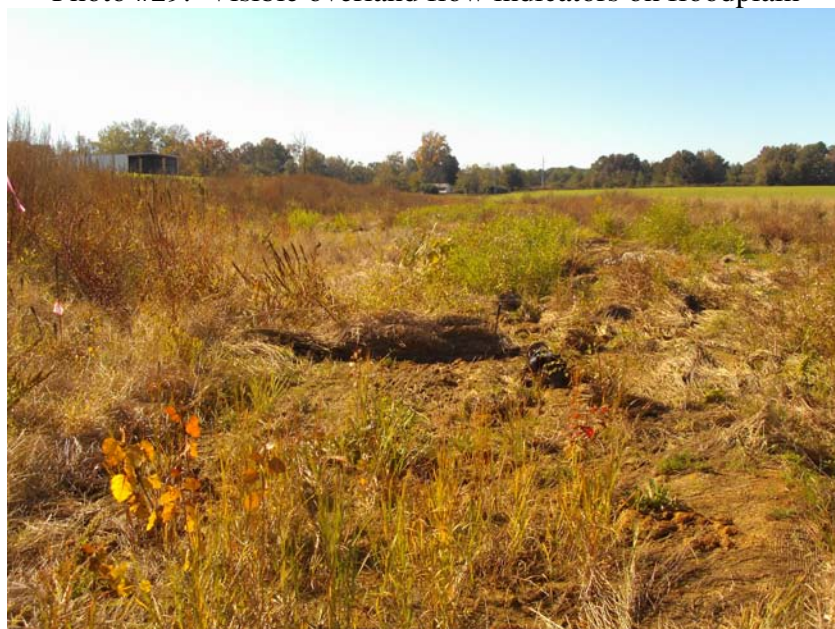
During the data collection site visit on October 25, 2011, visible wrack lines and debris on the floodplain were observed in several locations along the stream.

Photo #30. Wrack on floodplain
