**Newtown Stream and Wetland  
Restoration Project  
Union County, North Carolina  
EEP Project #94150  
Contract No. 002025**

**MY-03 Monitoring Report-Final**

Data Collected: September 2013  
Submitted: November 2013

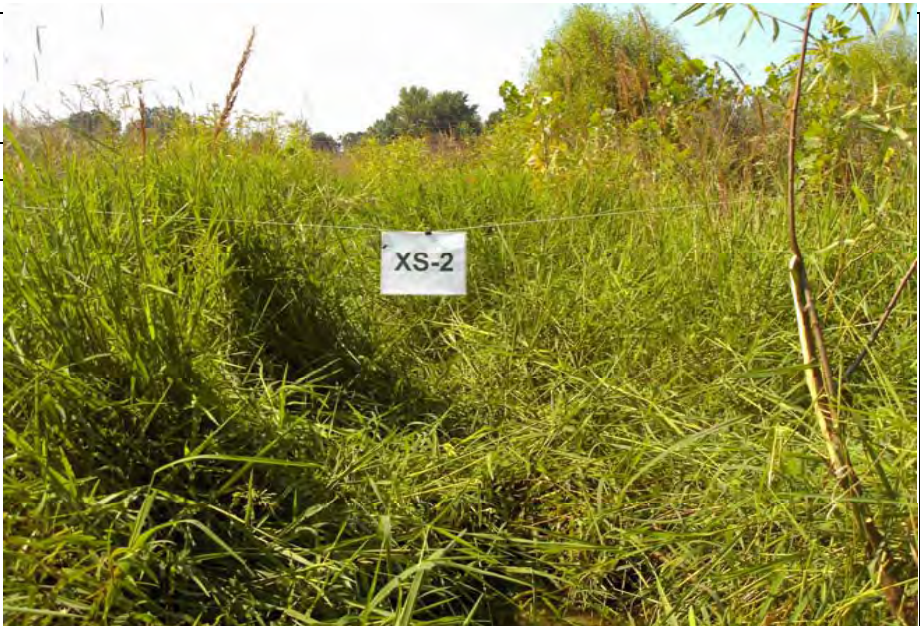
Cross Section 2

Photo of XS-2, looking in the downstream direction

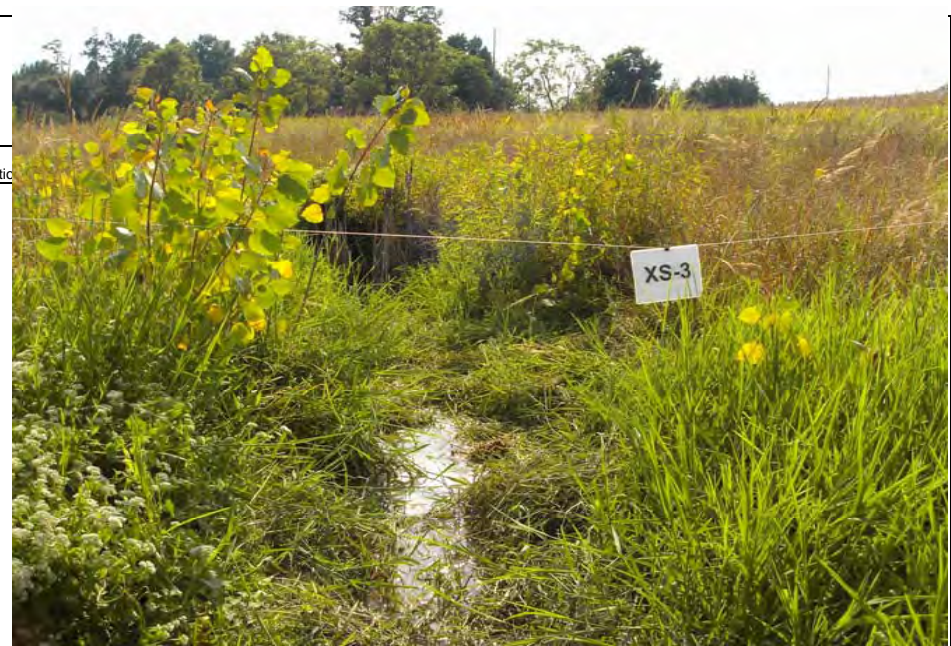
### Cross Section 3

Photo of XS-3 looking in the downstream direction

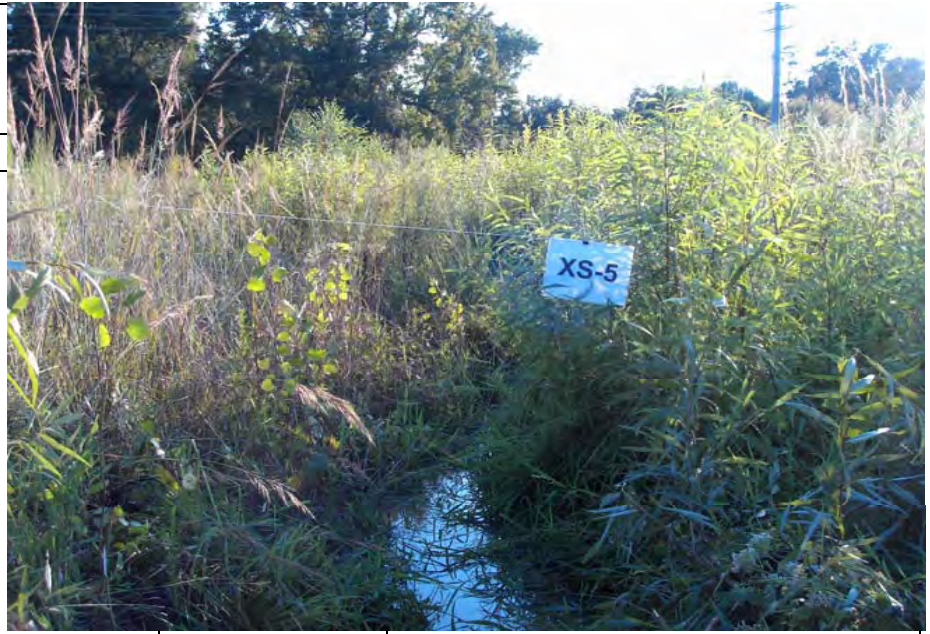
Cross Section 5

Photo of XS-5, looking in the downstream direction

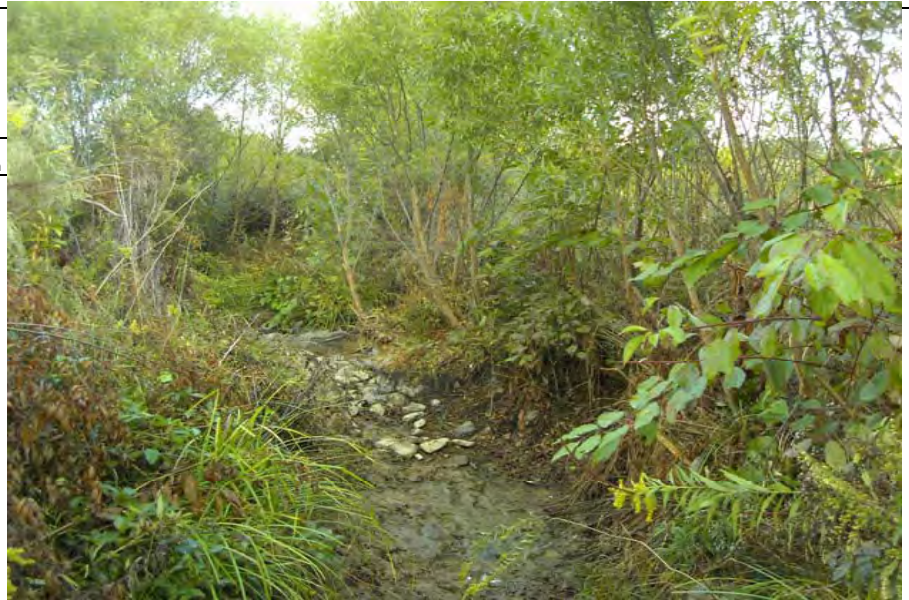
Cross Section 2

Photo of XS-2, looking in the downstream direction

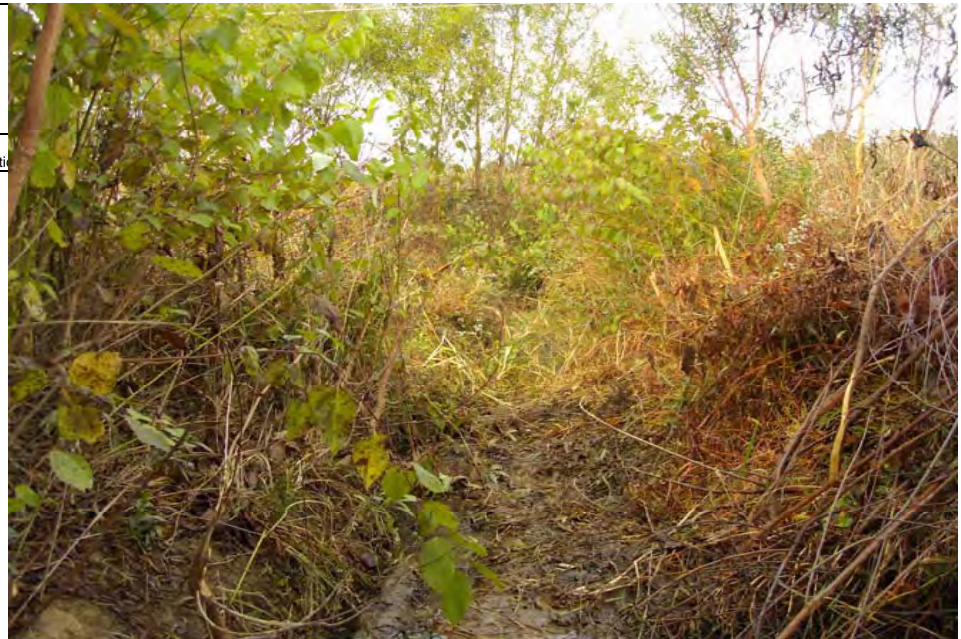
Cross Section 3

Photo of XS-3 looking in the downstream direction

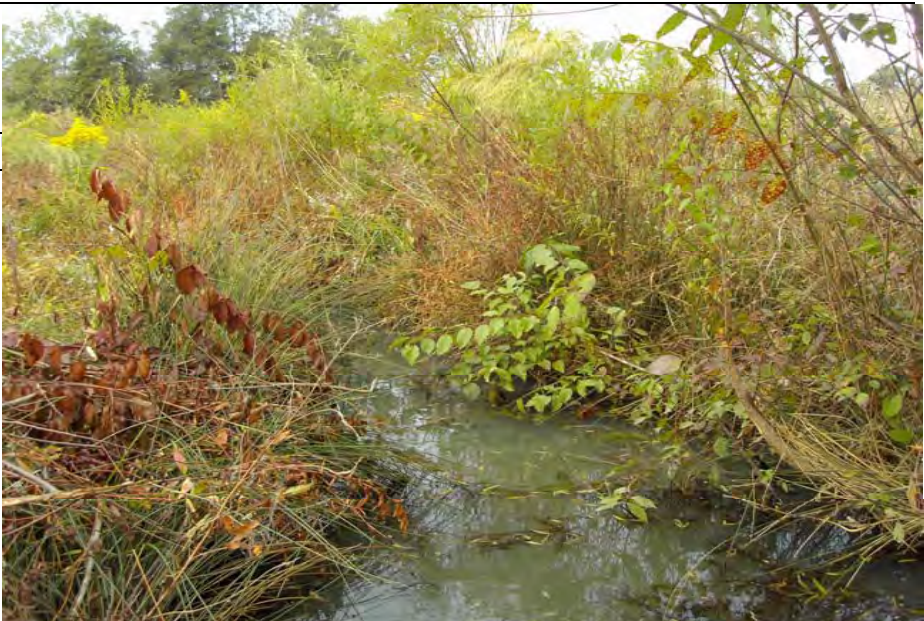
Cross Section 4

Photo of XS-4, looking in the downstream direction

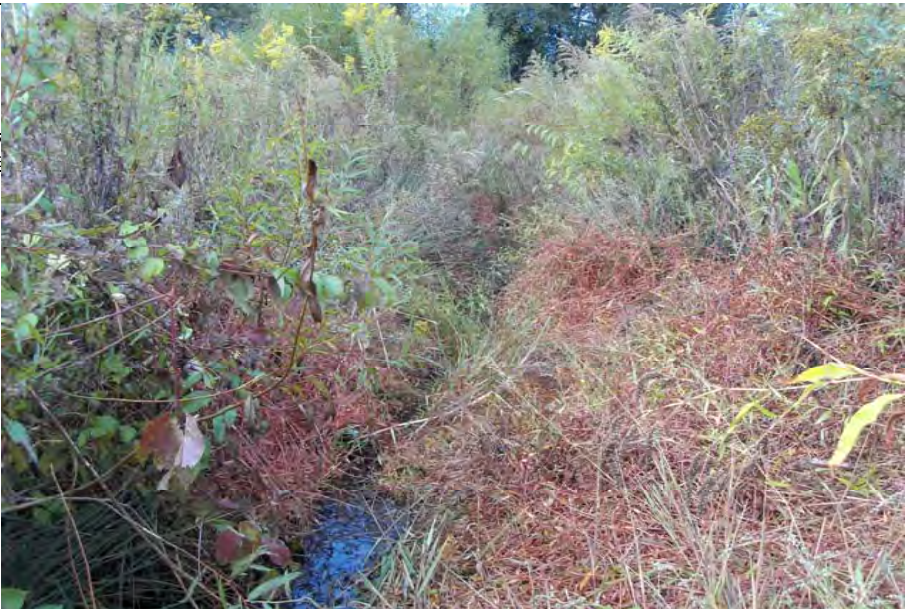
Cross Section 5

Photo of XS-5, looking in the downstream direction

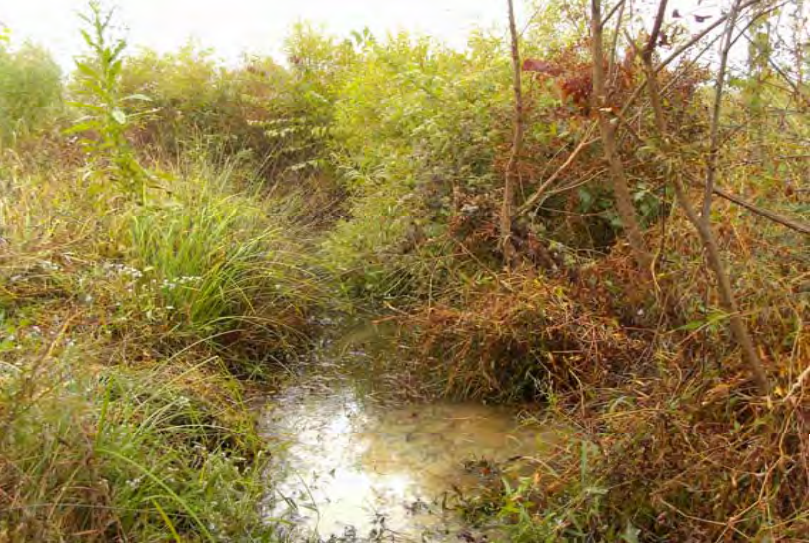
Cross Section 6

Photo of XS-6, looking in the downstream direction

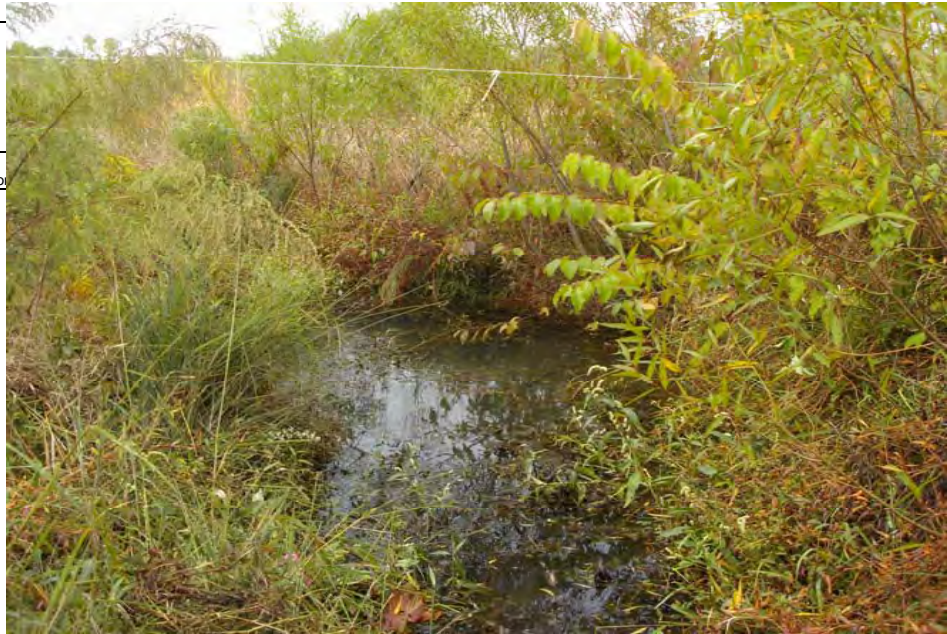
Photo of XS-7, looking in the downstream direction
