**Newtown Stream and Wetland  
Restoration Project  
Union County, North Carolina  
DMS Project #94150  
Contract No. 002025**

**MY-05 Monitoring Report**

Data Collected: March & June 2015

Submitted: December 2015

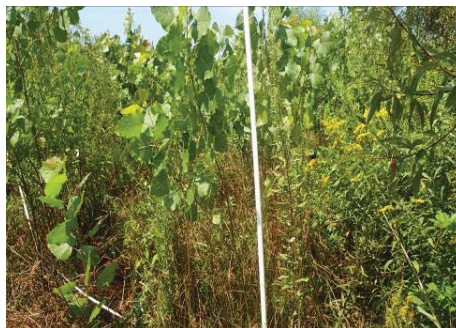
**Veg Plot 4**

While all the vegetation plots combined meet the criteria for total planted stems, planted stem counts for plots 4, 6, 8, and 11 were below the threshold requirements of 260 stems (Table 7). Plots 4, 6, and 8 exceeded the stem density requirements when including natural stems. Volunteers observed within the plot 4 and 7 were eastern cottonwood (*Populus deltoides*) trees. Eastern cottonwood is abundant throughout the vicinity of the stream confluence and is sporadically abundant throughout the stream buffer corridor. Volunteers observed within plot 8 include eastern silverling (*Baccharus halimifolia*) which was observed scattered in the vicinity of plot 8. Other volunteer species observed within the conservation easement were black willow (*Salix nigra*), eastern sugarberry (*Celtis laevigata*), winged sumac (*Rhus copallinum*), and slippery elm (*Ulmus rubra*). Volunteer species densities are low within plots 6 and 11. Plot 6 is located in an area where wetland hydrology is present providing optimal conditions for a dominant herbaceous layer that outcompeted the woody plantings resulting in the low stem density. Planted species surviving within Plot 6 are river birch (*Betula nigra*), button bush (*Cephalanthus occidentalis*), green ash (*Fraxinus pennsylvanica*), and swamp chestnut oak (*Quercus michauxii*). One volunteer box elder was observed within Plot 6. Plot 11 is located within an area where the herbaceous layer is relatively sparse and conditions are dryer. Planted species surviving are persimmon (*Diospyros virginiana*), swamp chestnut oak, and silky dogwood. No volunteer stems were observed.

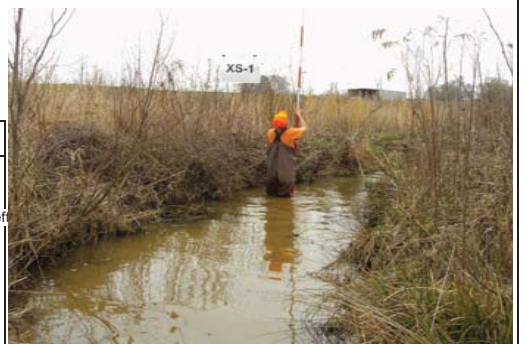
Cross Section 1

Photo of XS-1, looking in the downstream direction

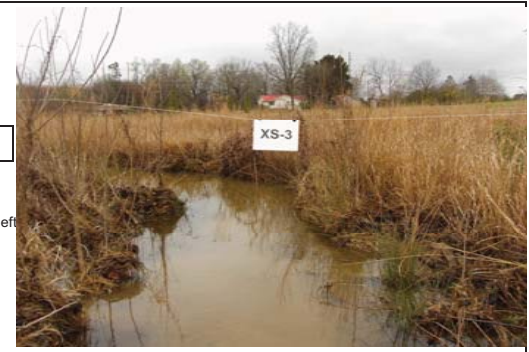
Cross Section 3

Photo of XS-3 looking in the downstream direction

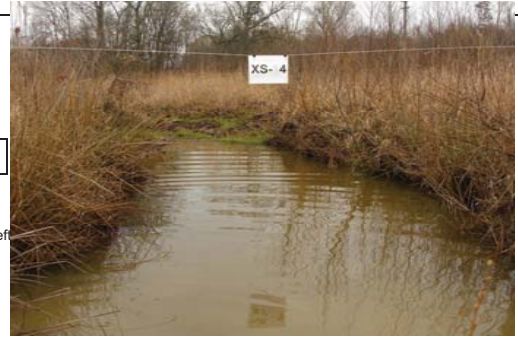
**Cross Section 4**

Photo of XS-4, looking in the downstream direction

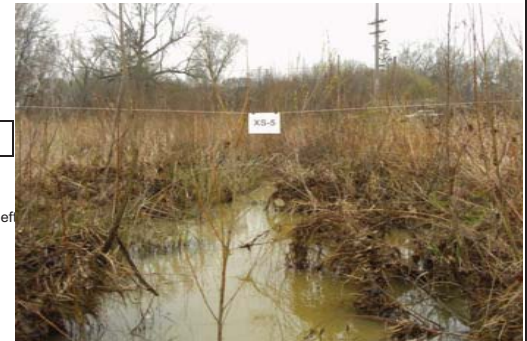
Cross Section 5

Photo of XS-5, looking in the downstream direction

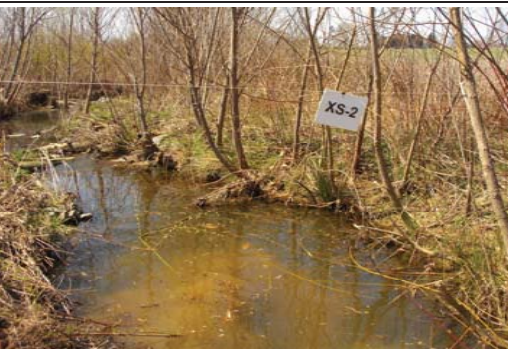
Cross Section 2

Photo of XS-2, looking in the downstream direction

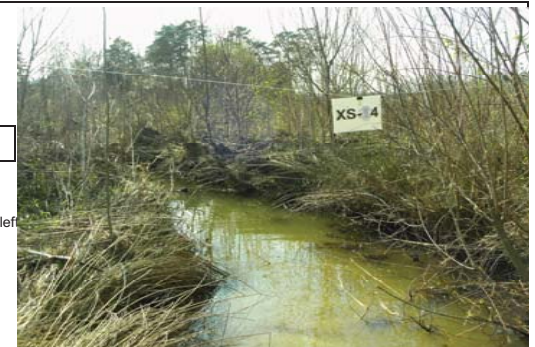
Cross Section 4

Photo of XS-4, looking in the downstream direction

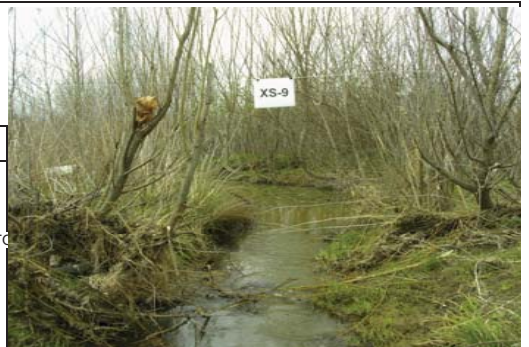
Cross Section 9

Photo of XS-9, looking in the downstream direction
