**MONITORING YEAR 1
ANNUAL REPORT**
Final

NORKETT BRANCH STREAM MITIGATION SITE
Union County, NC
DENR Contract 004673
NCEEP Project Number 95360

Data Collection Period: September 2014-October 2014
Draft Submission Date: December 17, 2014
Final Submission Date: January 13, 2015

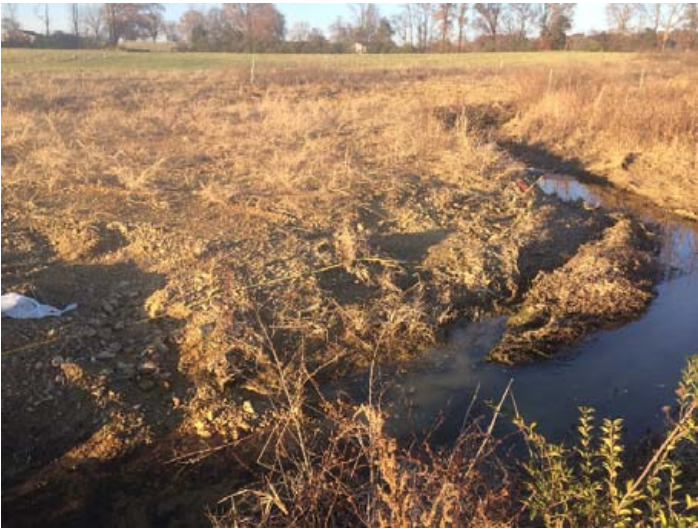
AOC-1: Bare bank on UT2 Reach 3B left bank, 12-1-2014

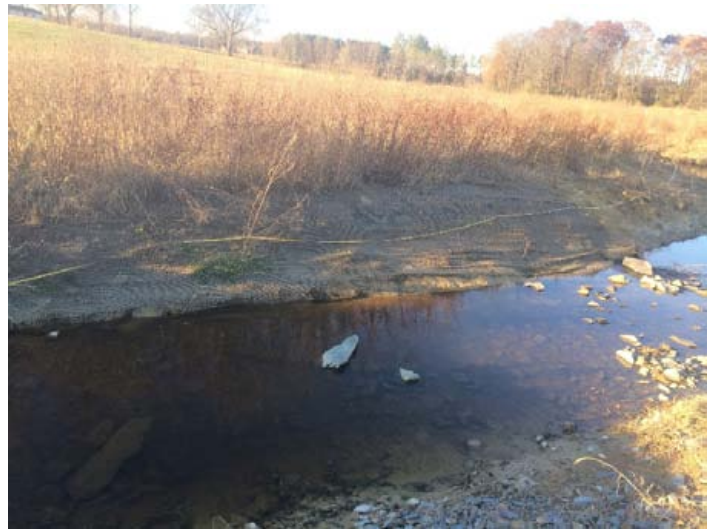
AOC-4; Bare bank Norkett Branch Reach 2 left bank, 12-1-2014

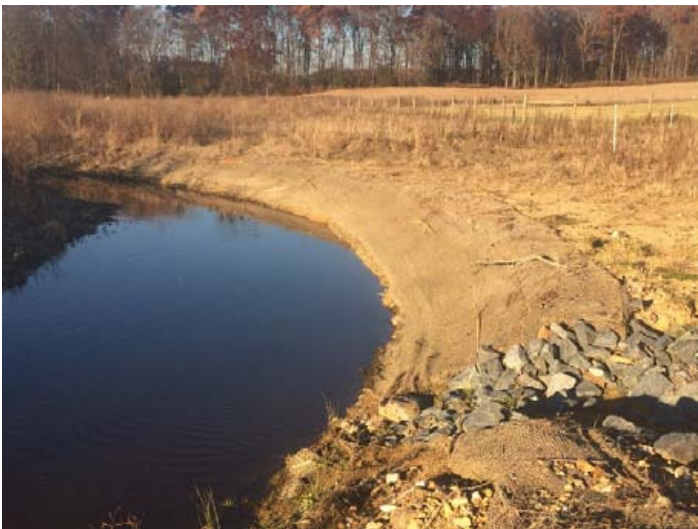
AOC-5: Bare bank Norkett Branch Reach 2 right bank, 12-1-2014
