MONITORING YEAR 5 ANNUAL REPORT

NORKETT BRANCH STREAM MITIGATION SITE

Union County, NC
DEQ Contract 004673
DMS Project Number 95360

Data Collection Period: June - October 2018
Final Submission Date: December 12, 2018

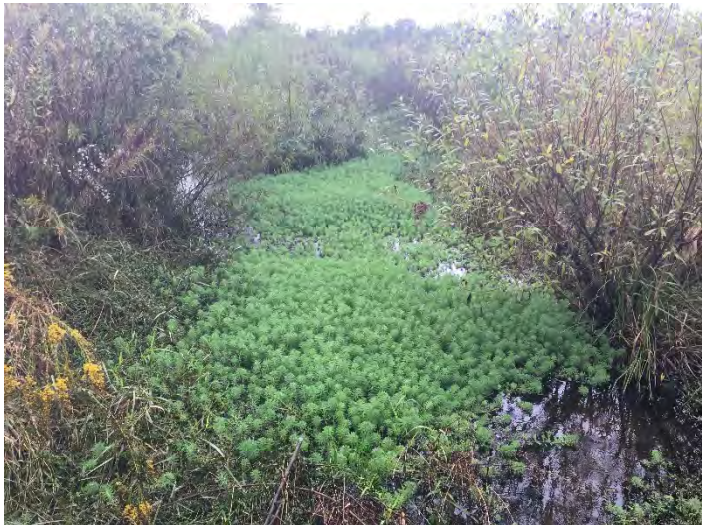
Invasive Plant Population (Parrotfeather) – 10/17/2018

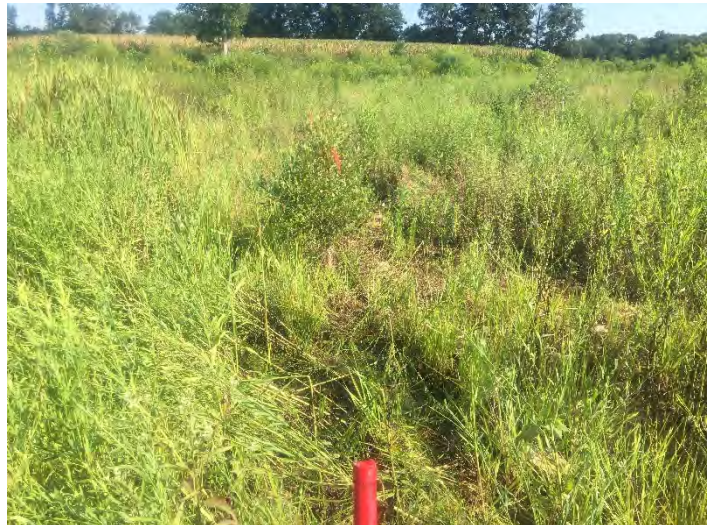
Poor Woody Growth Norkett Branch – 10/17/2018
