MONITORING YEAR 7 ANNUAL REPORT Final

NORKETT BRANCH STREAM MITIGATION SITE

Union County, NC
DEQ Contract 004673
DMS Project Number 95360
USACE Action ID Number 2012-01082
NCDWR Project Number 13-0250

Data Collection Period: March – November 2020
Final Submission Date: January 19, 2021

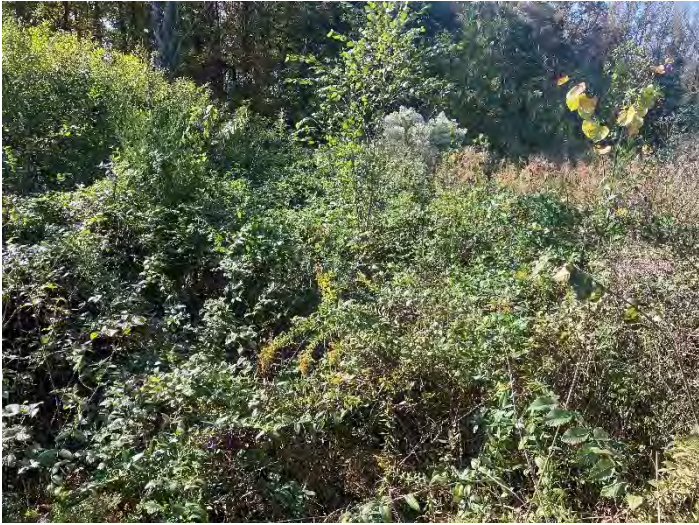
Invasive Plant Population (Japanese Honeysuckle) – UT2 Reach 3A
11/3/2020

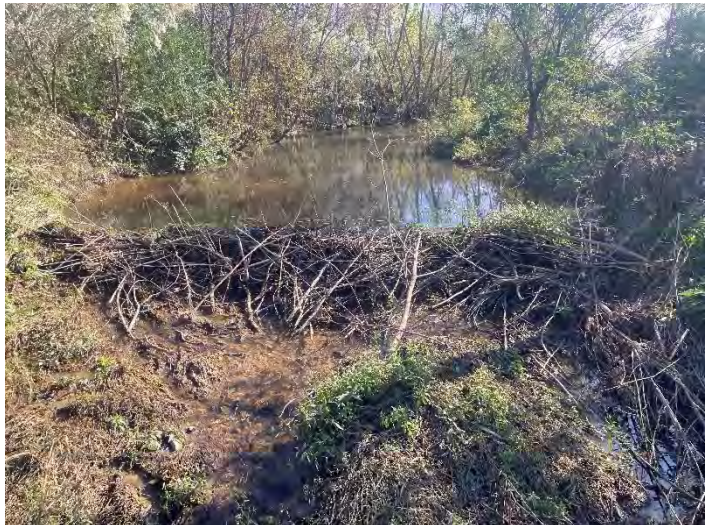
Beaver Dam – Norkett Branch Reach 2
11/3/2020

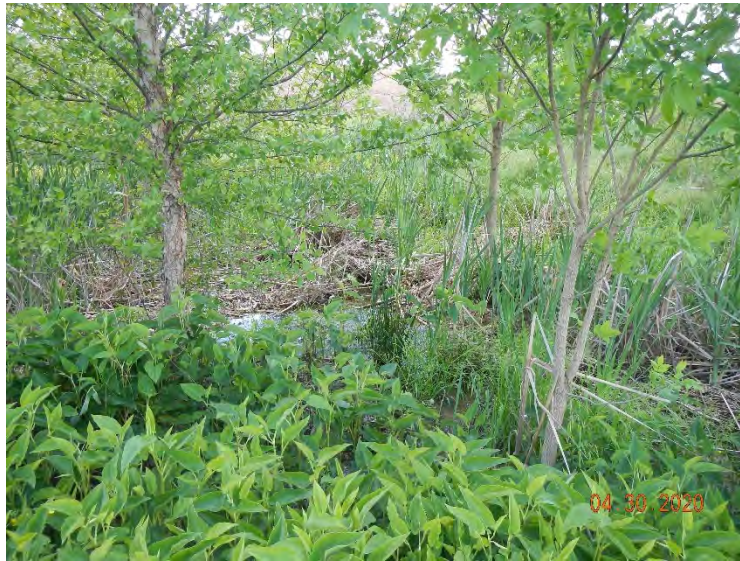
BH – 1 (Vicinity)

Depth (Inches)	Matrix Color	Redox Color	Texture	Notes
0 – 3	10 YR 4/2 (100%)	N/A	Silt loam	No redox, organic materials common
3 – 9	10 YR 5/2 (75%)	5YR 5/6 (25%)	Silt loam	Meets F3 indicator
9 - 13	10 YR 5/2 (85%)	5YR 5/6 (15%)	Silt loam

Hydrology indicators present: Inundation (1”), saturation (4”), iron oxidizing bacteria, drift deposits

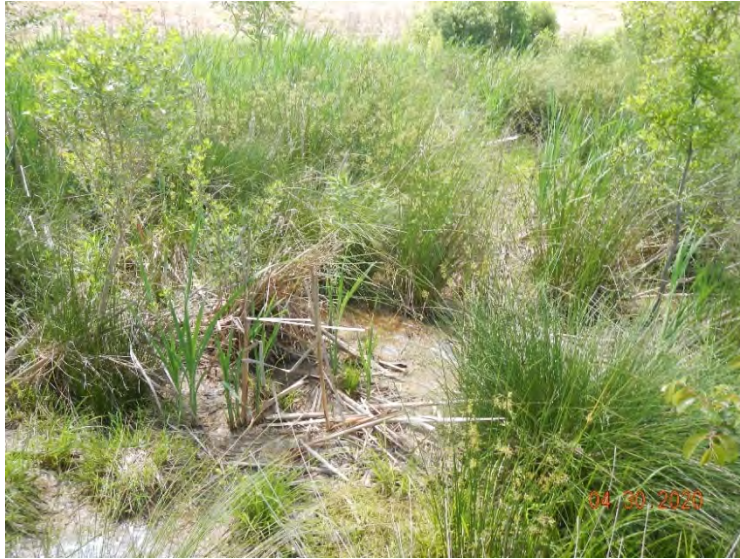
BH – 2 (Vicinity photo / No soil boring photo taken)

BH – 2 (Very similar soils and hydrology to BH -1)

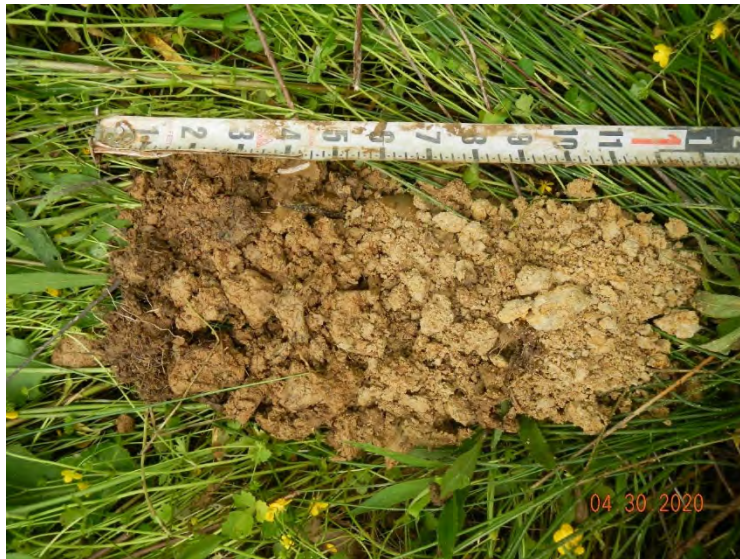
BH - 3 (No vicinity photo taken)

Depth (Inches)	Matrix Color	Redox Color	Texture	Notes
0 - 2	10 YR 4/3 (100%)	N/A	Silt loam	No redox
2 - 7	10 YR 5/3 (80%)	5YR 4/6 (20%)	Silt loam	
7 - 13	2.5Y 7/2 (75%)	10YR 6/6 (25%)	Silt loam	Meets F3 indicator

Hydrology indicators present: Drift deposits

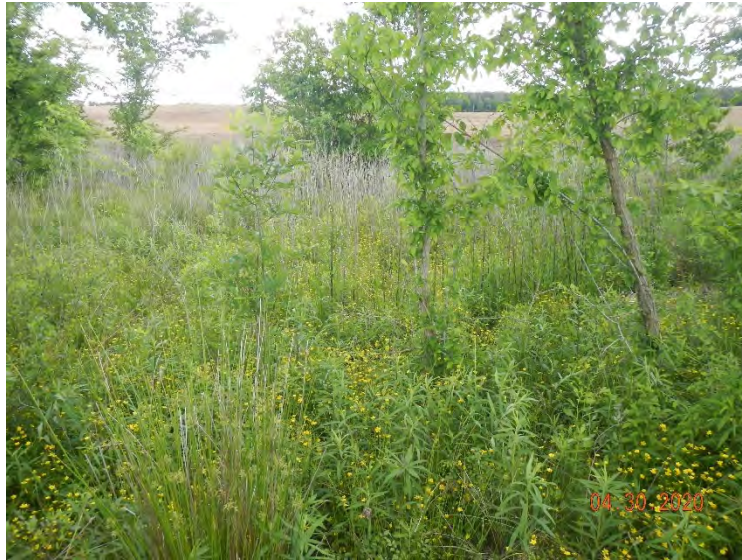
BH – 4 (Vicinity)

Depth (Inches)	Matrix Color	Redox Color	Texture	Notes
0 – 3	10 YR 5/2 (90%)	5YR 4/6 (10%)	Silt loam	Meets F3 indicator
3 – 8	2.5Y 7/2 (70%)	10YR 5/6 (30%)	Loam	Meets F3 indicator
8 – 13	10YR 6/2 (70%)	10YR 5/6 (30%)	Loam

Hydrology indicators present: Drift deposits
