Annual Monitoring Report

Monitoring Year 7 of 7

North Fork Mountain Creek Stream and Wetland Restoration Site

NCDMS Project No.: 94151

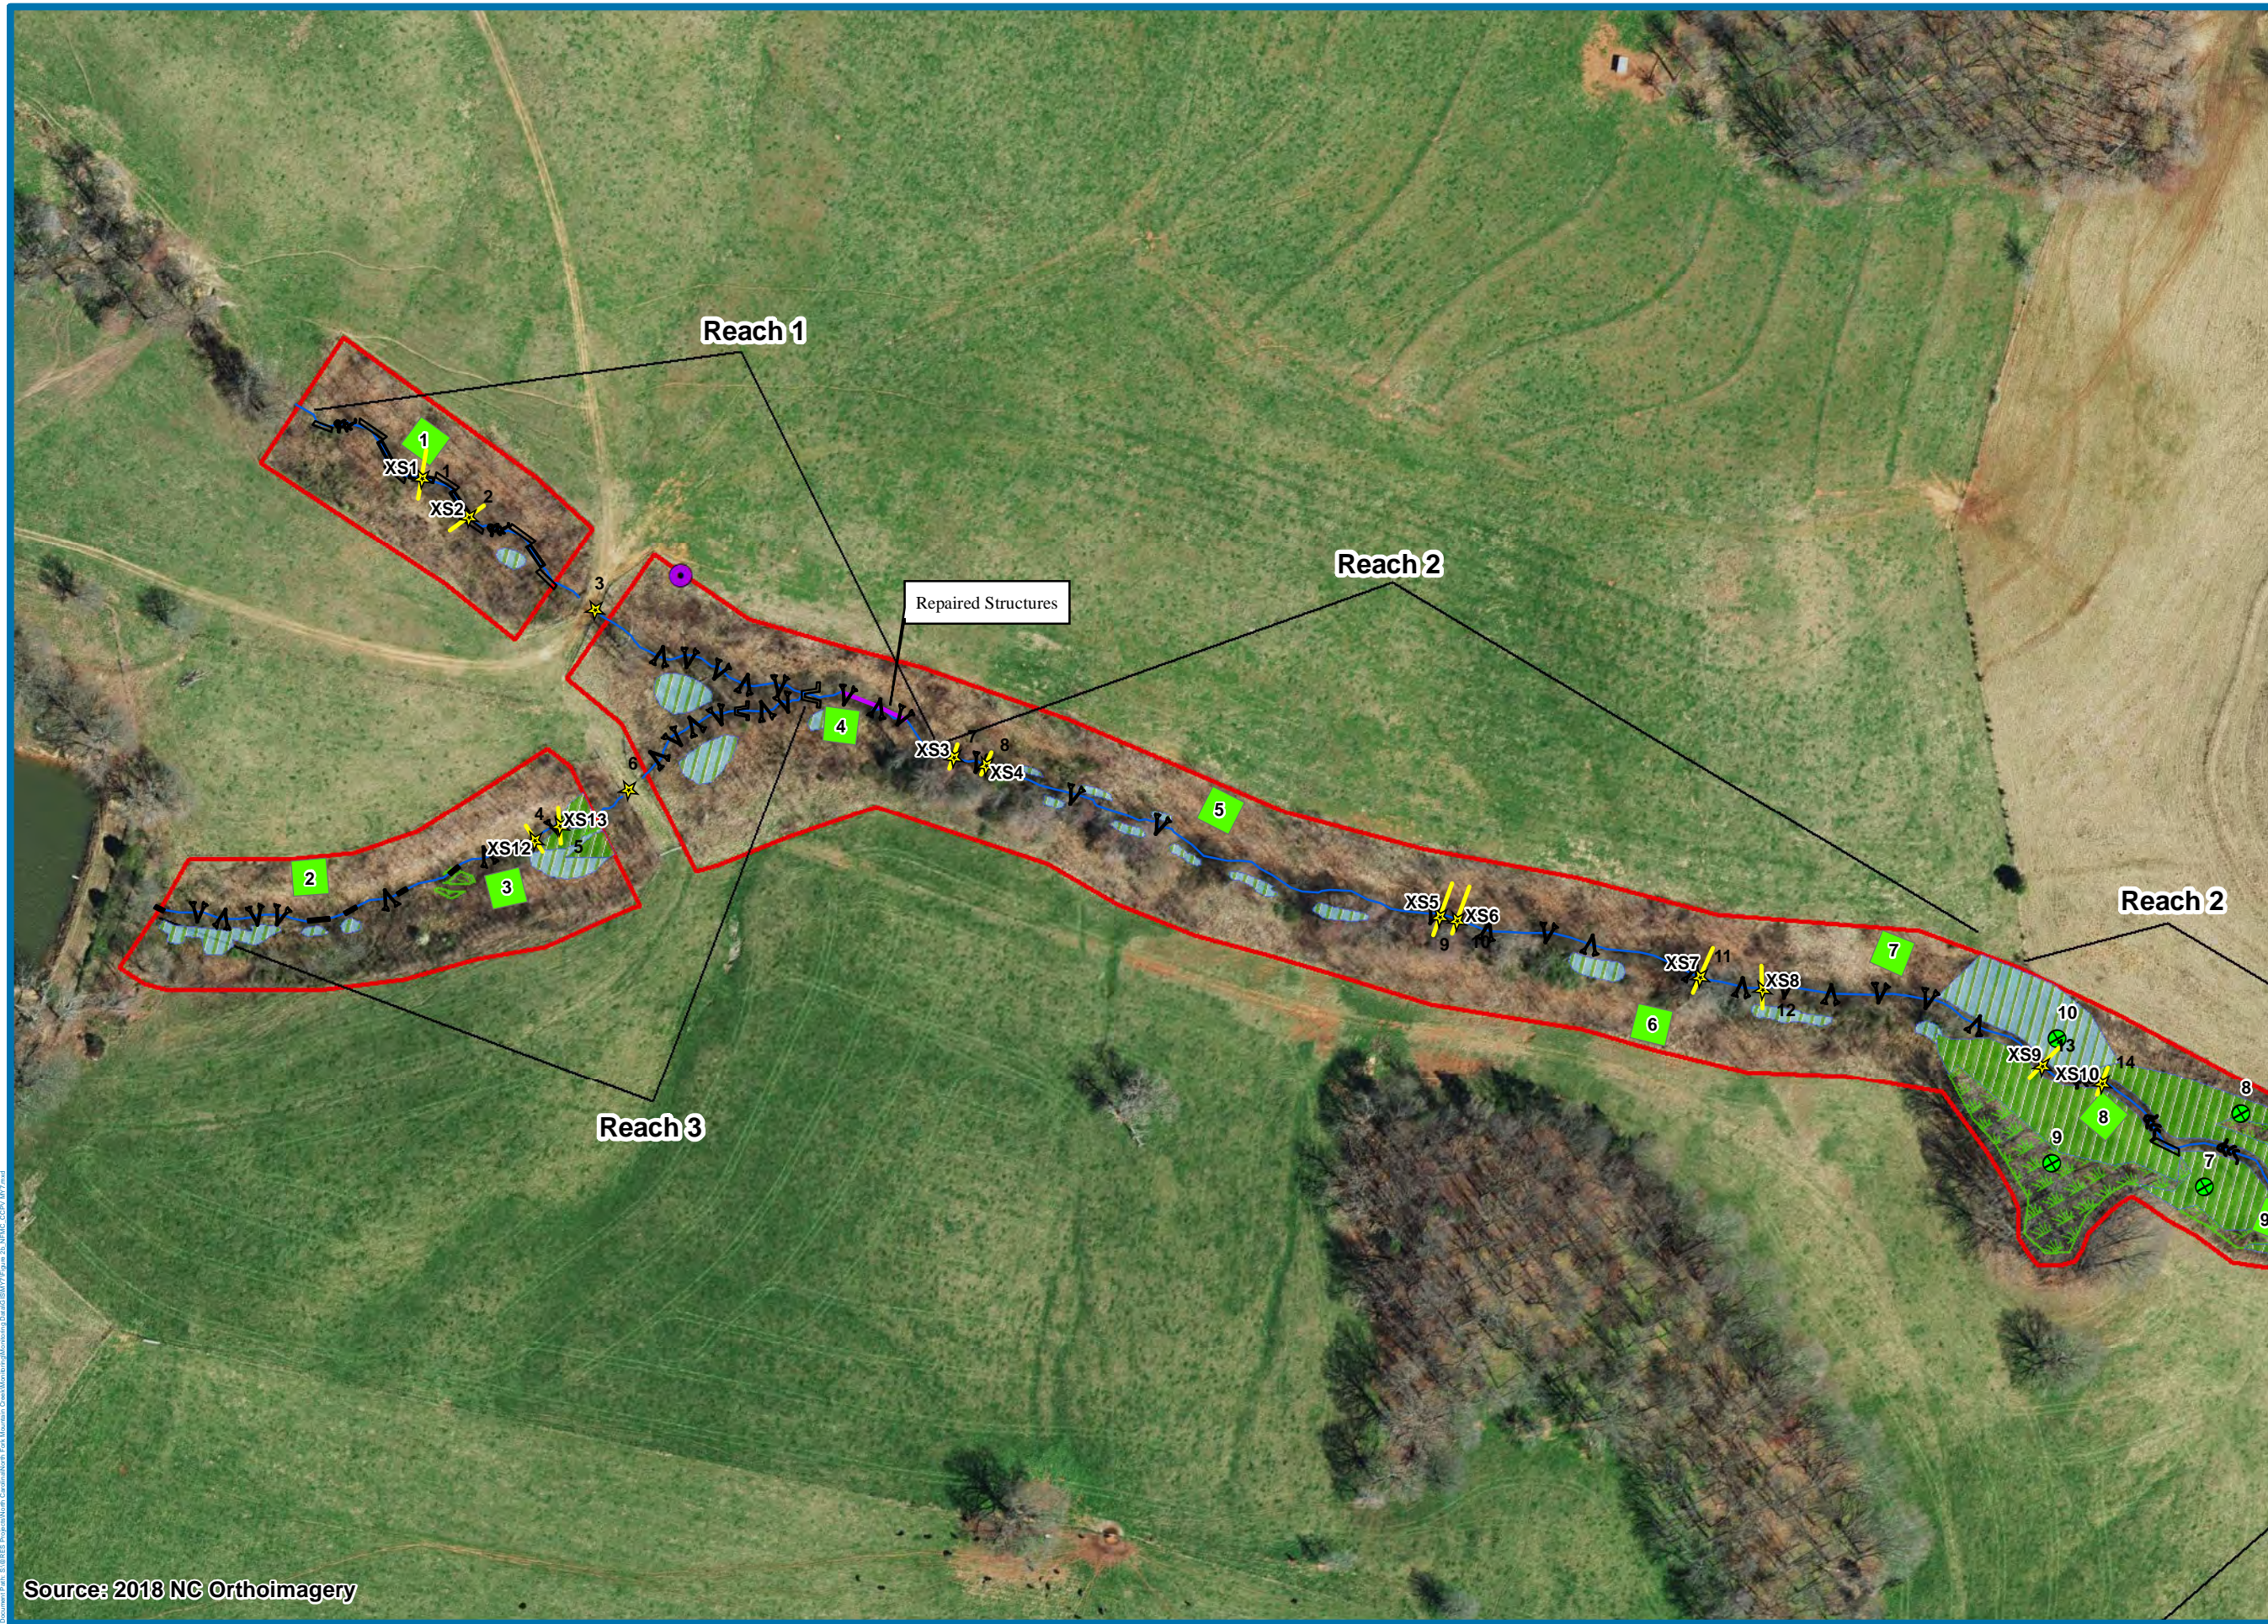
Figure 2b.
NFMC
Stream & Wetland
Restoration Project
MY7 2018

In May 2018, RES joined NCDMS on site to determine the severity of the problem areas reported in previous years. It was determined that the two potential problems on site are the series of stressed structures on Reach 1 (**Figure 2, Table 4a**) and a stretch of bed degradation on Reach 4. The issue with the stressed structures was water piping under and around the structures. This was causing bed and bank instability. The stressed structures were hand repaired in November 2018. RES used a mixture of gravel and bentonite pellets to plug only the area where the water was routing between the structures and piping under them. The structure where the water was cutting around into the bank, was removed and the eroded bank was armored with coir logs, soil, matting, and livestakes. The area of bed degradation on Reach 4 is confined between two grade control structures. Based on the mature vegetation, RES decided that utilizing heavy equipment to stabilize this small section (130 ft), would result in more damage than benefit to the project. Additionally, the MY7 cross morphology data shows that XS21 has equalized and matches closely to the baseline/MY1 cross section. The vegetation problem areas noted in previous years have been resolved in MY7. The areas of poor growth have improved, and the invasive species areas were treated again in August 2018.

A more detailed description of the repair has been added to the report: “The stressed structures were hand repaired in November 2018. RES used a mixture of gravel and bentonite pellets to plug only the area where the water was routing between the structures and piping under them. The structure where the water was cutting around into the bank, was removed and the eroded bank was armored with coir logs, soil, matting, and livestock.”

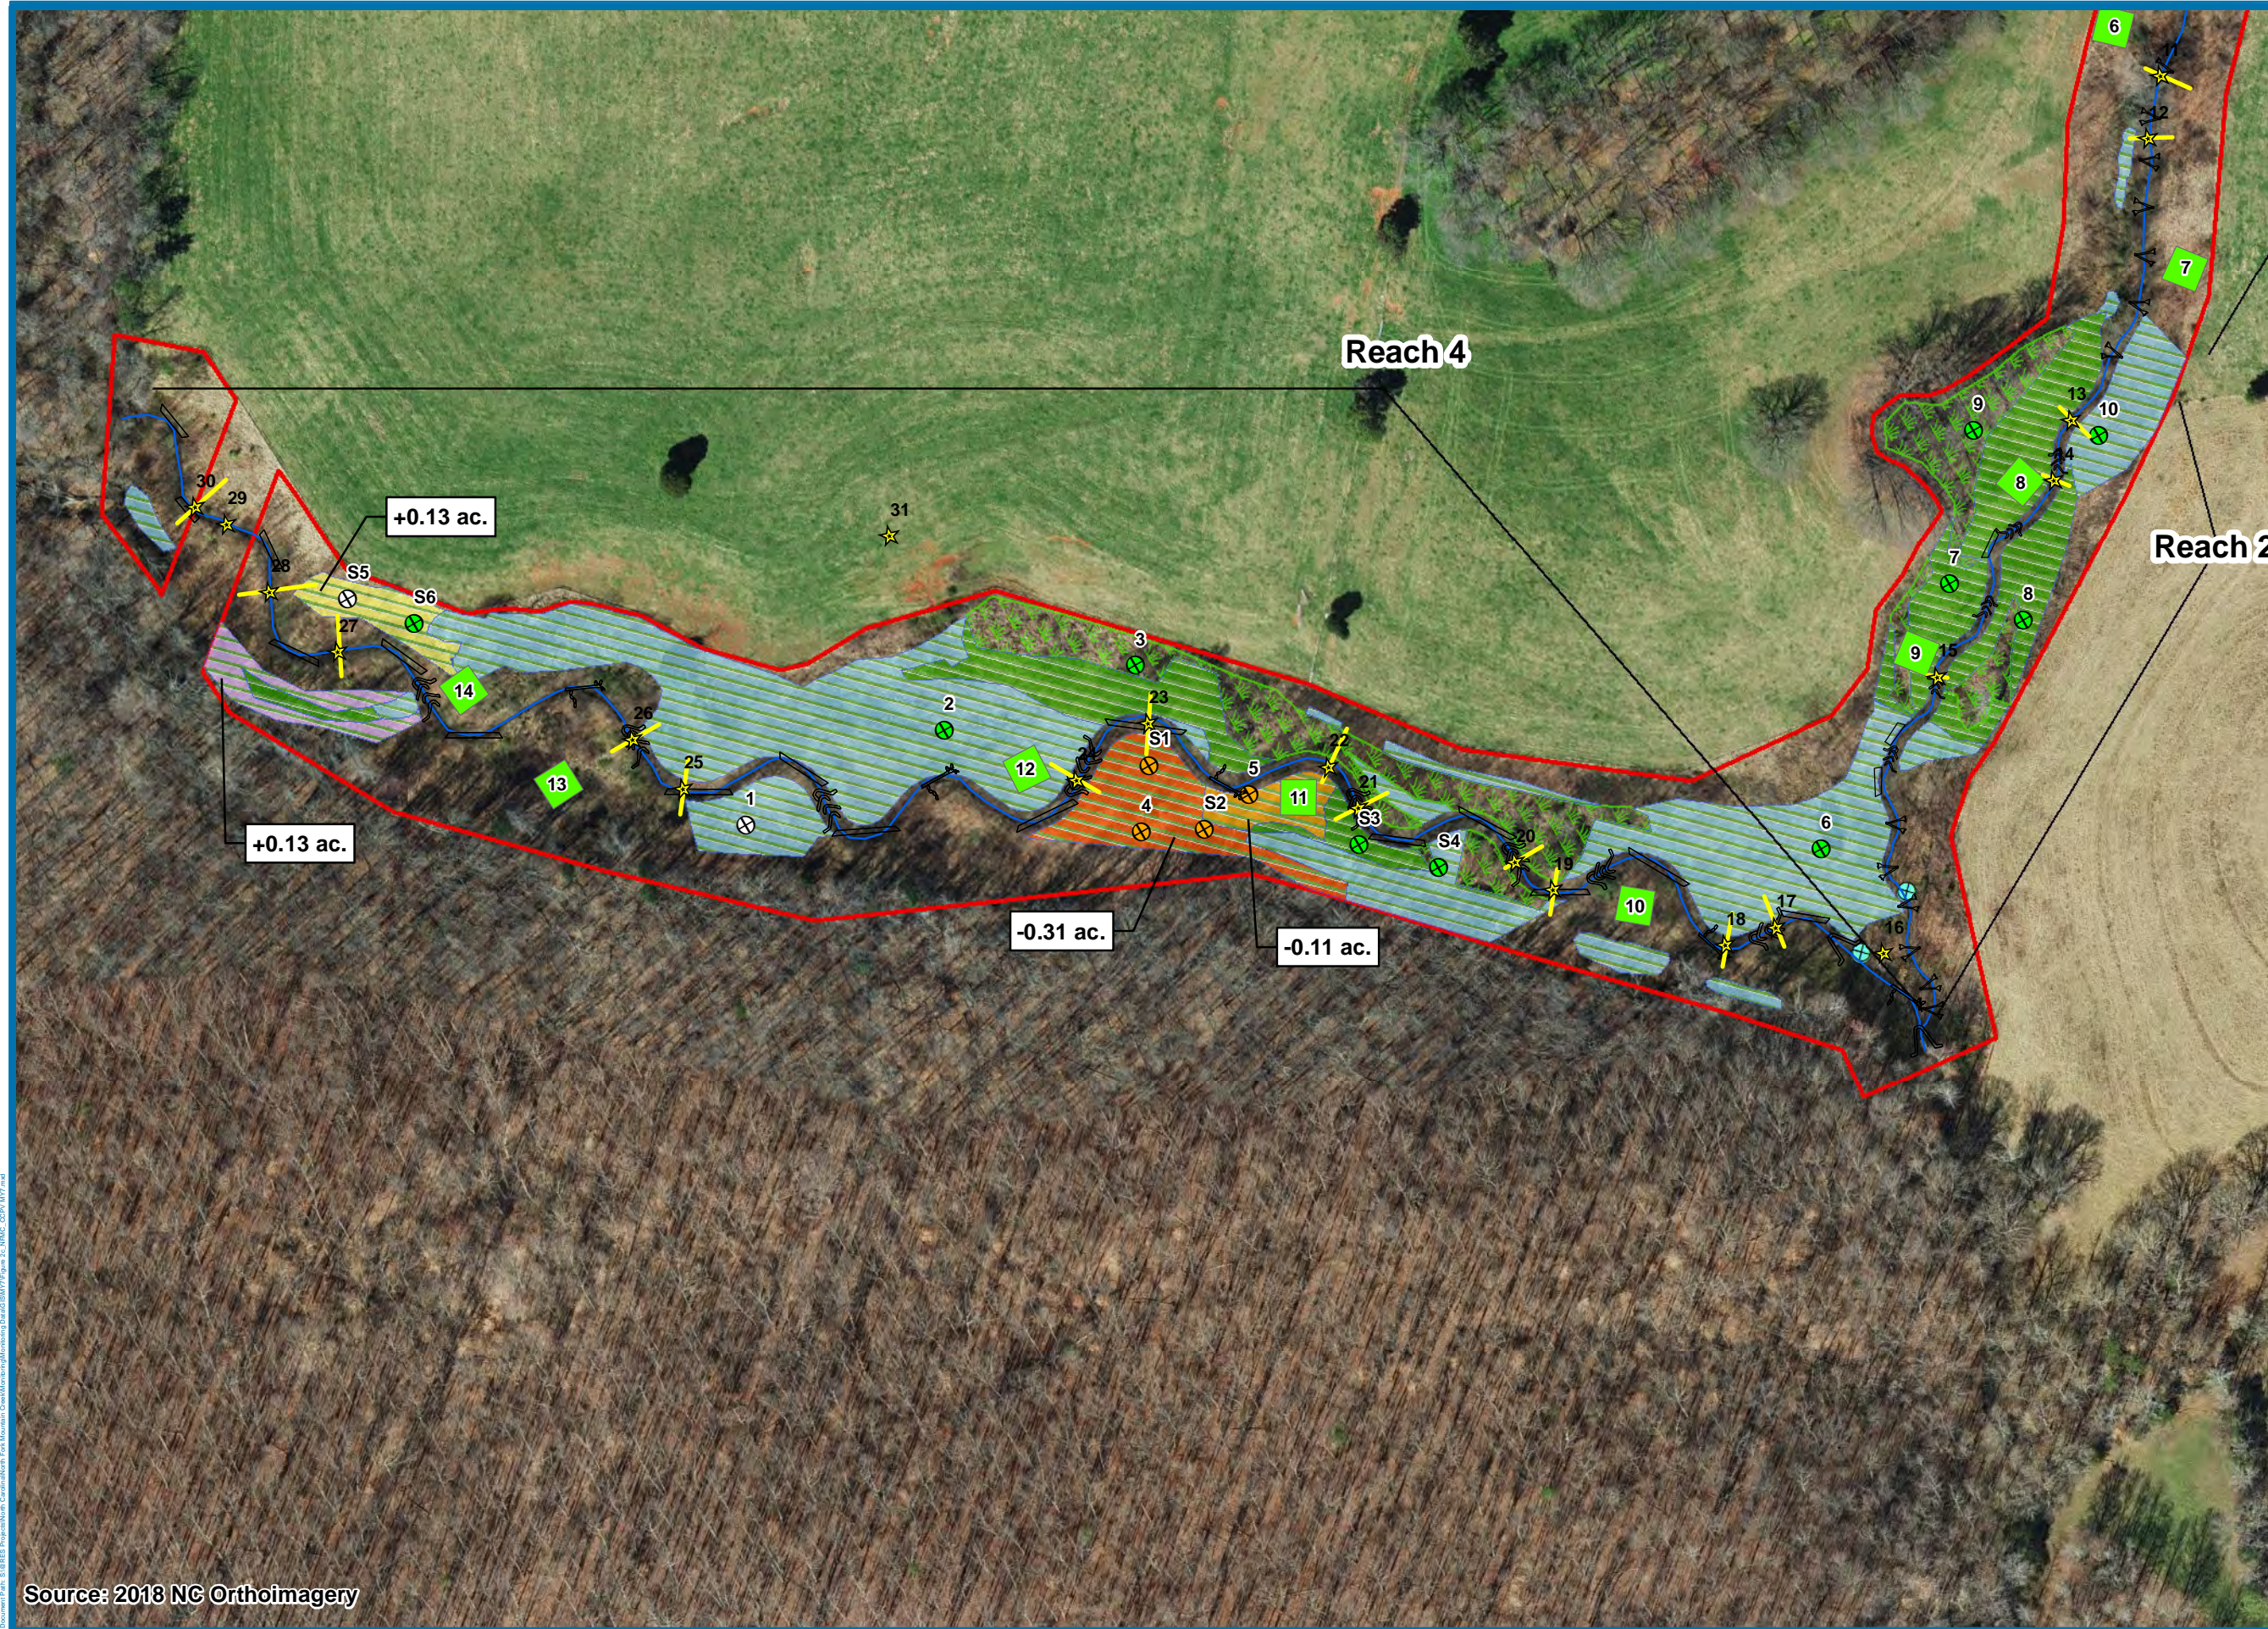
Figure 2c.
NFMC
Stream & Wetland
Restoration Project
MY7 2018

[The wetland area near wells NFMC-S1, NFMC-S2, NFMC-4, and NFMC-5 has consistently failed to meet hydrology success criteria over the monitoring period. This failing area sits at a higher elevation than the adjacent wetland restoration/creation areas, and lacks sufficient wetland hydrology needed to form hydric soils. In February 2019, RES staff delineated the failing area out of the crediting area. The failing area is comprised of 0.31 acres of wetland creation and 0.11 acres of wetland restoration. The 0.13 wetland creation area that RES proposed in MY4 2015 has exceeded success criteria in every monitoring year since installation. During the February 2019 site visit, RES staff delineated another expansion area of wetland creation located in a concave position along the upper right bank floodplain of Reach 4. This expansion area surrounds existing wetland restoration and creation areas and displays surface water/high water table, hydric soil, and hydrophytic vegetation. This has been added to the project performance section.](#)

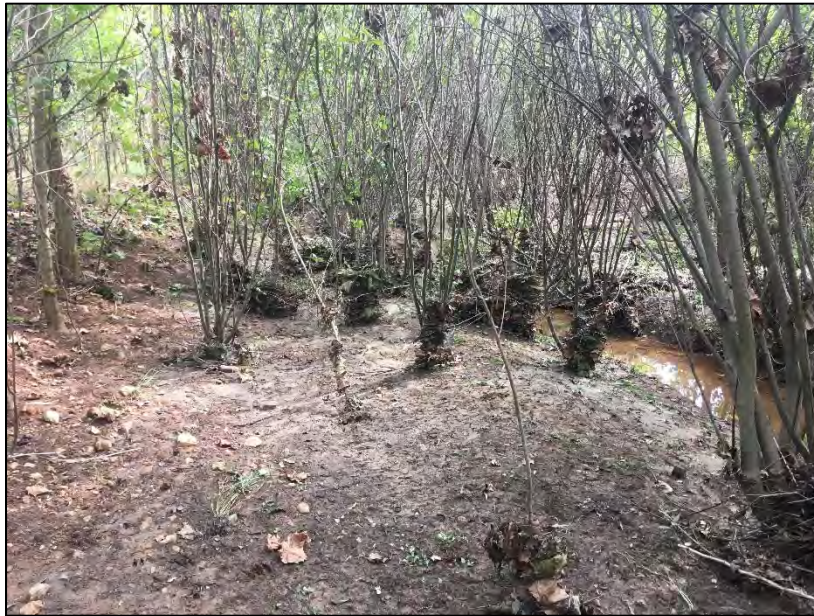
Wrack lines @ Reach 2
