Northgate Park (Ellerbe Creek) Stream Restoration Monitoring Report

DMS Project # 272 Contract#: 6230
USACE Action ID#: 200620453 DWR Project#: N/A
County: Durham
Monitoring Year 04*

Data Collection: 2015
Construction Completed: December 2008
Submitted: December 2015

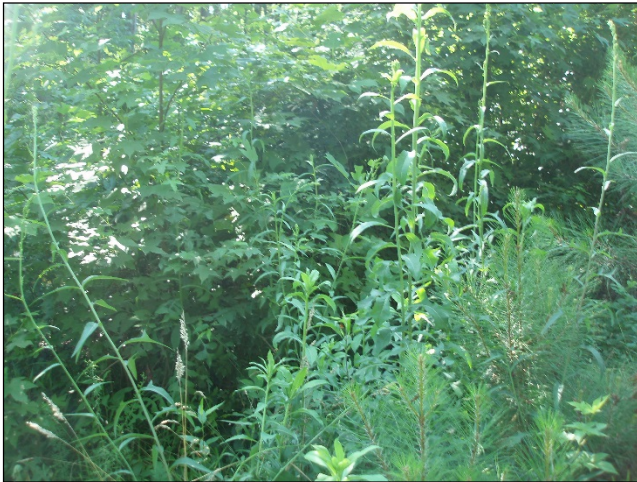
Plot 1 Photo – Taken looking southeast from the plot origin. MY04 – 6/29/15

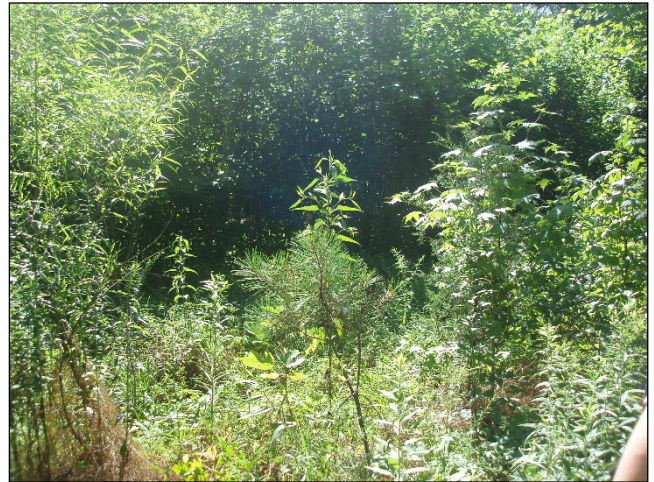
Plot 4 Photo – Taken looking south from the plot origin. MY04 – 6/29/15

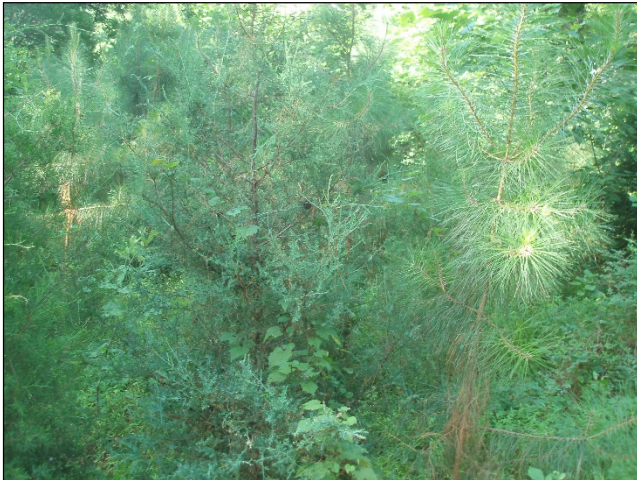
Plot 2 Photo – Taken looking south from the plot origin. MY04 – 6/29/15

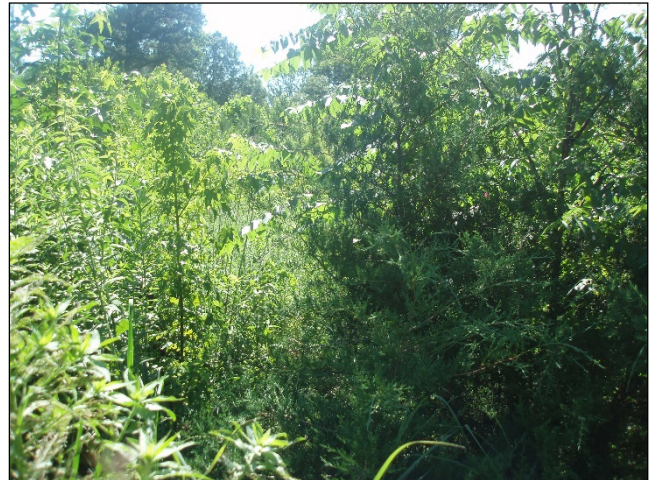
Plot 5 Photo – Taken looking east from the plot origin. MY04 – 6/29/15

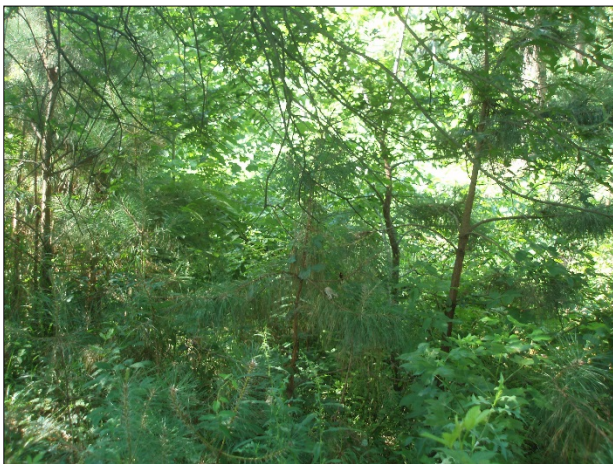
Plot 3 Photo – Taken looking east from the plot origin. MY04 – 6/29/15

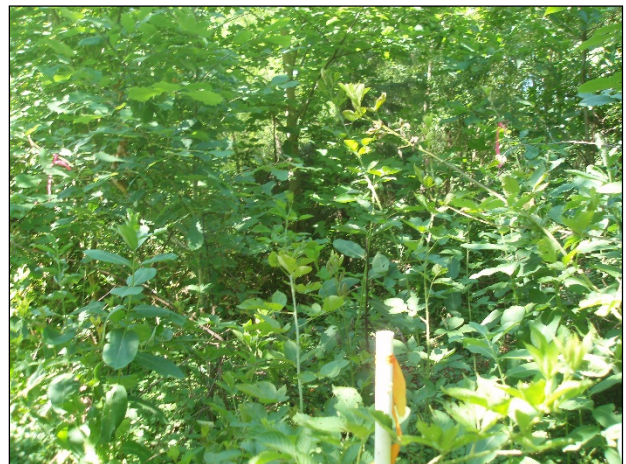
Plot 6 Photo – Taken looking south from the plot origin. MY04 – 6/29/15
