**Open Springs Mitigation Project  
Randolph County, North Carolina**

**Year 3 Monitoring Report**

**November 2007**

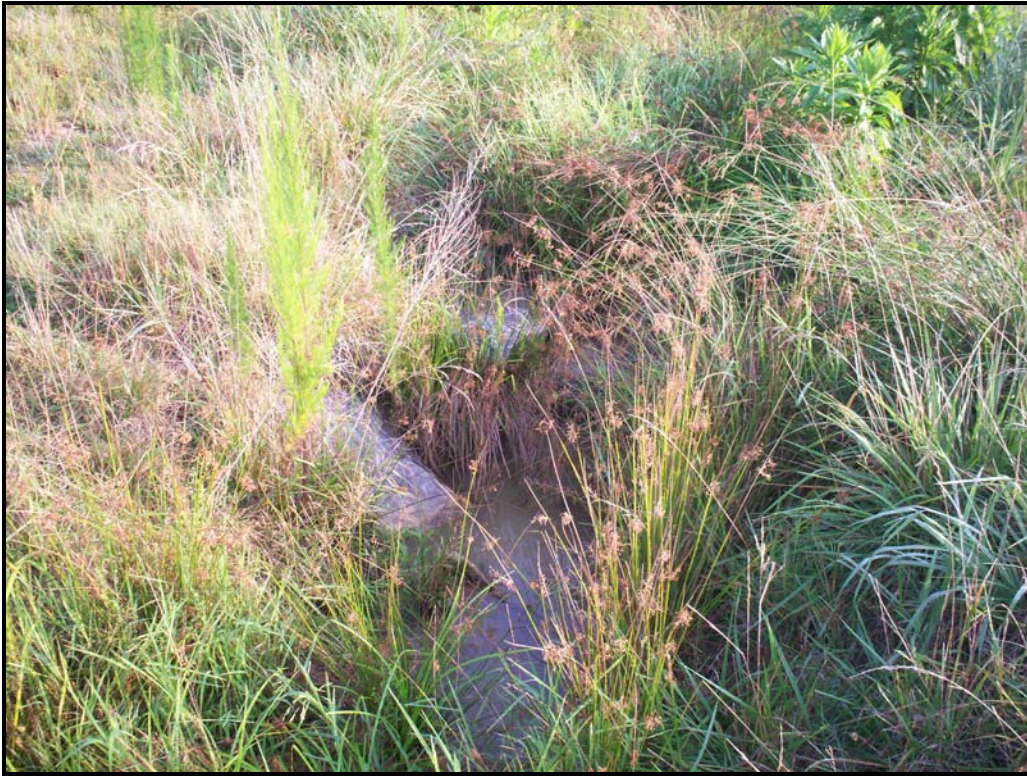
**Photo 3. Rock cross vane at STA 25+00 - looking upstream.**

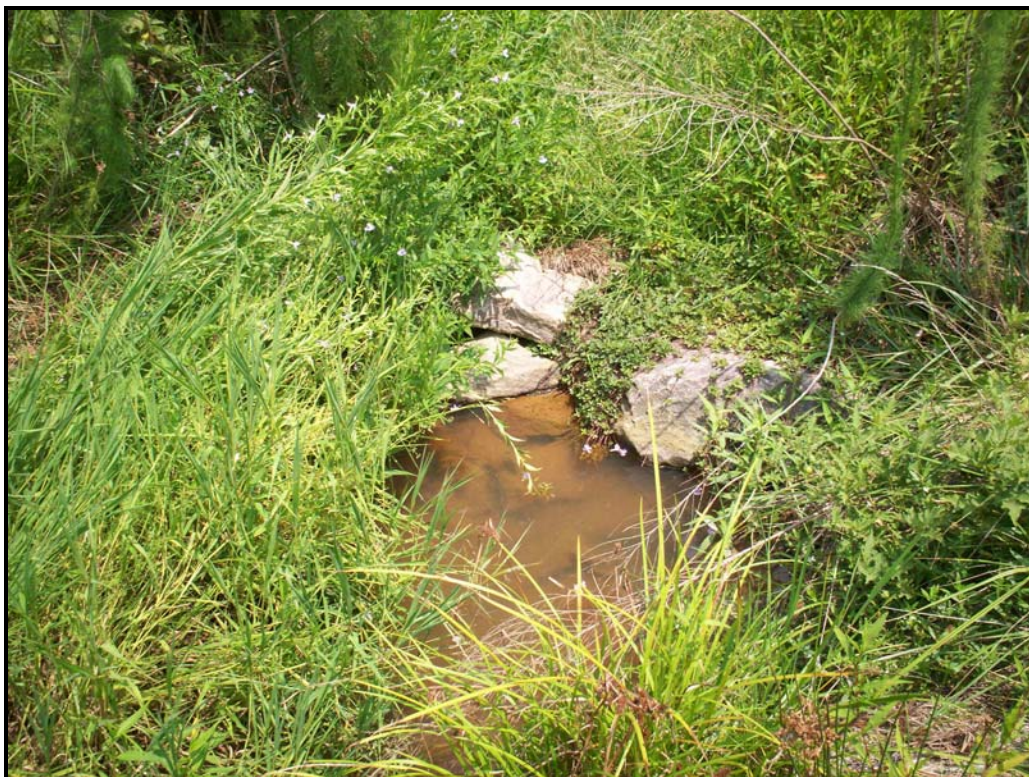
**Photo 6. Rock cross vane at STA 14+75 - looking upstream.**
