MY2 Monitoring Report

Owen Farms Mitigation Site
Transylvania County, NC

NCDMS Project No. 100064
NCDMS Contract No. 7532
NCDMS RFP No. 16-007334
(Issued 9/8/2017)

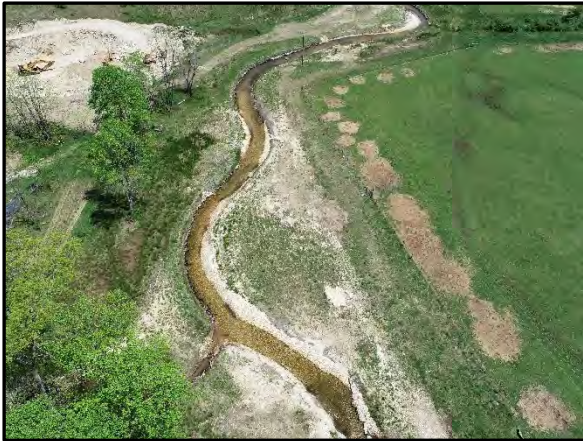
3.21 Aerial overview of West Fork French Broad River looking downstream, 5/10/2022

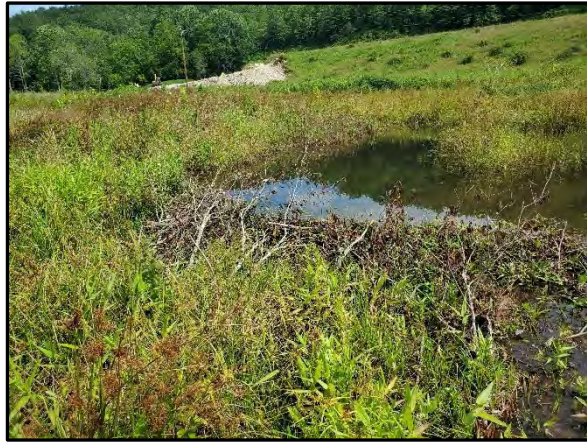
**3.37 Beaver dam on UT5 at STA 18+75,
8/17/2022**

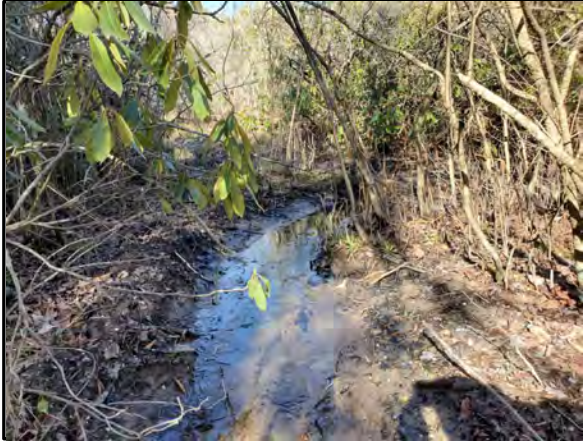
3.54 UT2 Single thread channel, 1/20/2022

8. IRT requested that a photo point be added on UT 2 to verify that a stream channel is present and active, given the beaver activity that was observed downstream of the easement.

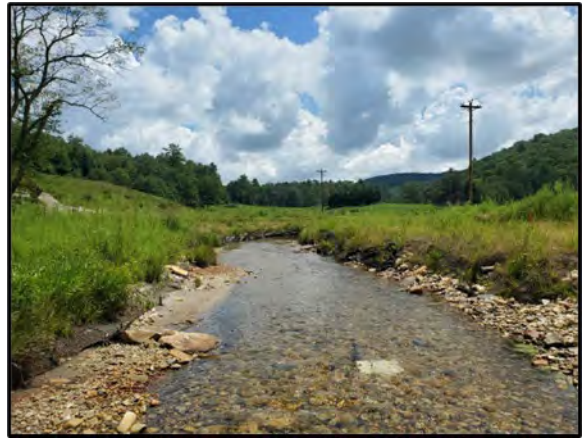
**4.2 West Fork French Broad Cross
Section 2: 8/18/2022**

With the exception of the areas listed in the section above, the vast majority of WFFBR has been stable over the past monitoring year. Cross section geometry along WFFBR has remained consistent with the As-Built condition with the exception of Cross Section 2 which experienced severe erosion along the right bank during the storm event in May 2022, which led to lateral migration of the cross section. Evidence of this can be seen in Figure 4.2 and Figure 5.3. It is worth noting that Cross Section 2 was surveyed prior to the repair activities in November 2022 where the right bank was built back closer to the As-Built condition and stabilized using sod mats.
