**ANNUAL REPORT FOR 2003**

**Paint Fork Creek Stream Mitigation Site (Brigmon Site)  
Madison County  
WBS Element 32573.4.1  
TIP No. A-10WM**

Prepared By:  
Office of Natural Environment & Roadside Environmental Unit  
North Carolina Department of Transportation  
December 2003

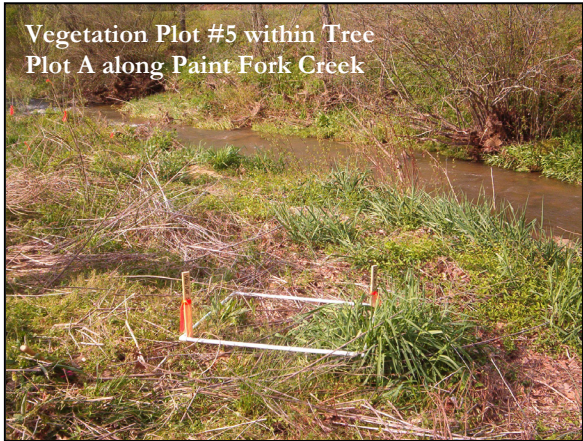
Plot 5. Canary grass, fescue, meadowrue, and henbit were observed in and immediately adjacent to the plot. No other woody stems were noted within five feet of the vegetation plot.

Vegetation Plot #5 within Tree Plot A along Paint Fork Creek

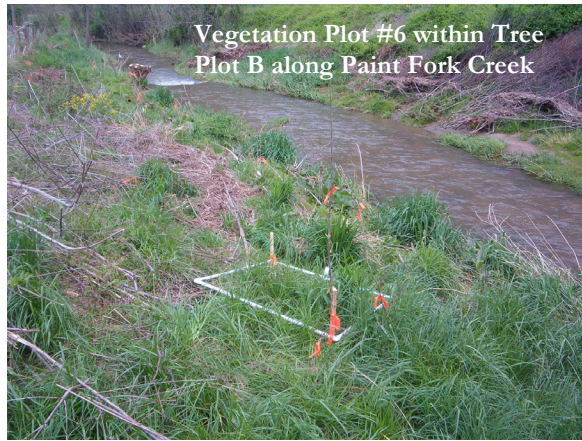
Plot 6. Canary grass, fescue, plantain, and meadowrue were observed in and immediately adjacent to the plot. In addition, two silky dogwoods and one green ash were noted within five feet of the vegetation plot.

Vegetation Plot #6 within Tree Plot B along Paint Fork Creek

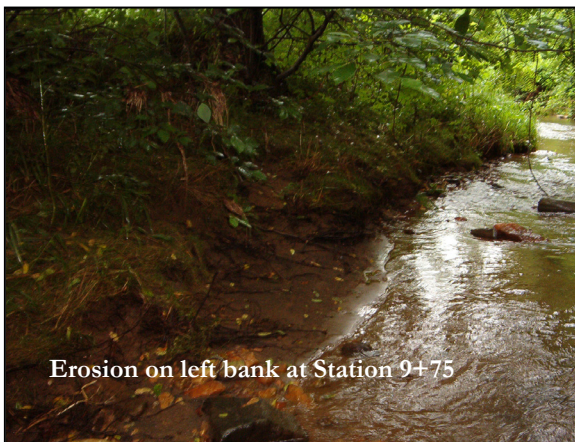
Erosion on left bank at Station 9+75
