**YEAR 3 MONITORING and CLOSEOUT REPORT**  
**for the**  
**BRIGMON MITIGATION SITE**  
**PAINFORK CREEK,**  
**MADISON COUNTY, NORTH CAROLINA**  
**EEP PROJECT NUMBER 92700**

Prepared in Partnership with the  
North Carolina Ecosystem Enhancement Program  
1652 Mail Service Center  
Raleigh, N.C. 27699-1652

North Carolina Wildlife Resources Commission  
Watershed Enhancement Group  
December 2008

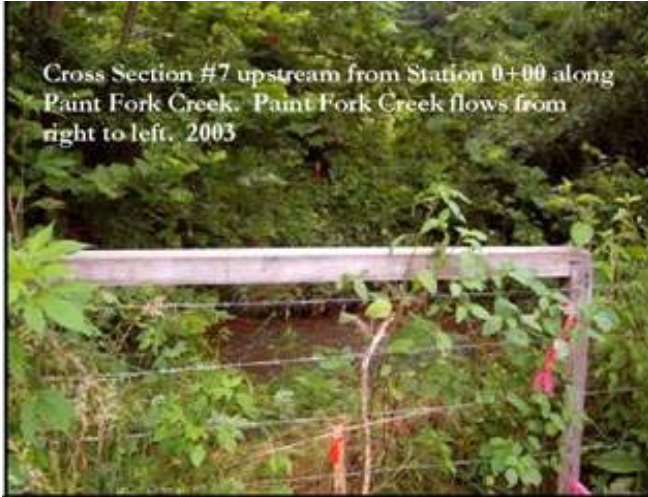
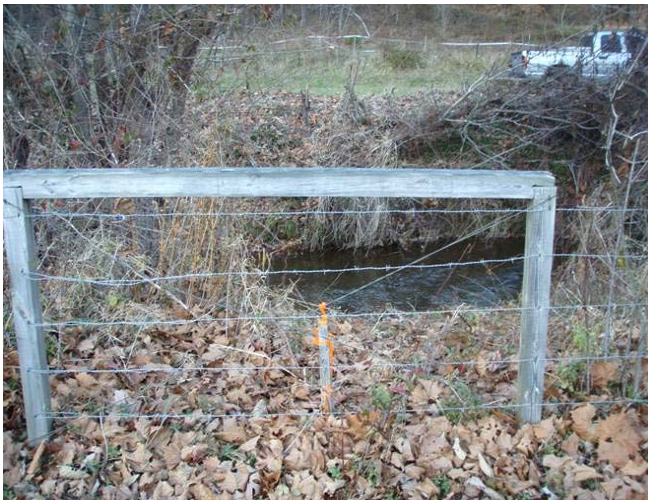
*Cross-section 7 (Run; Appendix Table A.1.).*—The left channel bank has degraded slightly ( $\approx 1.0$  ft) and the right channel bank has aggraded  $>0.5$  ft since project construction. However, during the MY3 survey both channel banks at this cross-section appeared stable. The thalweg degraded  $\approx 1.0$  ft following the as-built survey, as revealed during MY1 and MY2, but was found to be at the same elevation as the as-built thalweg elevation during the MY3. Although minor changes in channel bank location and thalweg elevation have been observed over the course of monitoring, this cross-section appeared stable with no areas of active erosion observed in MY3. The width/depth ratio for this cross-section was below 12.0 for MY2 and MY3, and the entrenchment ratio was 2.2 (slightly entrenched), making this cross-section an E stream type. Adjustments were not made to the right bank during construction because of the proximity to SR 1350.

Cross-section 7, left to right bank, March 2003.

Cross-section 7, left to right bank, May 2004.

Cross-section 7, left to right bank, December 2007.

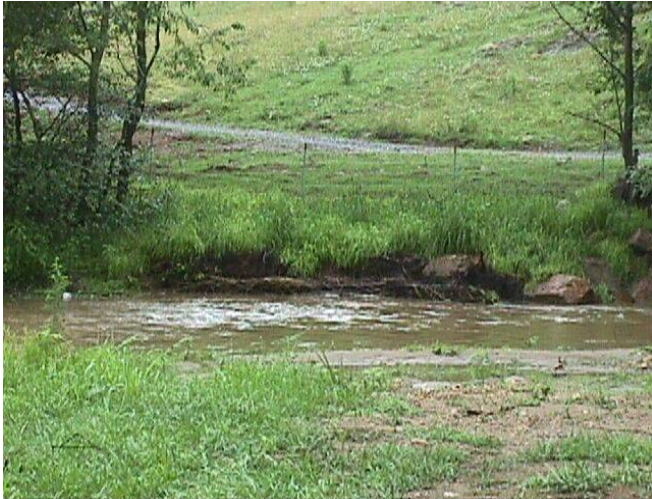
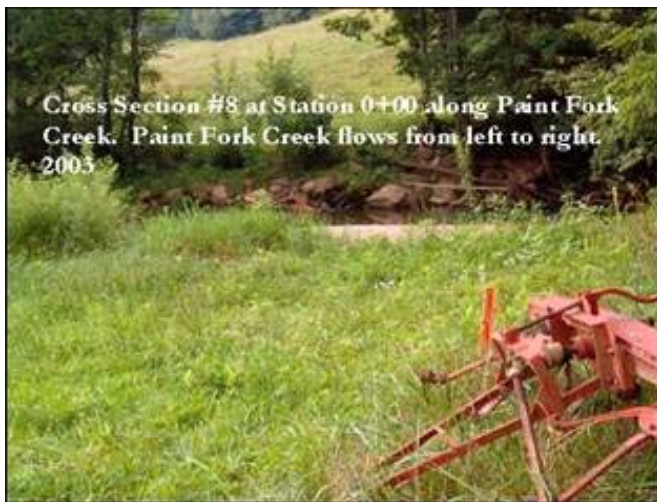
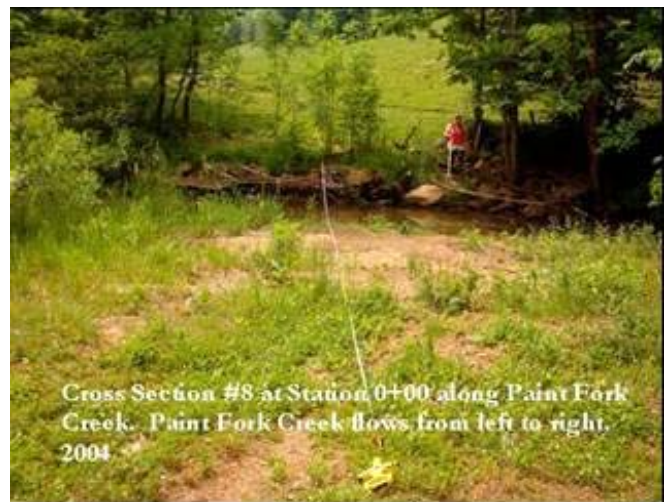
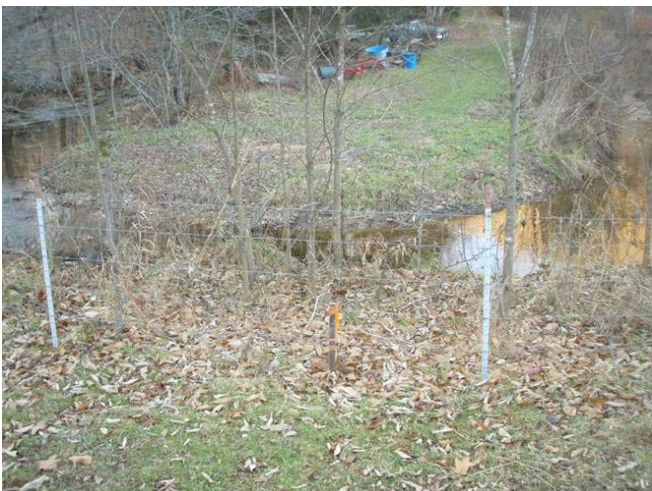
*Cross-section 8 (Pool; Appendix Table A.2.).*—Following the removal of automobile bodies and construction of a bench on the left bank at this location, cross-section 8 has remained stable with little observed change in the left bank location or thalweg elevation. Aggradation has occurred on the point bar side of this large meander bend since construction. Installed vegetation, along with boulder and root wad protection, on the outside of the meander bend have aided in the long-term stability of this cross-section. Bankfull mean depth values recorded during the MY1 and MY2 surveys combined with bankfull widths resulted in width/depth ratios exceeding 12.0, therefore outside the E stream type classification. However, the MY3 width/depth ratio was 11.4 suggesting an E stream type classification.

Cross-section 8, right to left bank, June 2000.

Cross-section 8, right to left bank, March 2003.

Cross-section 8, right to left bank, May 2004.

Cross-section 8, left to right bank, December 2007.

Cross-section 8, facing downstream, December 2007.

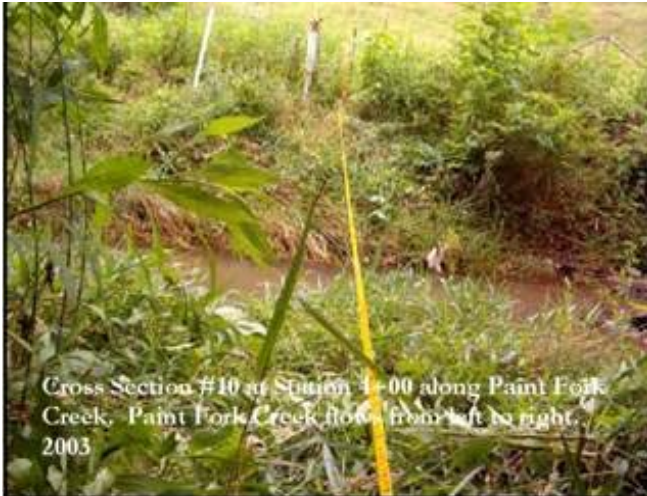
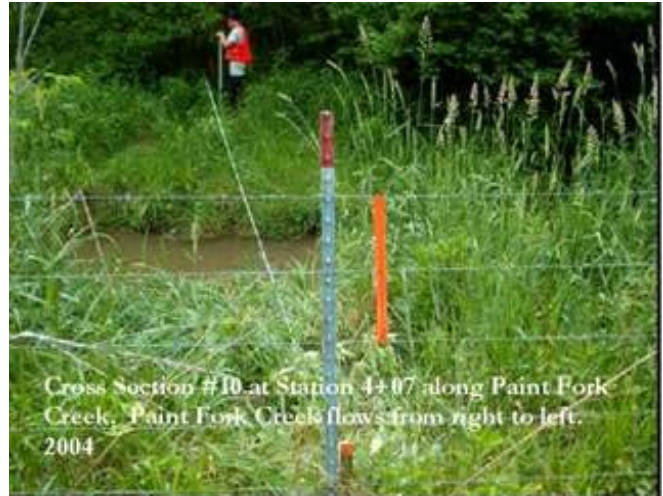
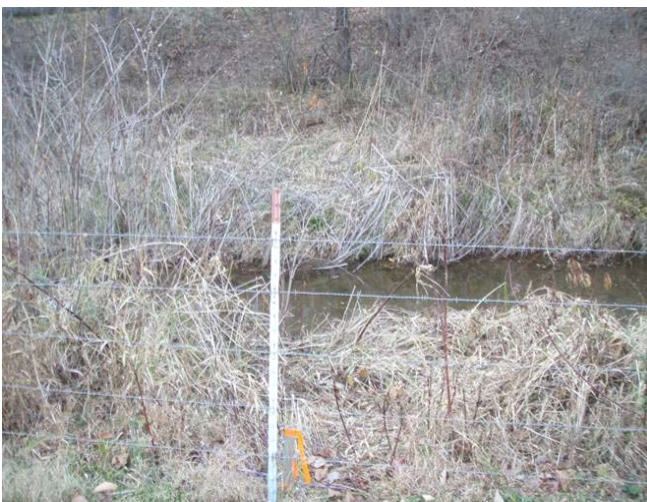
*Cross-section 10 (Run; Appendix Table A.4.).*—Channel dimensions at this cross-section have changed since the as-built survey in 2000. The left and right channel banks aggraded between the as-built survey and MY1, but the left bank then degraded  $\approx 1.5$  ft during the three years between the MY2 and MY3 surveys, although not to the contour found in the as-built survey. The thalweg elevation aggraded  $\approx 1.0$  ft following the as-built survey, but has remained at the same elevation during each of the three monitoring surveys. Vegetation observed along both channel banks was dominated by multiflora rose and various herbaceous species. Although the channel banks appeared stable with no active erosion during MY3, the reestablishment of woody

material was observed downstream of cross-section 9. A mid-channel bar has formed just upstream of cross-section 10 (sta. 18+00 to 18+40). Bar formation and aggradation of bed material at this location may be an artifact of a slightly over-wide channel (sta. 17+50 to 18+50) compared to the remaining lower portion of the reach. Channel width was observed to be narrower along the lower reach of the main stem compared to the pre-project condition. Active erosion and instability of channel banks and in-stream structures were not observed during the MY3 survey.

Cross-section 10, right to left bank, March 2003.

Cross-section 10, left to right bank, May 2004.

Cross-section 10, left to right bank, December 2007.

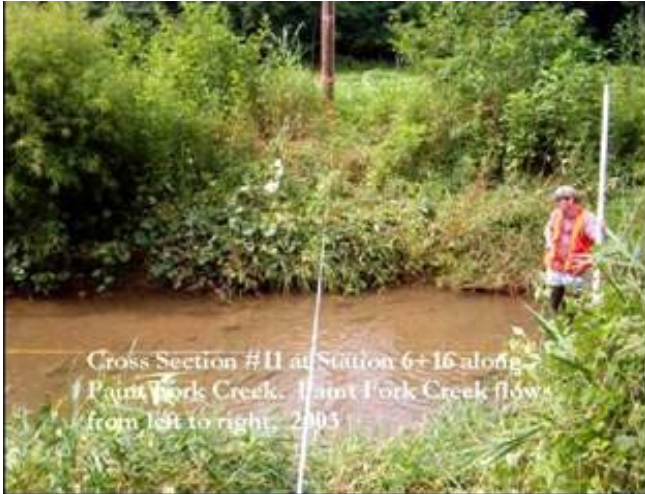
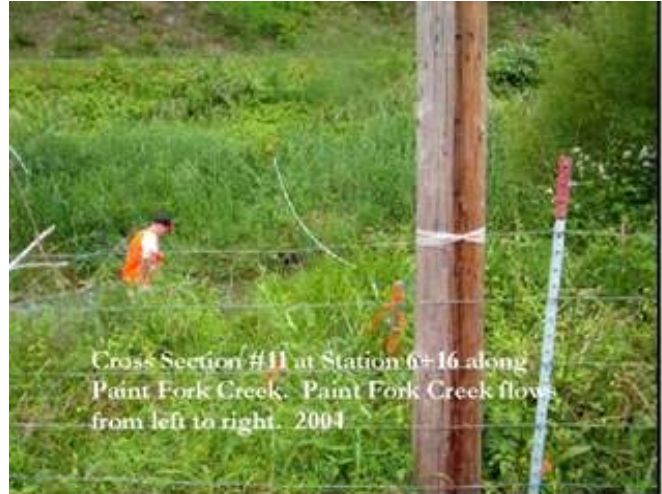
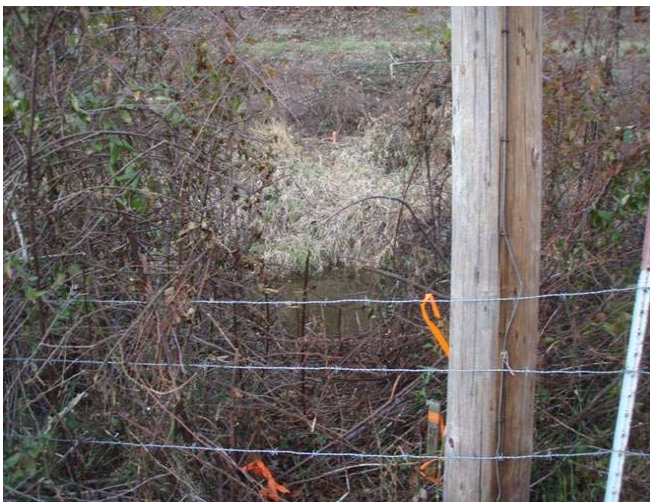
*Cross-section 11 (Glide; Appendix Table A.5).*—Channel dimensions at this cross-section have changed since the as-built survey in 2000. The left and right channel banks degraded between the as-built survey and the MY1 survey. Both channel banks have remained stable since the MY1 survey. Although the thalweg aggraded  $\approx 1.0$  ft following the as-built survey, it remained at the same elevation during each of the three monitoring years. The riparian vegetation primarily consists of multiflora rose and various herbaceous species. The channel banks appeared stable with no active erosion observed during the MY3 survey.

Cross-section 11, right to left bank, March 2003.

Cross-section 11, left to right bank, May 2004.

Cross-section 11, left to right bank, December 2007.

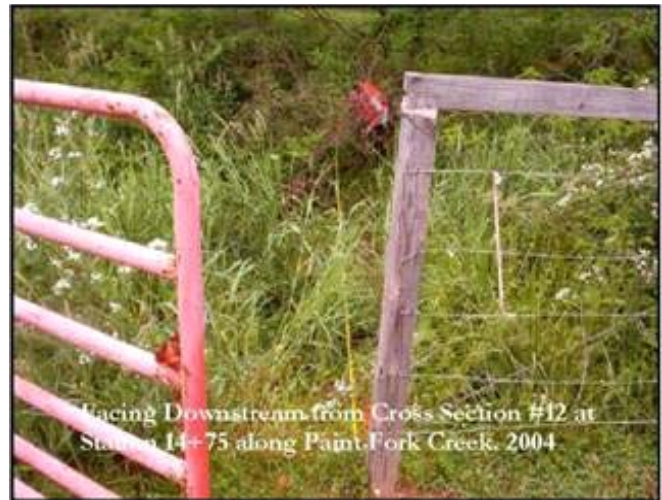
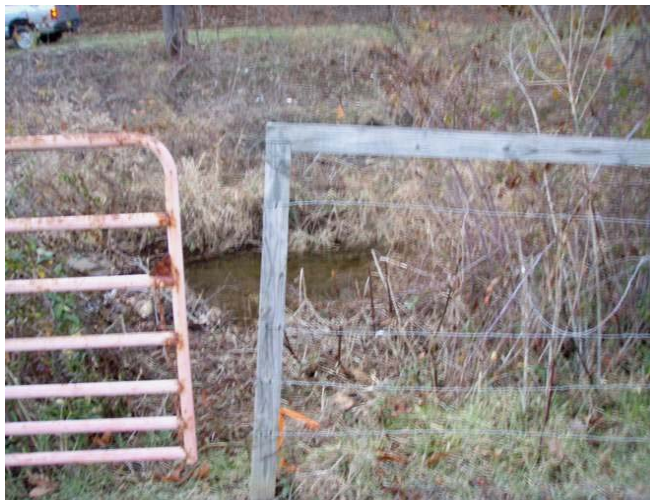
*Cross-section 12 (Run; Appendix Table A.6).*—The channel banks at this cross-section are stable with only minimal aggradation observed over the seven years since project completion. The thalweg aggraded  $>1.0$  ft between the as-built survey and MY1; however, no change in thalweg elevation has been observed during the three monitoring surveys. The observed aggradation may be the result of the in-stream structure (rock cross vane) directly below this cross-section contributing to the accumulation of bed material. In fact, the channel bed surface at this location was observed to be flat and dominated by finer particle sizes. This was observed at the two previous cross-sections as well, all of which are just upstream of in-stream structures. Otherwise, channel adjustments made following the as-built survey appeared to have stabilized and no areas of active erosion were observed during MY3.

Cross-section 12, facing downstream, March 2003.

Cross-section 12, left to right bank, May 2004.

Cross-section 12, left to right bank, December 2007.

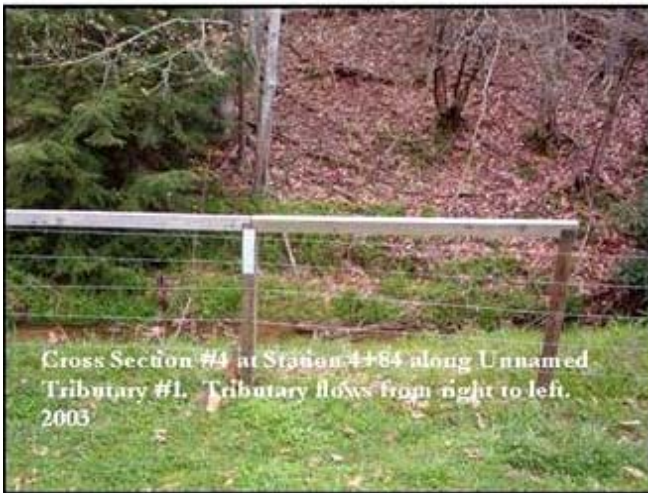
*Cross-section 4 (Riffle; Appendix Table A.7).*—The channel banks and thalweg at cross-section 4 have shown little evidence of change over the seven years since project completion. Minor aggradation on the left channel bank was noted between the as-built survey and the MY1 survey. Thalweg elevation has not changed since the MY1 survey. Variation in morphological values was noted during each of the three monitoring years (Appendix Table A.4.). Morphological values varied the most for MY1 when compared to MY2 and MY3. This variation is likely the result of a bankfull determination that was higher in elevation for MY1 than for MY2-3. Although the channel was moderately entrenched (1.9) in MY3, the left and right channel banks are stable.

Cross-section 4, left to right bank, March 2003.

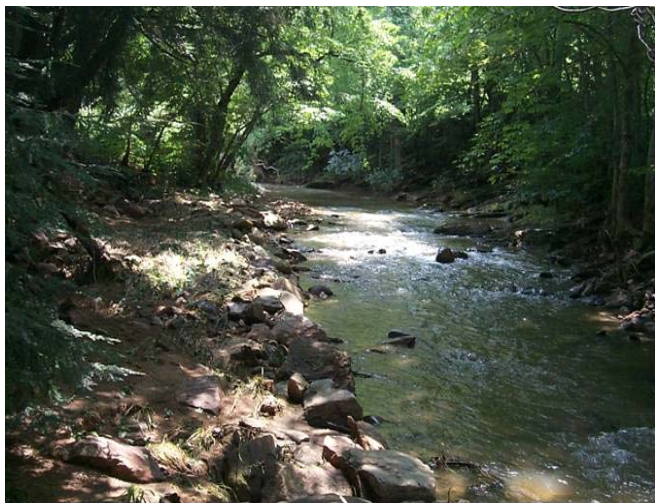
Bankfull photo, upstream to Cross-section 9, August 2, 2001.

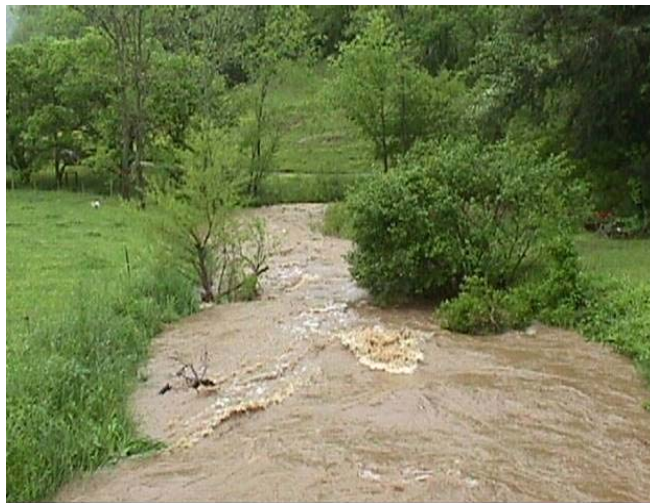
Bankfull photo, facing downstream from bridge, May 6, 2003.

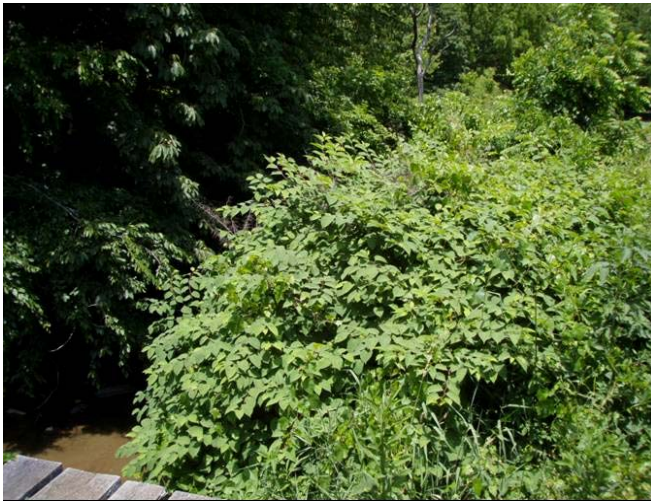
Photo sta. 1, facing upstream from bridge, June 2008.

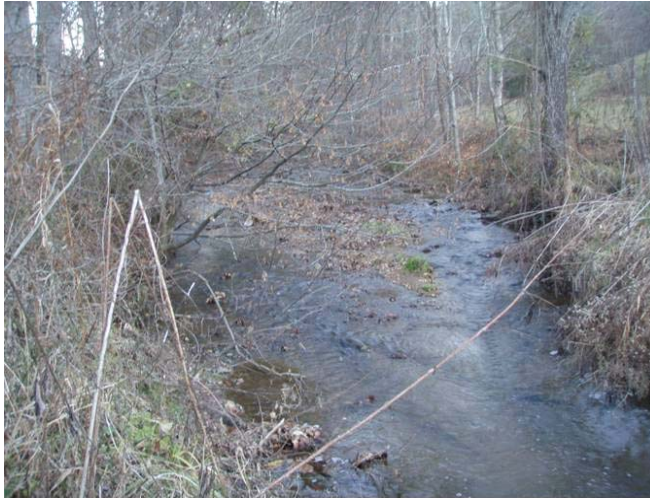
*Problem Areas.*—Observation of the riparian floodplain and the stream channel revealed a stable project area that is performing as desired seven years post-construction. Other than the previously noted mid-channel bar on Paint Fork Creek and short section of bank sloughing on the upper tributary, the problems identified during MY3 were in large part maintenance issues related to features associated with the farm management plan and not the physical or biological condition of the stream channel or riparian area.

Photo sta. 3, channel bar facing upstream, December 2007.

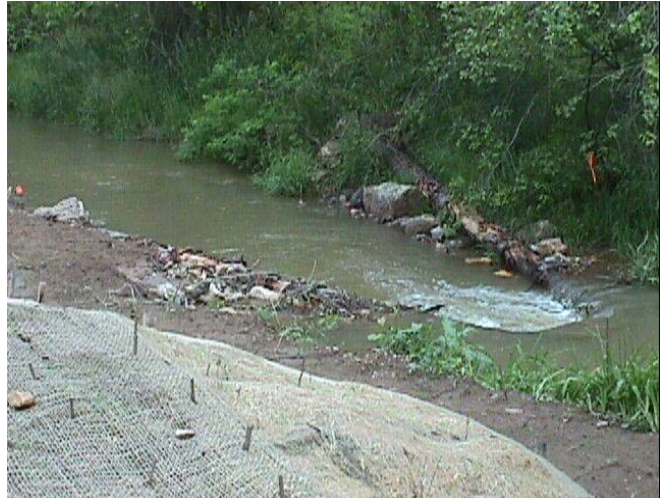
Photo sta. 4, hemlock vane facing downstream, May 2000.

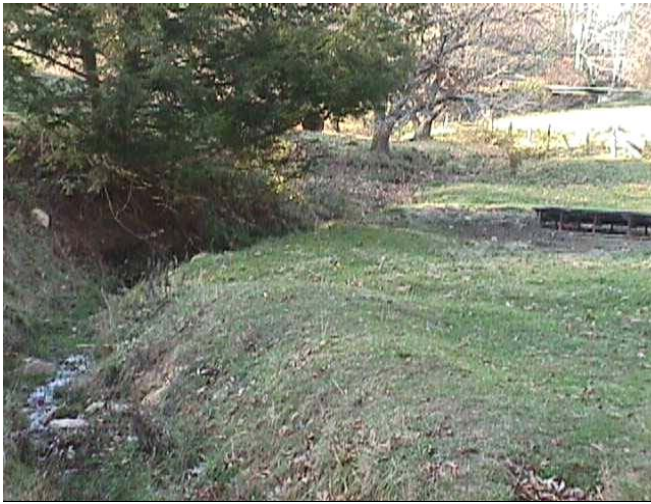
Photo sta. 5, upper tributary facing downstream, November 1999.

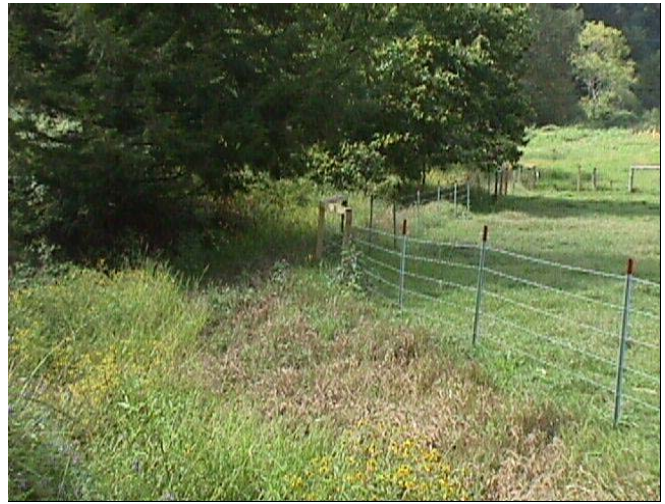
Photo sta. 5, upper tributary facing downstream, September 2000.

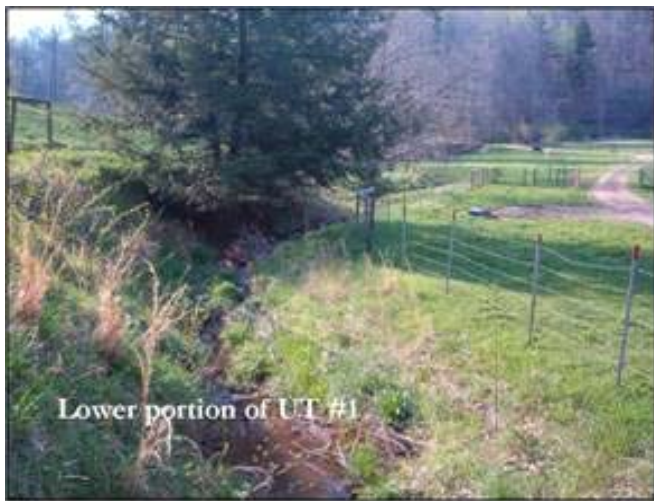
Photo sta. 5, upper tributary facing downstream, March 2003.

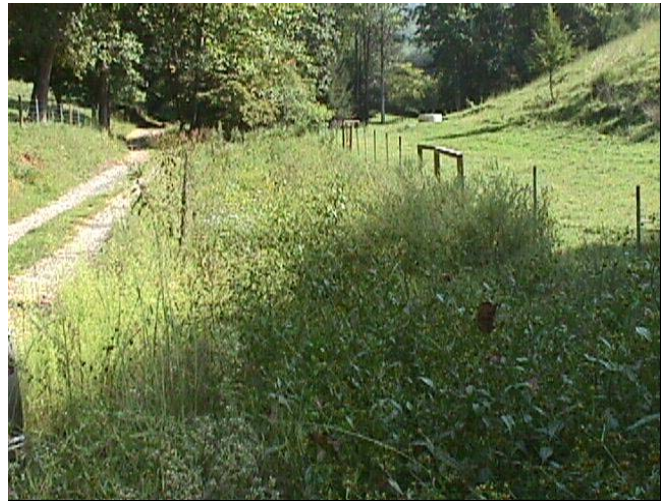
Photo sta. 6, lower tributary facing upstream, September 2000.

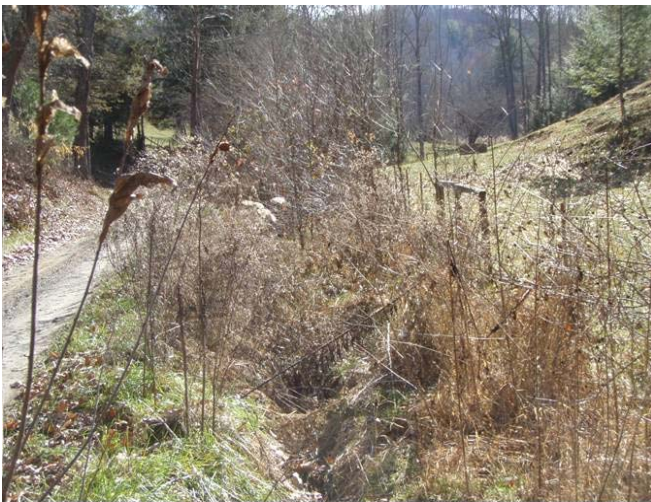
Photo sta. 6, lower tributary facing upstream, December 2007.

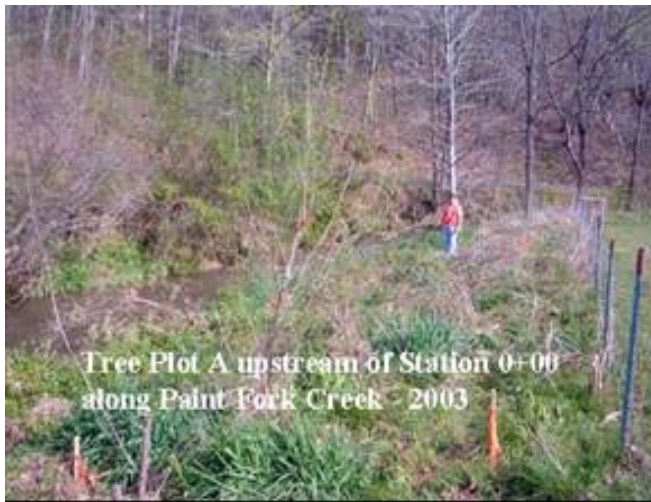
Tree plot A, left bank, facing upstream, March 2003.

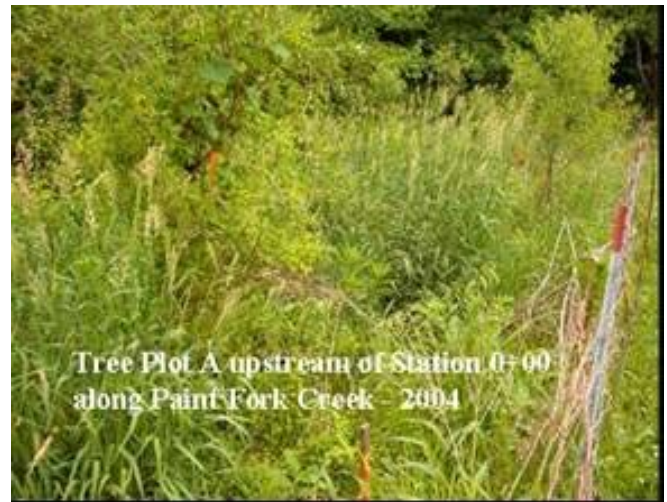
Tree plot A, left bank, facing upstream, March 2004.

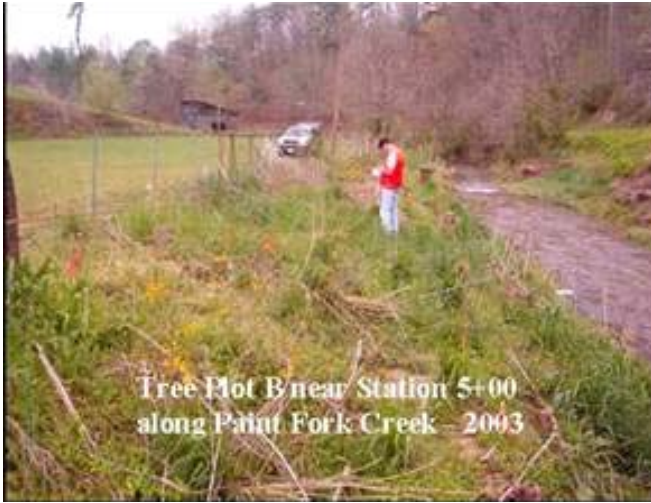
Tree plot B, left bank, facing downstream, March 2003.

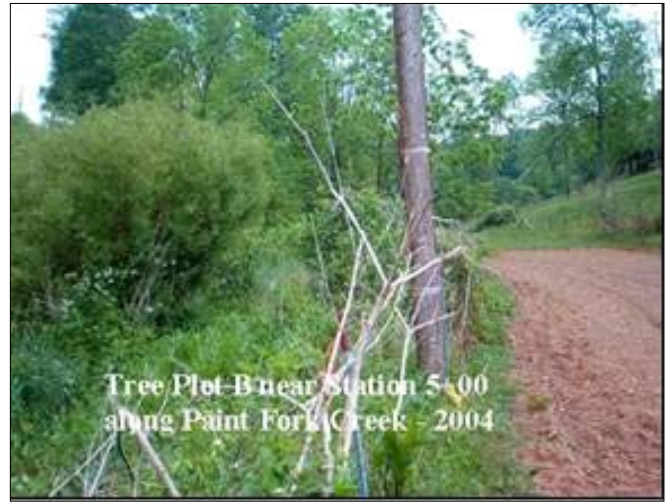
Tree plot B, left bank, facing upstream, May 2004.

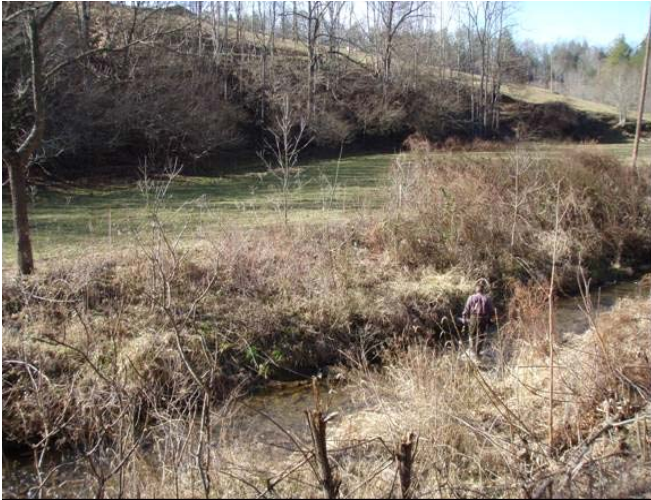
Tree plot B, right bank, facing downstream, January 2007.

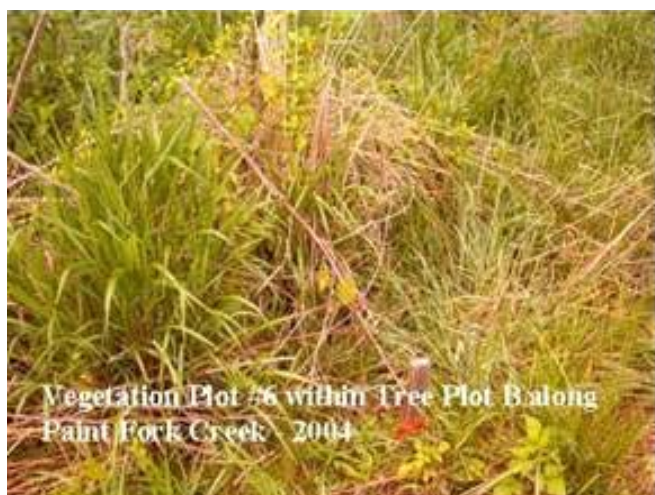
Vegetation plot 6, left bank, May 2004.

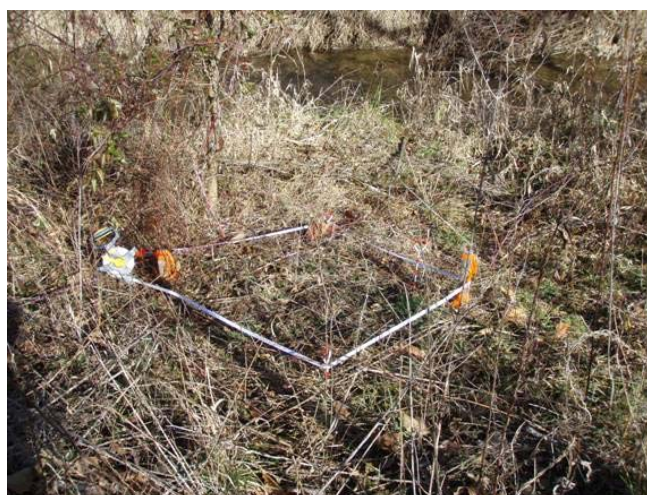
Vegetation plot 6, left bank, January 2007.
