Annual Monitoring Report

Monitoring Year 5 of 7

Pee Dee Stream Restoration Project

NCDMS Project No.: 95350

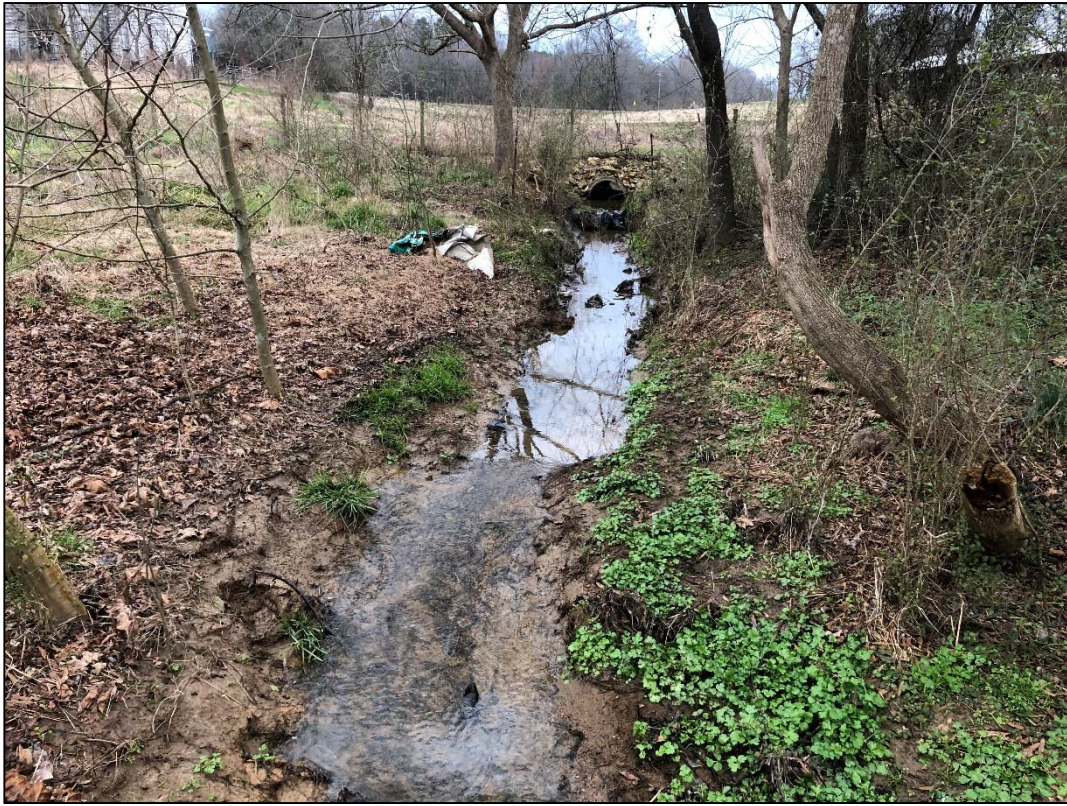
Thompson 1 above old pond looking upstream at new crossing

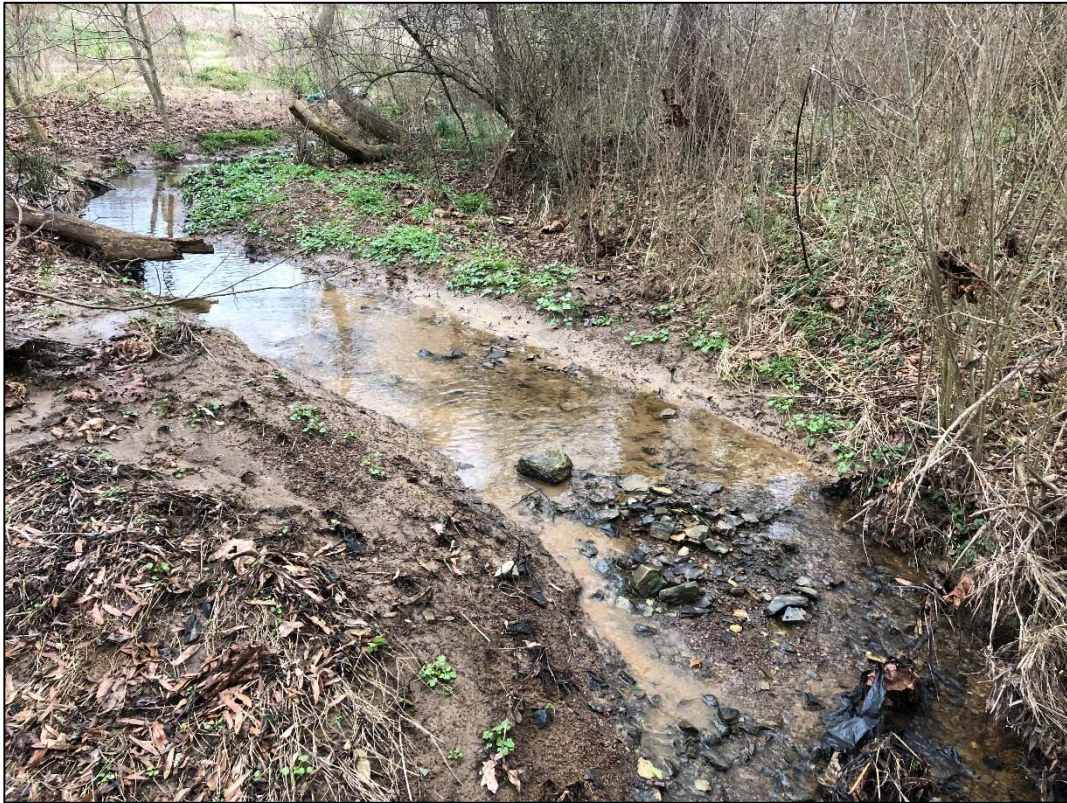
Thompson 1 above old pond looking upstream

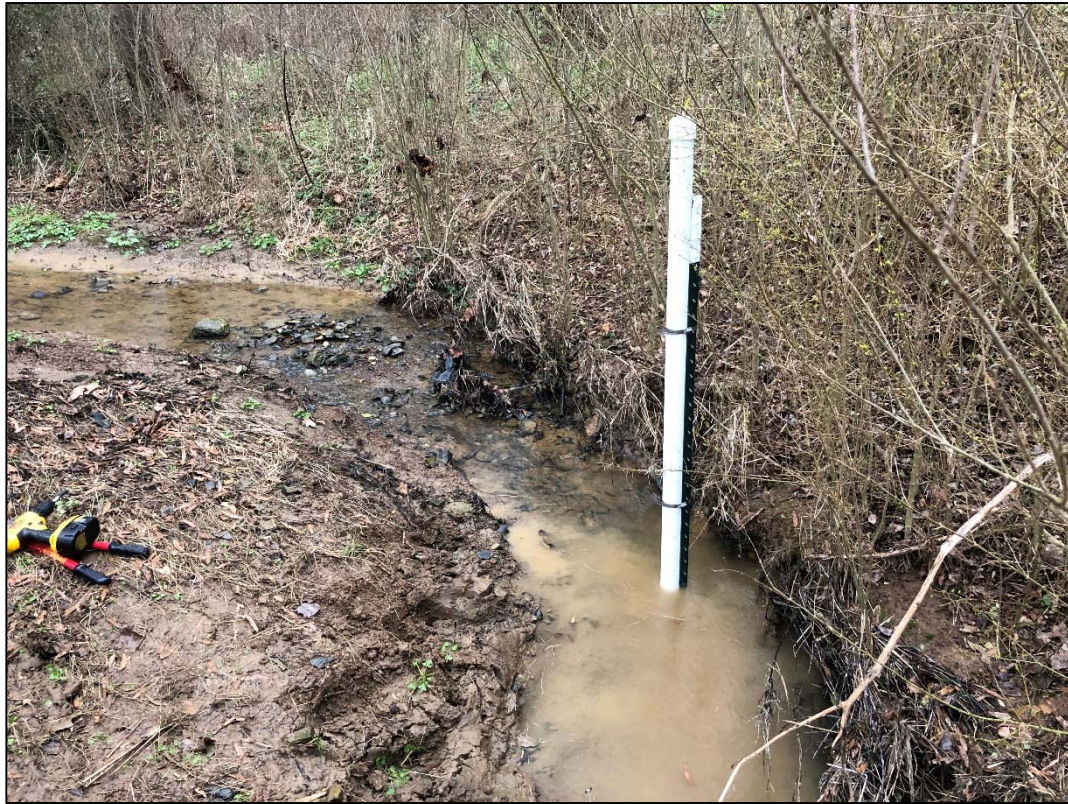
Thompson 1 above old pond looking upstream

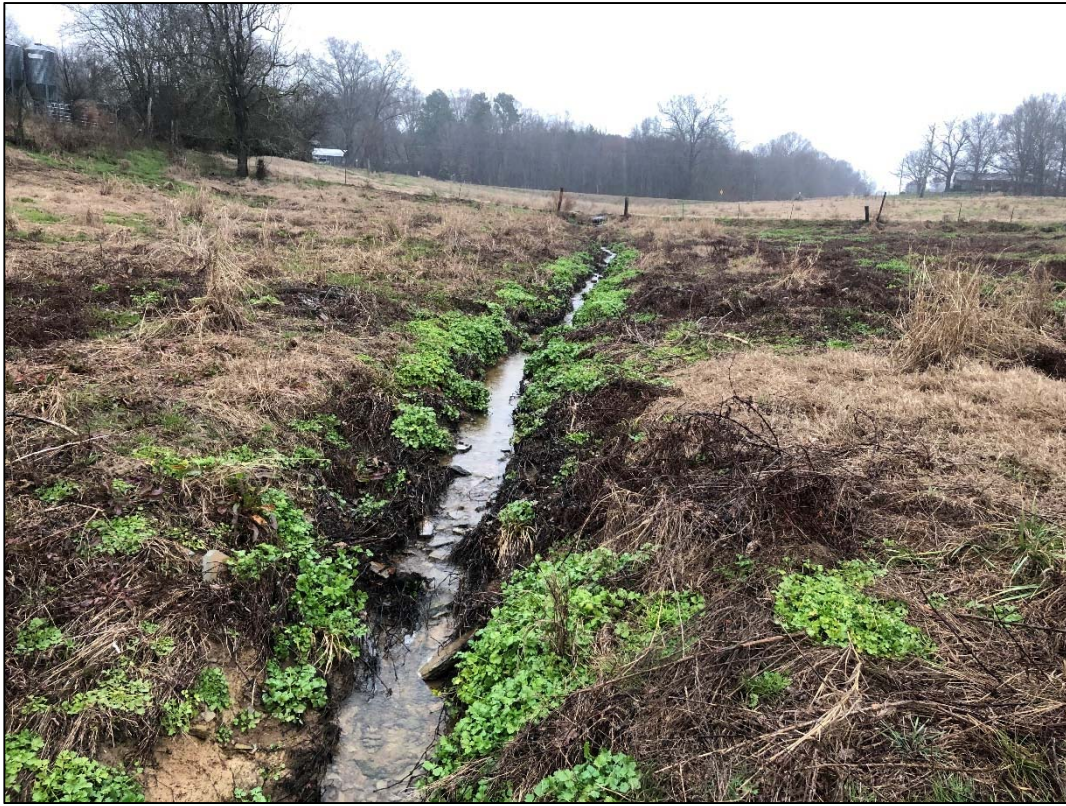
Following dam removal, the pond bottom cracked as it was drained. The cracks in the soil are up to a few feet deep. Any surface water that enters the pond bottom is lost into the cracks and a single-thread flow path is difficult to locate. Due to risk and budgetary constraints, RES does not plan on doing any work in this area.

Thompson 1 above old pond looking downstream into pond bottom

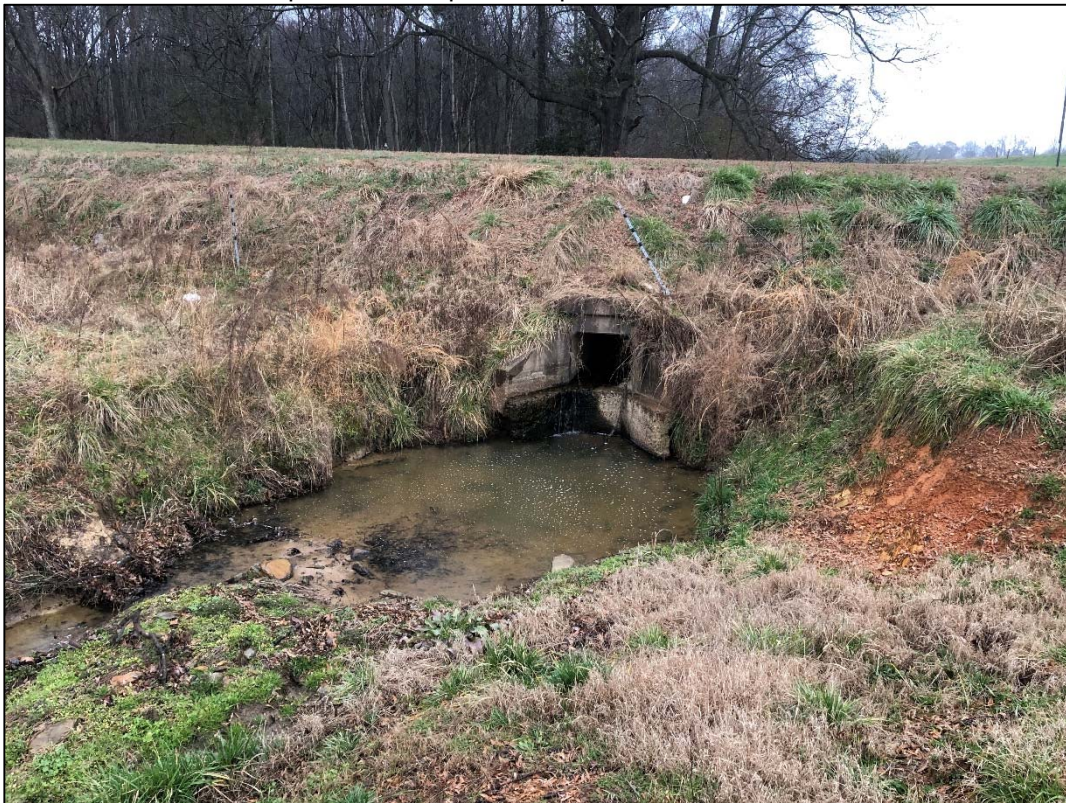
Thompson 1 in the pasture upstream of the easement

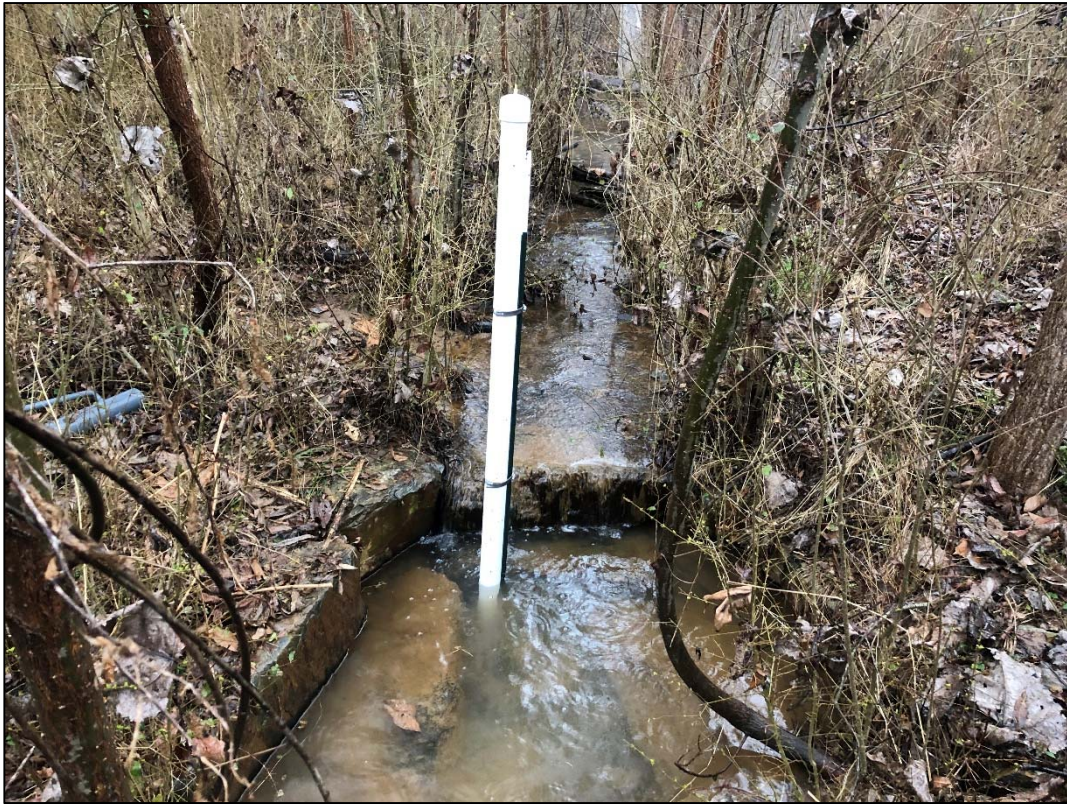
Thompson 1 looking upstream at Pee Dee Road

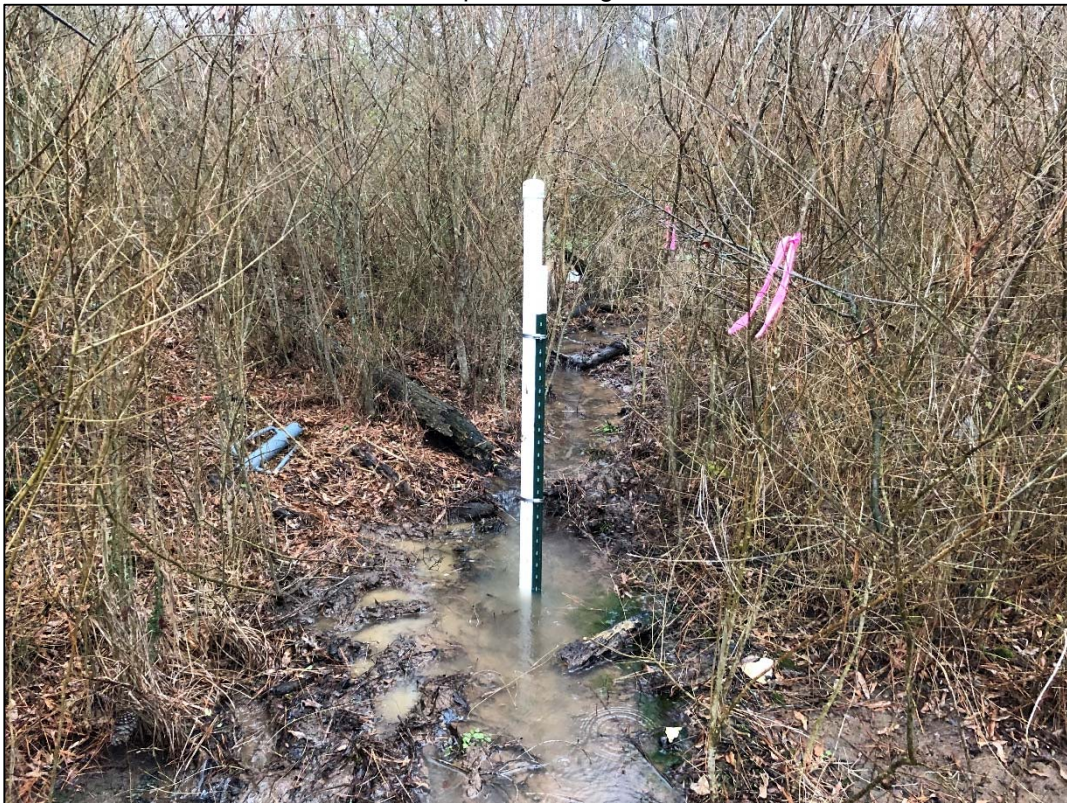
Dale 1 in old pond looking downstream
